HECO Report

March 3, 2004

Pukele Substation Outage

Dated May 11, 2004

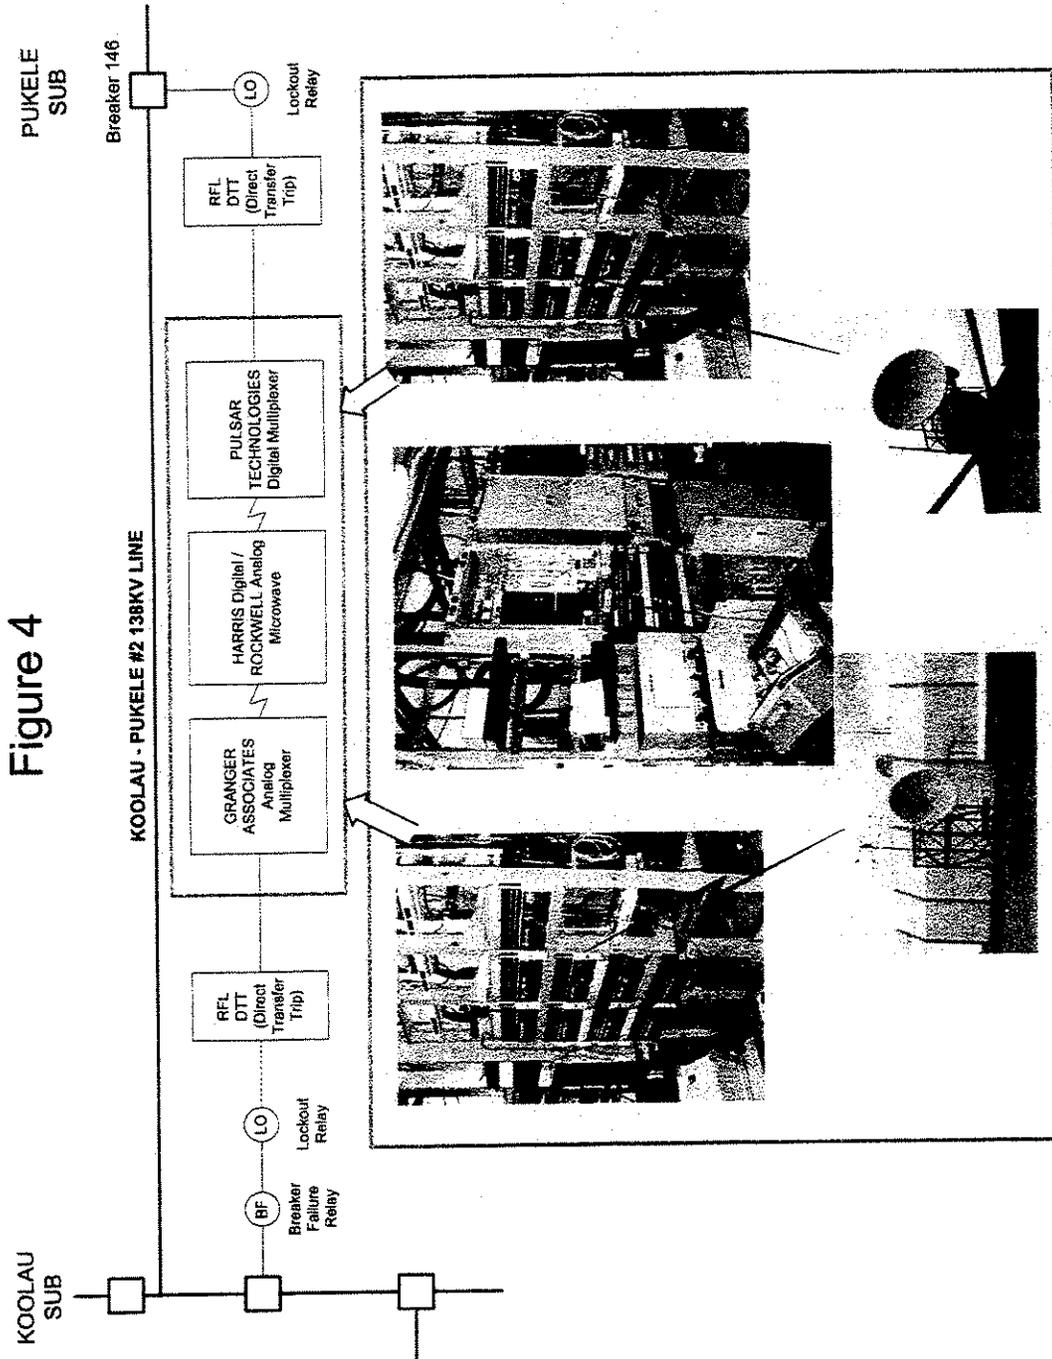
Figure 4 Basic Communications Path for the Koolau-Pukele #2 138 kV line

4. It is believed that the continuously transmitted POTT trip signal emanating from Koolau breaker No. 122, and which was assigned to multiplexer channel 14, was misrouted or "hopped" to channel 13 when synchronization was lost. Channel 13 is assigned to the Koolau-Pukele No. 2 breaker failure DTT (direct transfer trip). When the DTT received this trip signal, it immediately tripped open Breaker No. 146, removing

A loss of synchronization of the Harris digital microwave communications equipment created a loss of synchronization of the Pulsar digital multiplexer, allowing the continuously transmitted POTT (permissive overreaching transfer trip) signal from the Koolau No. 1 138 kV Breaker No. 122 to be misrouted (channel-hopped) into the Pukele No. 2 138 kV Breaker No. 146 breaker failure DTT (direct transfer trip) channel. This immediately tripped Breaker No. 146 and resulted in the loss of power to the Pukele Substation.

1. The POTT signal for the Koolau-Pukele No. 1 138 kV transmission line was separated from the breaker failure DTT signal for the Koolau- Pukele No. 2 138 kV transmission line in the digital multiplexer channels. This work, which is consultant recommendation #2, was completed on April 6, 2004. The POTT signal for Koolau-Pukele No. 1 line precedes the breaker failure DTT signal for Koolau-Pukele No. 2 line, and the two channel assignments have been separated so they are no longer adjacent. As stated earlier, with POTT preceding DTT, any future channel-hopping event will not cause an inadvertent breaker trip. In addition, by placing the POTT signal on channel 3 and leaving the DTT signal on channel 13, this eliminates any possibility channel-hopping creating a repeat occurrence. Figure 8 shows the new channel configuration.

2. Work is underway to place the breaker failure DTT equipment on a different frequency from the POTT permissive signal (consultant recommendation #1). By using different frequencies, the transfer trip equipment for either POTT or DTT protection scheme will not recognize a trip signal from the other scheme should the communications system coincidentally experience a loss of synchronization and a possible misrouted trip signal to other transfer trip equipment. This is to ensure that a channel-hop event will not cause a repeat occurrence. The crystals have been received from the vendor and this work will be completed by the end of May 2004.

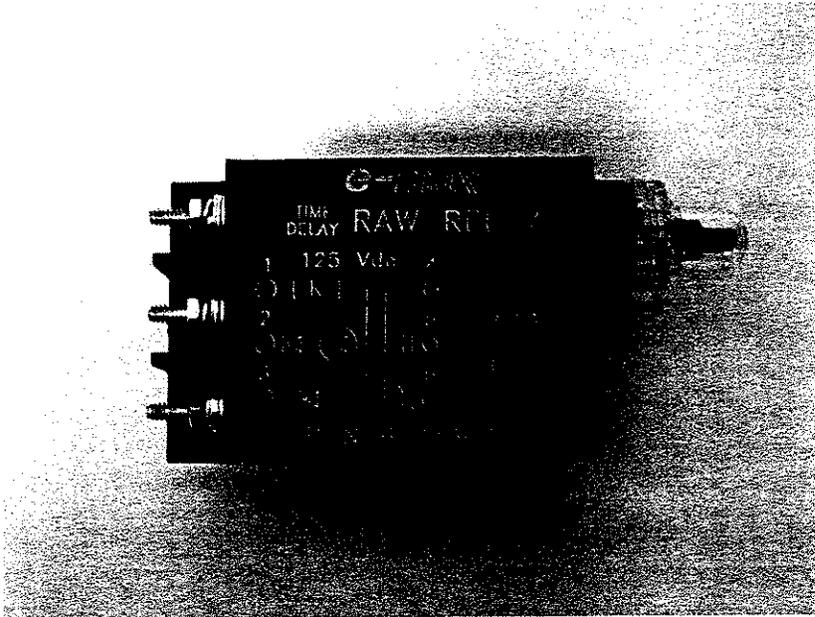
Figure 6 DC Voltage Relay 74 RAW

Situation 2 was initially thought to be a potential cause of the unexpected operation of the DTT scheme at Pukele Substation. Upon replacing the relay, it turned out that the LED indicator lamp was shorted. A bench test of the relay, witnessed by Power Engineers, Inc., indicated that despite the shorted indicator lamp, only 6 milliamps more passed through the device compared to a similar relay. It was within normal specifications. It takes approximately 1 ampere (1000 milliamps) of current to “pick up” or energize the trip coil at Pukele Substation. Situation 2 was therefore ruled out as a possibility (See Figure 6).

2. The 74 RAW DC voltage relay at the Pukele substation ("Pukele") had a burned out LED. If this relay had failed and allowed enough current to pass, it could have tripped the 86TT without any other indication. This was ruled out by testing the 74 RAW relay and the 86TT relay and confirming that the 74 RAW relay would only transmit 6 milliamps while the 86TT requires 1 ampere to trip.

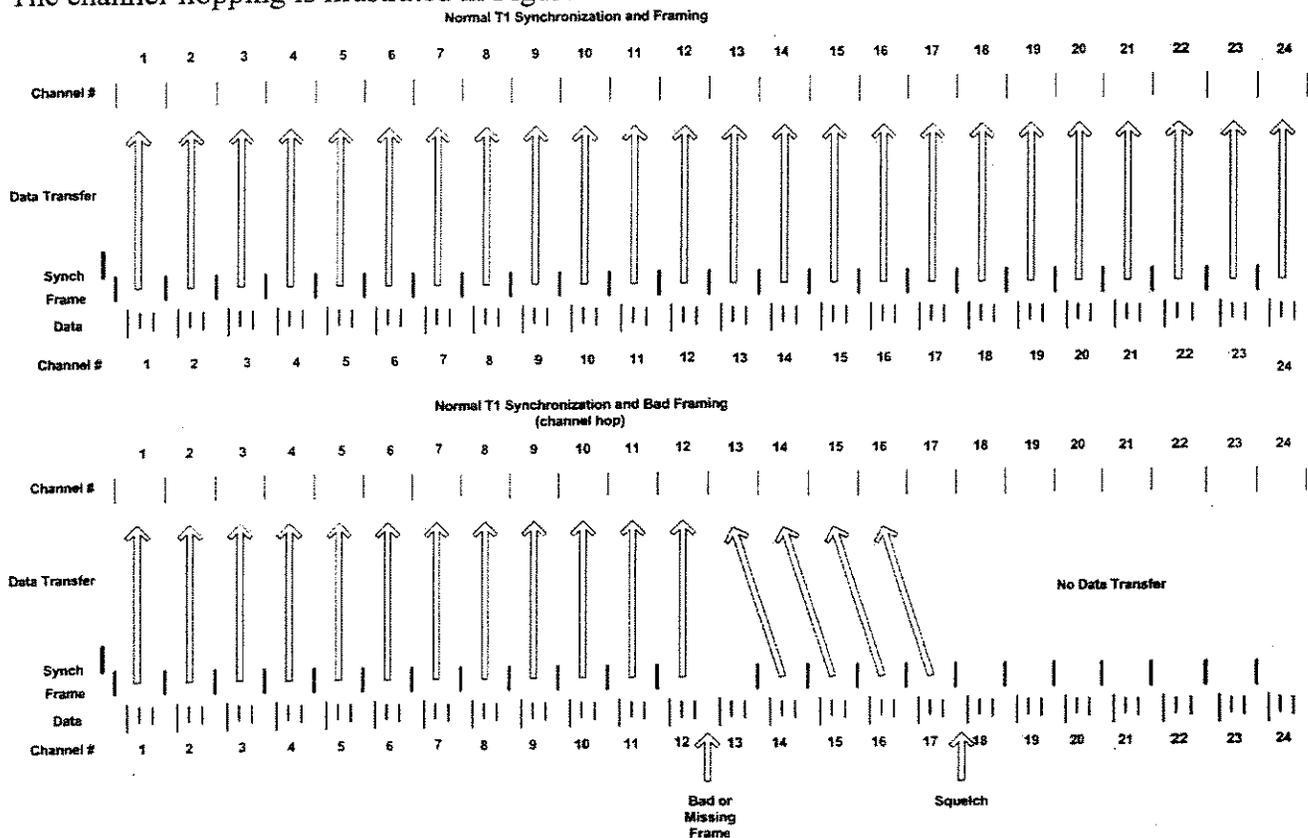
Figure 1 - T1 Framing with channel-hopping illustration.

The channel-hopping is illustrated in Figure 1.

Based on information from the RFL presentation, the clear indication of communication system distress and loss of synch, the POTT and DTT schemes all using the same guard and trip frequencies, the Ko'olau-Pukele Line #1 being open for maintenance, and the Line #2 DTT residing on channel 13 with the set POTT tone residing on the adjacent channel 14, we feel channel-hopping is the most probable cause of the Pukele breaker 146 86TT trip.

1. Replace RFL cards for the DTT channels with different frequency groups than the POTT so that if channel-hopping occurs the data from the POTT permissive signals will not be recognized as frequencies to trip the breakers on DTT. This is recommended system wide.
2. Rearrange the POTT and DTT channels such that the POTT channels precede the DTT channels to prevent a POTT signal hopping into a DTT channel. This is recommended system wide.
3. Wire alarm contacts for RFL output operation to the EMS system to allow more detailed analysis of events.
