Subject: Docket No. 2006-0431
October 15-16, 2006 Outage Investigation

***A Summary Report of
The Public Meeting Held by Hawaiian Electric Company, Inc., Hawaii Light
Company, & Maui Electric Company Regarding the Outage & Restoration of
Electric Power Systems Following the October 15, 2006 Earthquakes
October 23, 2006
Hawaii State Capitol Auditorium***

Earthquake Event

October 15 and 16, 2006

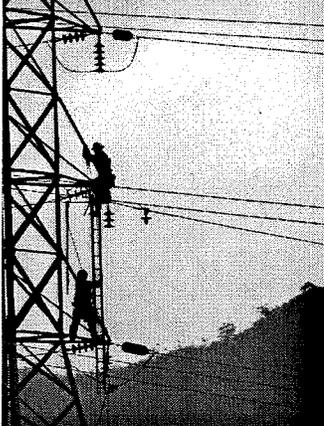
Earthquake Damage

10/15/2006 07:09:06 46KV OCB 4467 (K001) TRIP

- The earthquake causes damage to the Koolau-Wailupe #1 46kV circuit causing it to trip off-line at 7:09 am
