Subject: In the Matter of the Investigation of Hawaiian Electric Company, Inc.,  
Hawaii Electric Light Company, Inc., and Maui Electric Company, Limited,  
Related to the Major Power Outages of October 15-16, 2006  
Docket No. 2006-0431

## **HAWAII ELECTRIC LIGHT COMPANY**

Investigation of 2006 Hawaii Island Power Outage  
PUC Docket Number 2006-0431

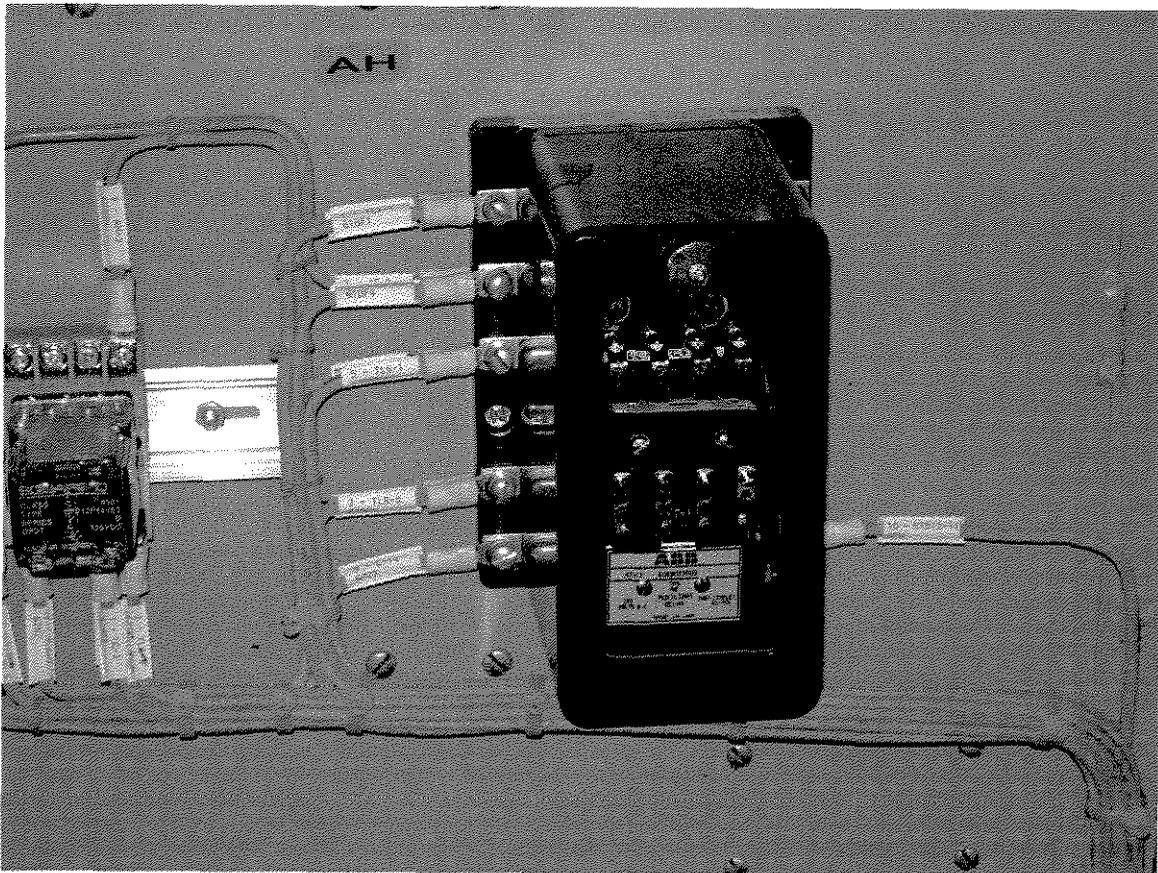
Figure 5: Transmission line AR relay.

Inspection and assessment by the T&D staff during and subsequent to the restoration indicate that relays on 12 of the 69 kV lines that tripped recorded a direct trip (DT), with no other fault sensing relay initiating the trip. After some investigation, it appears that an auxiliary relay contact momentarily closed, attributed to the earthquake shaking, to direct trip the transmission circuits. These relays are an ABB Style AR auxiliary relay. These auxiliary relays are commonly used in the electric utility industry to provide additional contacts from one relay to other protection and control schemes. The HELCO AR relays are typically mounted on the back of the relay panel, as shown in Figure 5, or on swing panels located on the rear of the main relay and control panel.

These auxiliary relays do not result in a lockout condition so the lines were able to be remotely closed through the SCADA by the System Operator by 0800 hours. While these relays mis-operated, the inadvertent operation resulted in disconnecting load on the west side of Hawaii which helped to offset the loss of the HEP combined cycle units and Hill 6, as indicated in section 3.2.3 above. Relays on transmission lines 7300, 7700, 8600 and 6500 indicated that they had tripped due to phase-to-phase faults, most likely due to phase wire contacts due to the earthquake shaking. These trips are evaluated to be correct operations.

1. The main underlying cause of the partial system outage was the earthquake inducing the operation of relays during the seismic shaking of transmission line ABB Style AR auxiliary relays; and Qualitrol Fault Pressure sensors with electro-magnetic target relays. This led to an outage of the transmission system from north of Kealia in South Kona to Pepeekeo on the Hamakua coast. The earthquake also initiated the trips of HEP on vibration. The loss of load on the east side of the island from the transmission system separation initially resulted in over frequency on the remaining portion of the system, which then went into under frequency and load shed when Puna Steam, Hill 6 and Hill 5 went off-line. Recommendations are presented to assess and remedy these issues.

1. Evaluate the transmission relaying equipment, mounting methods, and operational schemes related to the employment of ABB, Style AR auxiliary relays to provide relay protection schemes that are less likely to miss-operate during seismic events.
2. Investigate and evaluate the likely miss-operation of the Qualitrol Fault Pressure sensors with magnetic target relays protective equipment installed on HELCO transformers. Determine appropriate sensor/relay replacements or scheme changes that reduce the likelihood of the tripping of substation and generator step-up transformers due to miss-operation during seismic events.

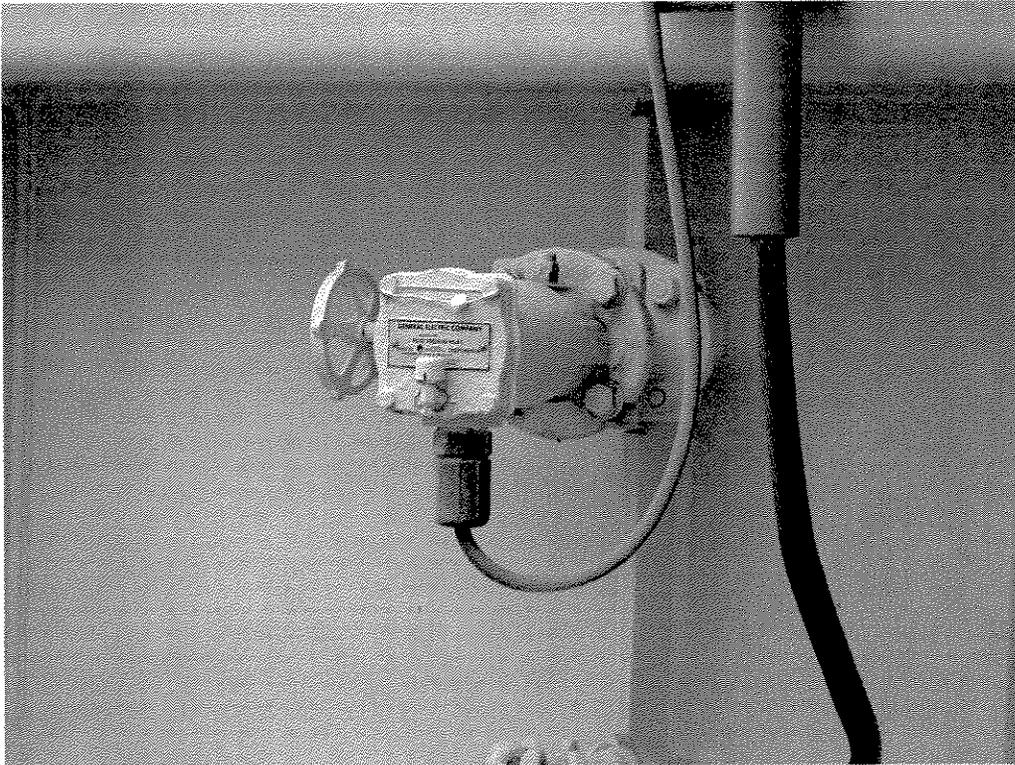
Figure 6: Transformer Fault Pressure Sensor Qualitrol.

HELCO T&D staff noted that 8 transformers had the 86T operate and lock out, had similar sensors and target relays. These sensors are a Qualitrol Fault Pressure sensor as shown in Figure 6 with a magnetic target relay as shown in Figure 7.

The transformers were visually inspected and no indication of an overpressure condition was noted, such as rupture of a pressure release disk or setting of the pressure release flag. Once the coincidence on equipment was noted, HELCO staff test closed on the Keahole diesel generator transformer while monitoring the existing metering and protective relaying. Since Hawaii is remote from transformer repair facilities, they determined that an internal fault would most likely require replacement of the transformer rather than shipping the unit to a repair facility. Thus, there was little risk that re-energizing a faulted transformer, and increasing internal damage would extend the outage time if a replacement would be required anyway. When this transformer did not show any sign of a fault, they then continued to reset the other substation transformer 86T lockout relays and re-energize the transformer while monitoring the metering and relaying for signs of an internal fault. At this time, it has not been determined whether the miss-operation was due to the sensor or the target relay. It is possible that the sensor construction allowed the seismic acceleration of the oil to trigger the device or that the target relay closed its contact due to seismic shaking.
