CONDOMINIUM PUBLIC REPORT

Project Name(*): THE ROYAL PALM AT WAIPIO - PHASES II & III
Address: See attached page 1a
(Conversion)

Registration No. 3653 Effective date: February 27, 2001
Expiration date: March 27, 2002

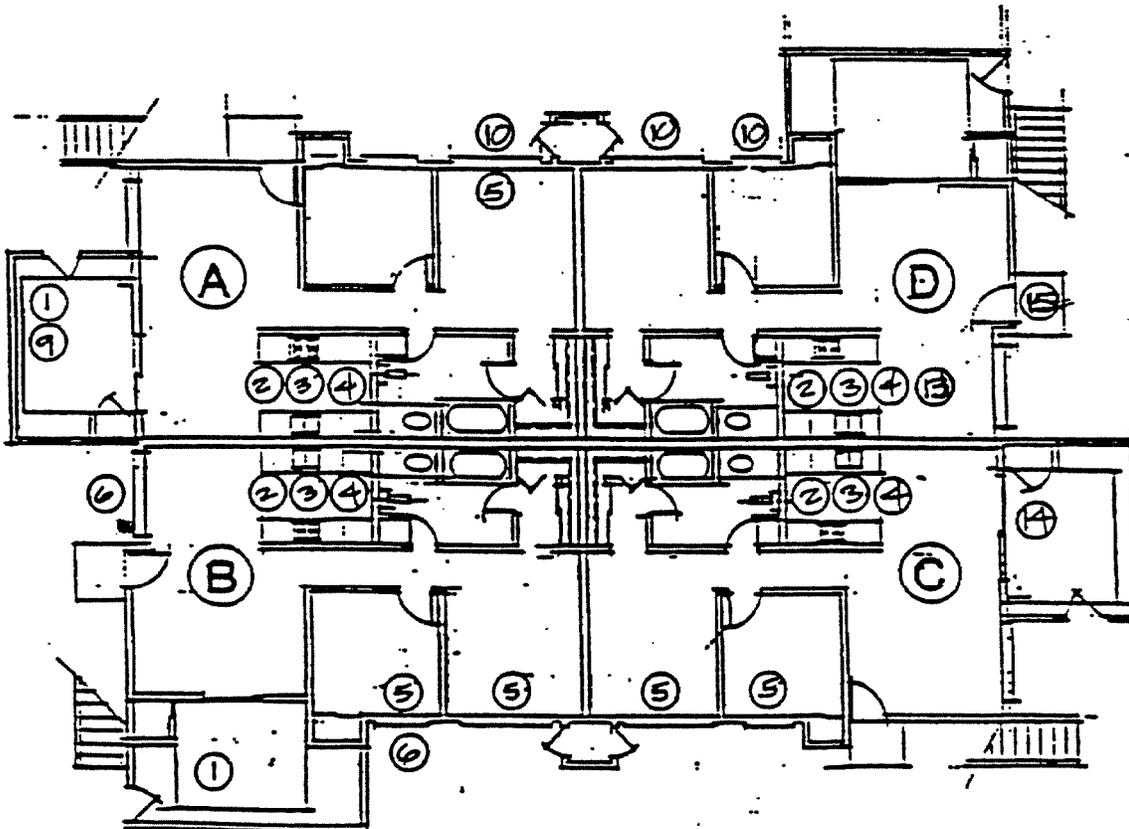
FIRST FLOOR PLAN
SC: 1/16" = 1'-0"

- A15- Automatic door closer missing. new to match existing.
- A16- Screen door latch does not engage. Repair or replace as required.

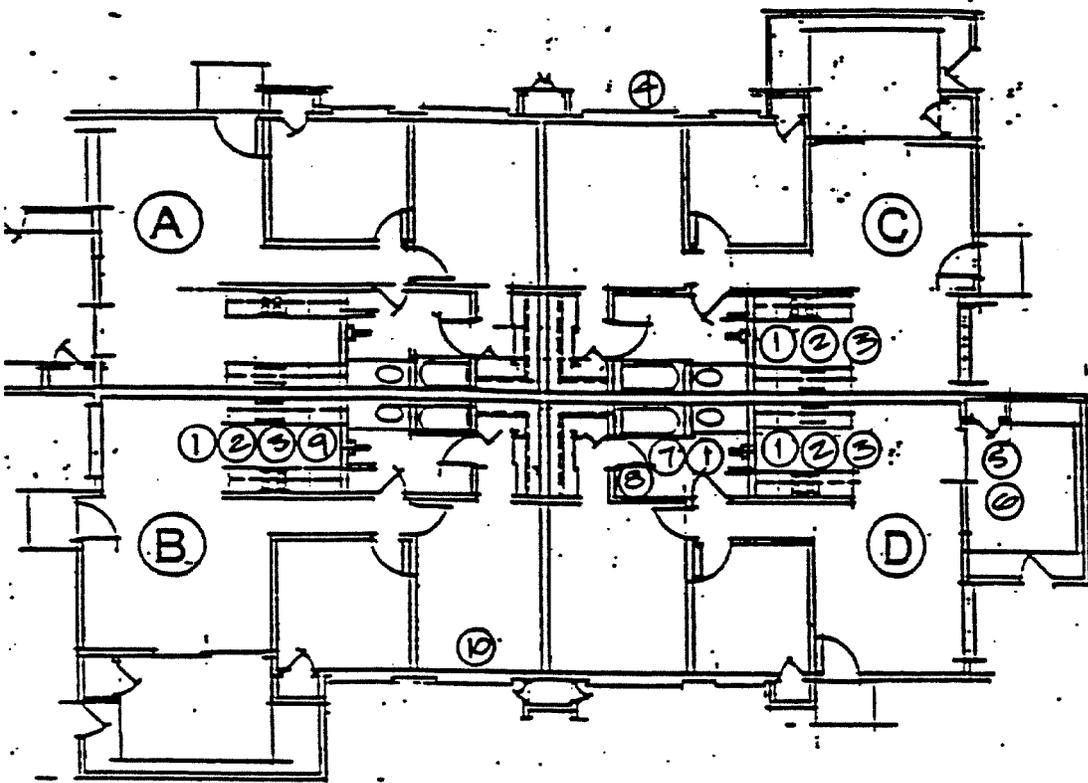
FIRST FLOOR PLAN
SC: 1/16" = 1'-0"

- A1- Lower cabinets water
* damaged and finish mismatched at face condition.
- A2- Upper cabinet doors above sink, edge conditions worn. Repair of cabinet doors may be necessary or add new corner protection guards.
- A3- P. Lam countertop
* scarred.
- A4- Window glass water
* stained.
- A5- Sliding screen door operation untracks. Adjust door guide or may replace w/new door leaf.
- A6- Sliding door screen damaged. Replace w/new screen.
- A7- Medicine cabinet
** mirror door finish pitted.
- A8- Upper cabinet door
** leafs. Do not match melamine finish colors differ.
- A9- Light diffuser lens warped. Replace w/new to match existing.
- A10- Mini blind blades bent. Replace damaged assembly unit w/new to match existing.

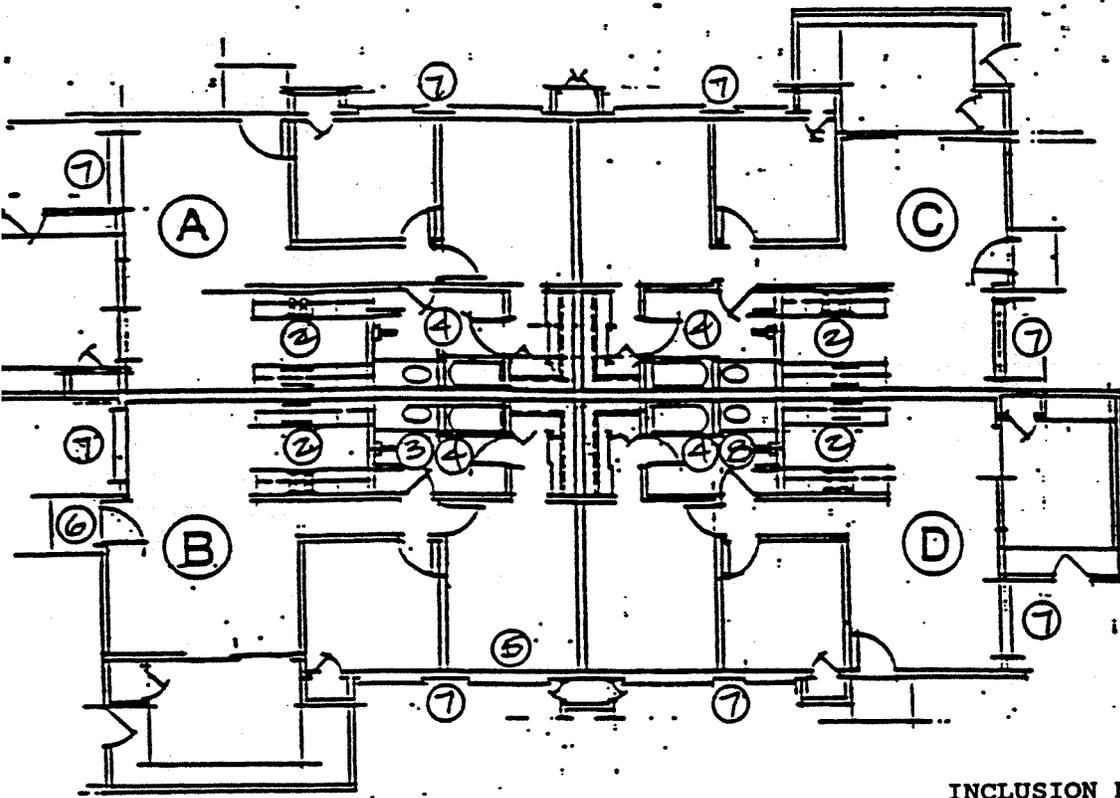
FIRST FLOOR PLAN
SC:1/16"=1'-0"

- A1- Deck soffit edge trim separation. Caulk w/Flexible sealant.
- A2- Lower cabinets water damaged and mismatched at face condition.
- A3- Mirror finish at Vanity pitted.
- A4- Towel bar finish tarnished.
- A5- Window frame trim dented. Correct warped condition of frame.
- A6- Entry door surface chipped. Patch and touch-up paint.
- A7- Window glass water stained.
- A8- Toilet paper holder missing. Replace.

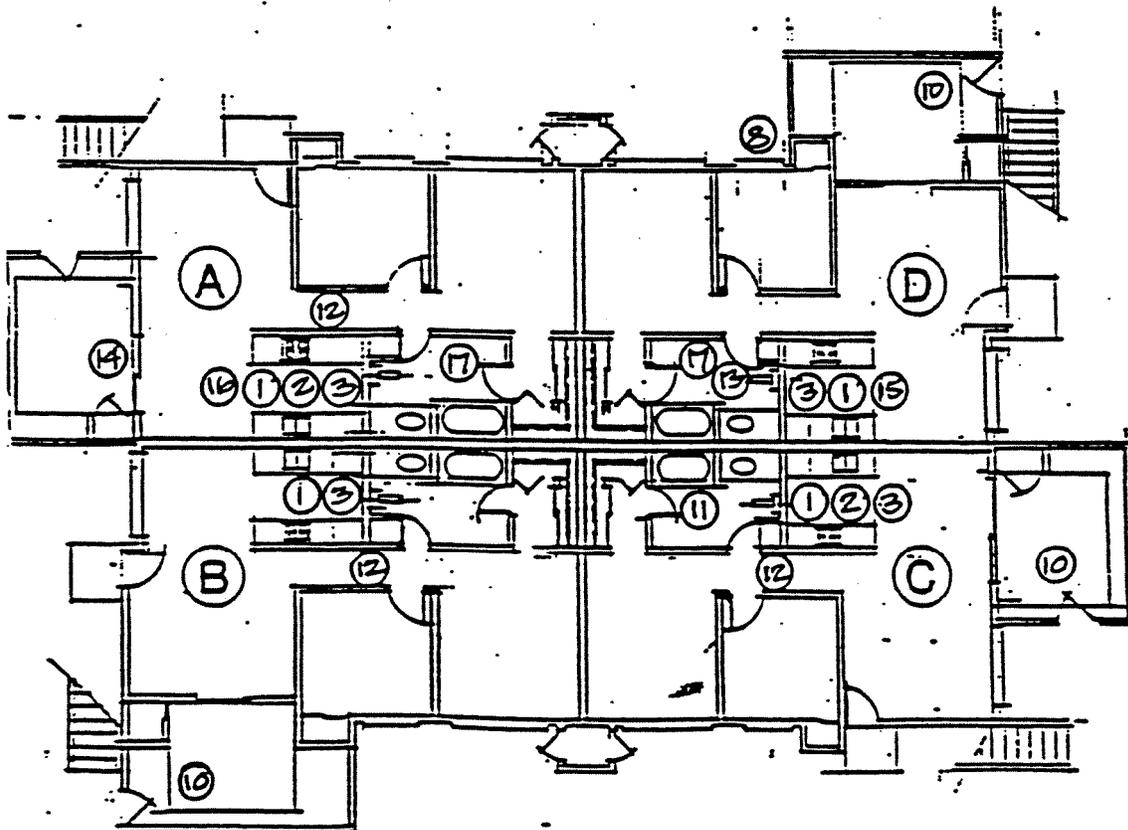
FIRST FLOOR PLAN
SC:1/16"=1'-0"

- A15- P.Lam counter top surface burned. Replace w/new to match existing.
- A16- P.Lam counter top bull nose chipped.
- A17- Touch-up paint around light switch

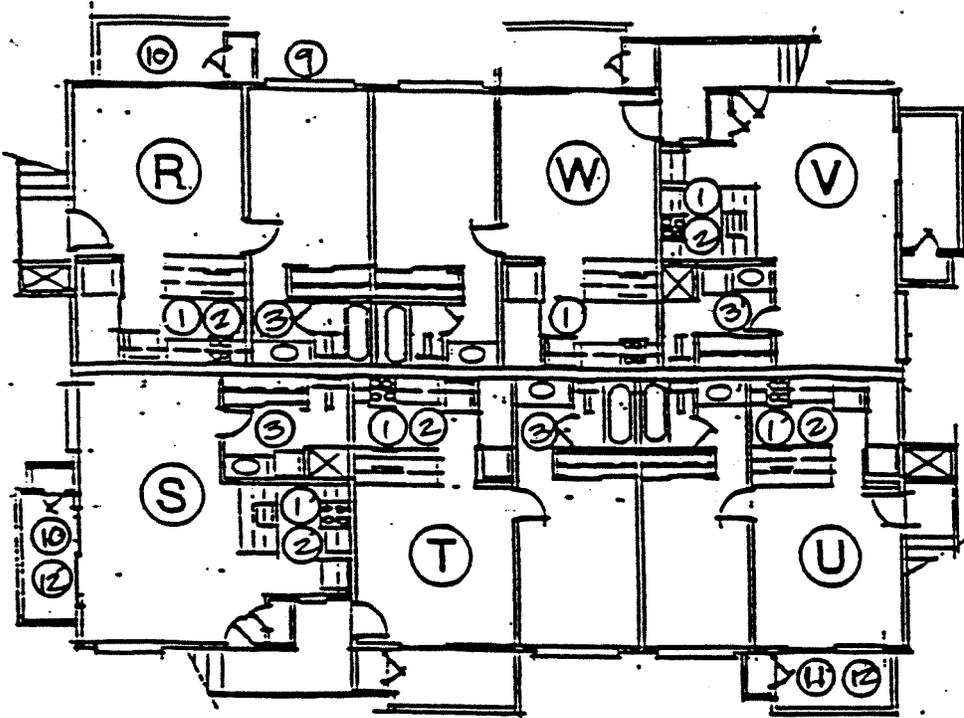
SECOND FLOOR PLAN
 SC: 1/16" = 1'-0"

- A1- Lower cabinets water damaged and finish mismatched at face condition.
- A2- P.Lam counter top scarred.
- * A3- Medicine cabinet mirror door finish pitted.

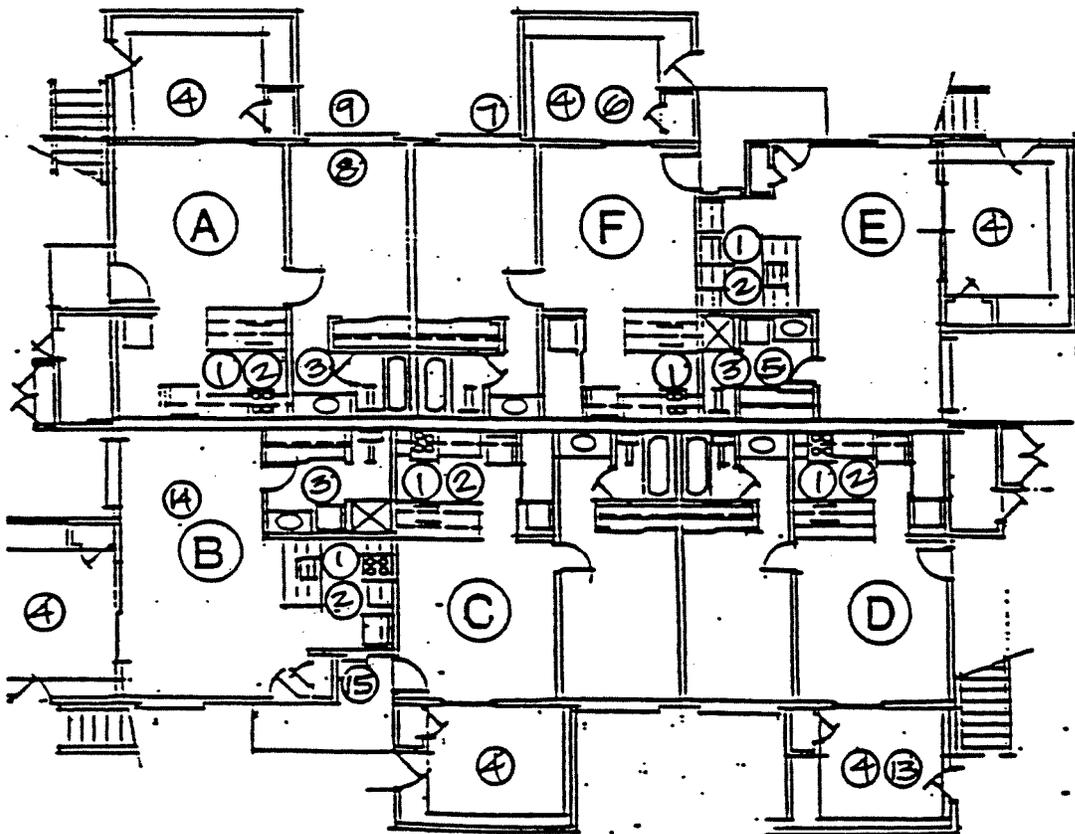
FIRST FLOOR PLAN
 SC: 1/16" = 1'-0"

- A13- Sliding screen door operation rough. Repair or replace w/ne to match existing.
- A14- Carpet appears worn and dirty.
- * A15- Window screen and frame is missing. Replace to match exist

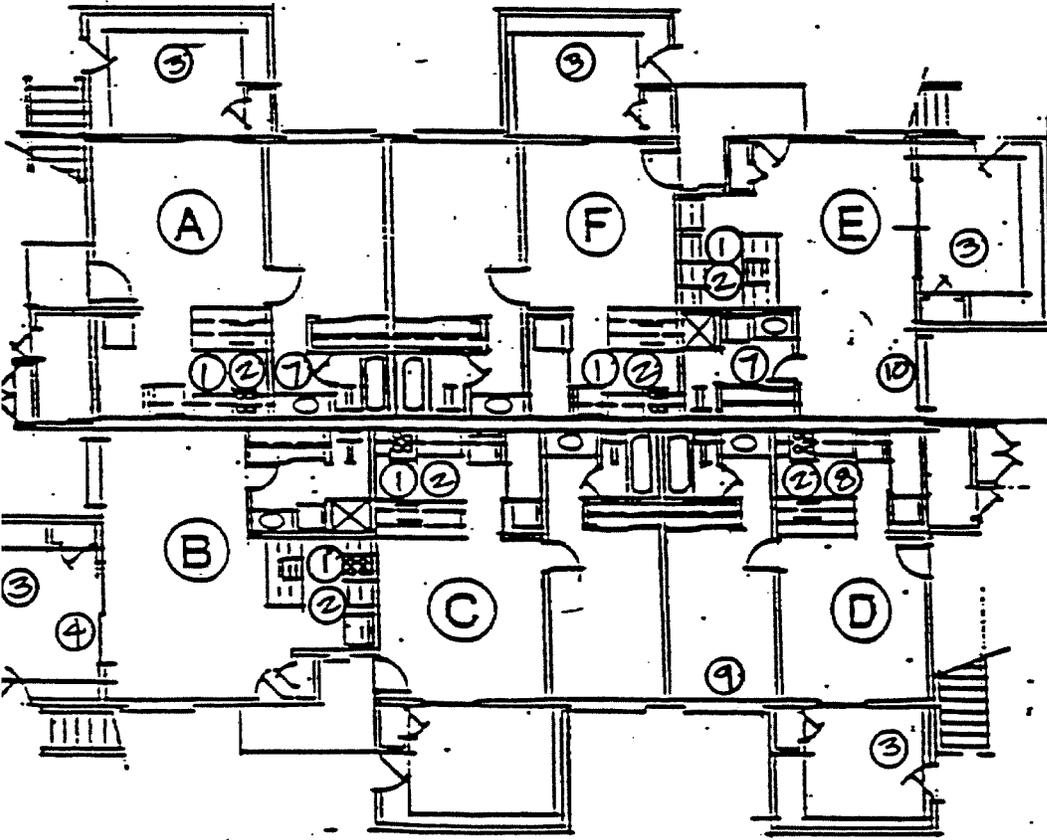
FIRST FLOOR PLAN
 SC: 1/16" = 1'-0"

- A1- P.Lam counter-top scarred.
- * Lower cabinets water damaged and finish mismatched at face.
- A2- Deck soffit edge trim separation. Caulk w/flexible sealant.
- A3- Sliding door screen damaged. Replace w/new pane.
- A4- Range top finish, paint worn at edge. Touch-up.
- A5- Deck soffit edge trim separation. Caulk w/flexible sealant.
- A6- Medicine cabinet mirror door finish pitted.
- * Upper cabinet doors above sink, edge conditions worn.
- A7- Mini blind blades bent. Replace damaged assembly unit w/new to match existing.
- A8- Window glass water stained.
- * Replacement may be desirable.

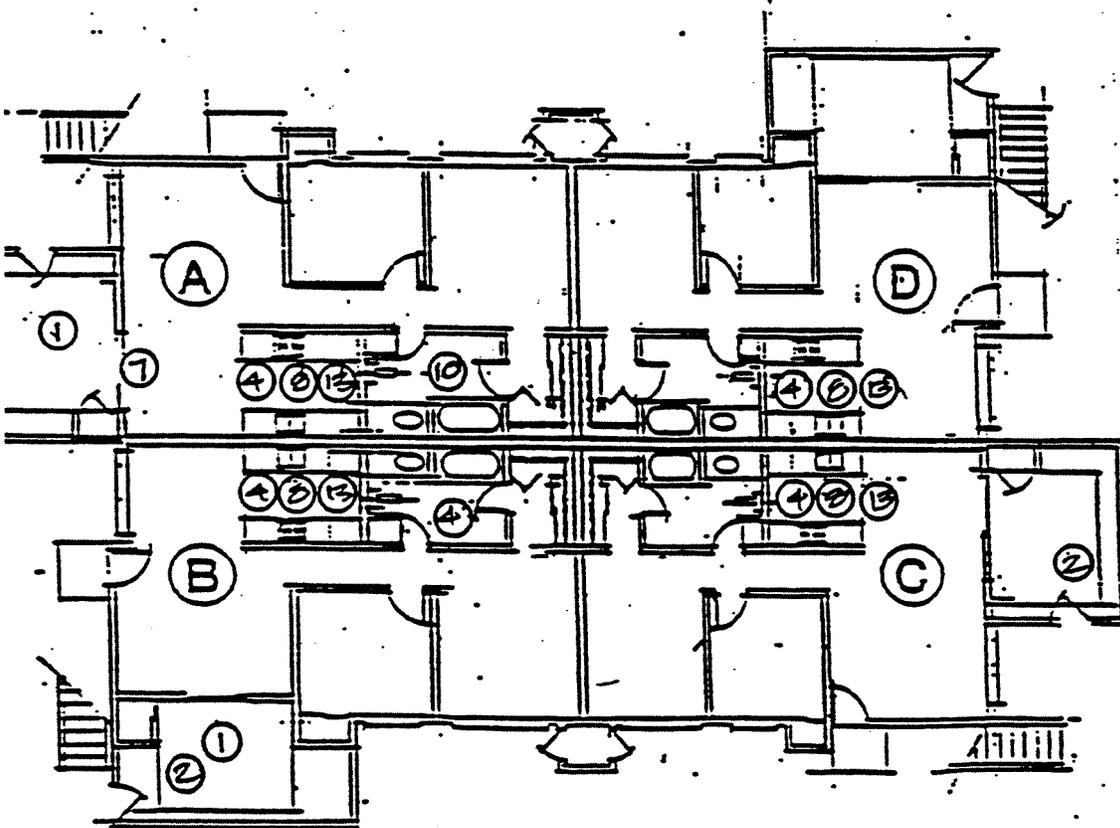
FIRST FLOOR PLAN
 SC: 1/16" = 1'-0"

- A13- P.Lam counter top scarred.
- A14- Patch Gyp. Board wall and touch-up paint to match existing.
- A15- Door stop hardware missing w/hole punctured in Gyp. Board wall. Install door stop and patch Gyp. Board wall to match existing.

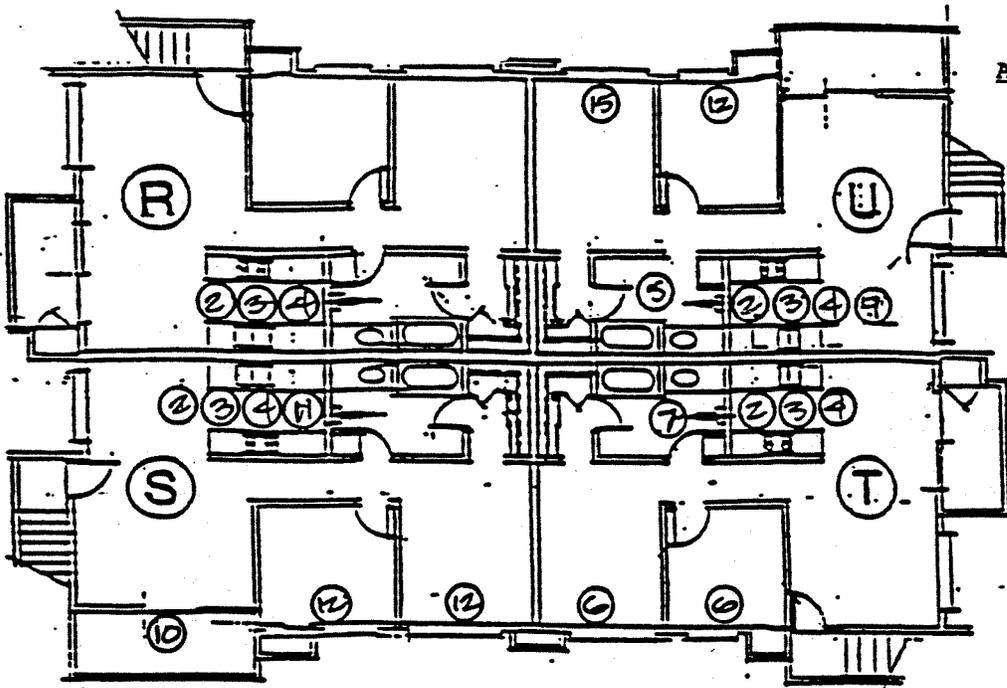
SECOND FLOOR PLAN
 SC: 1/16" = 1'-0"

- A1- Deck soffit edge trim separation caulk w/flexible sealant.
- A2- P.Lam counter top scarred.
- * A3- Lower cabinets water damaged at face condition.
- * A4- Upper cabinet doors above sink, edge condition worn. Replacement of cabinet doors may be necessary or add new corner protection guards.
- A5- Medicine cabinet mirror door finish pitted.
- * A6- Mini blind blades bent. Replace damaged assembly unit w/new to match existing.
- A7- Towel bar finish tarnished.
- * A8- Window glass water stained.
- * A9- Lower cabinets face mismatches.
- A10- Sliding door aluminum threshold pitted.
- * A11- Light diffuser lens cracked. Replace w/new to match existing.
- A12- Window screen frame pitted.
- * A13- Screen dock frame broken. Replace to match existing.
- A14- Door stop hardware missing. Replace w/n to match existing.
- A15- Window screen damaged. Replace w/new screen.

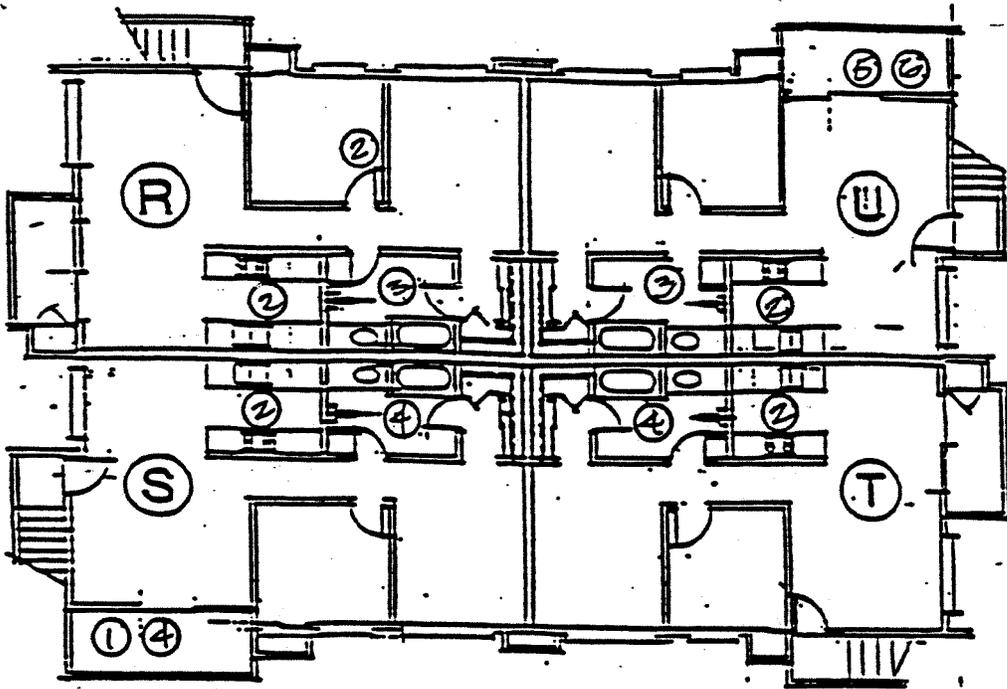
SECOND FLOOR PLAN
 SC: 1/16" = 1'-0"

- A1- Lower cabinets water damaged and mismatched at face condition.
- * Door stop hardware missing with hole punctured in Gyp. Board wall. Install door stop and patch Gyp. Board wall, to match existing.
- A2- Towel bar finish tarnished.
- A3- Exterior wall dusty with accumulation of soot and minor paint peeling. Remove dust and loose paint. Prep wall and repaint to match existing.
- A4- Wasp nest on Lanai exterior wall. Remove nest and touch-up paint to match existing.
- A5-

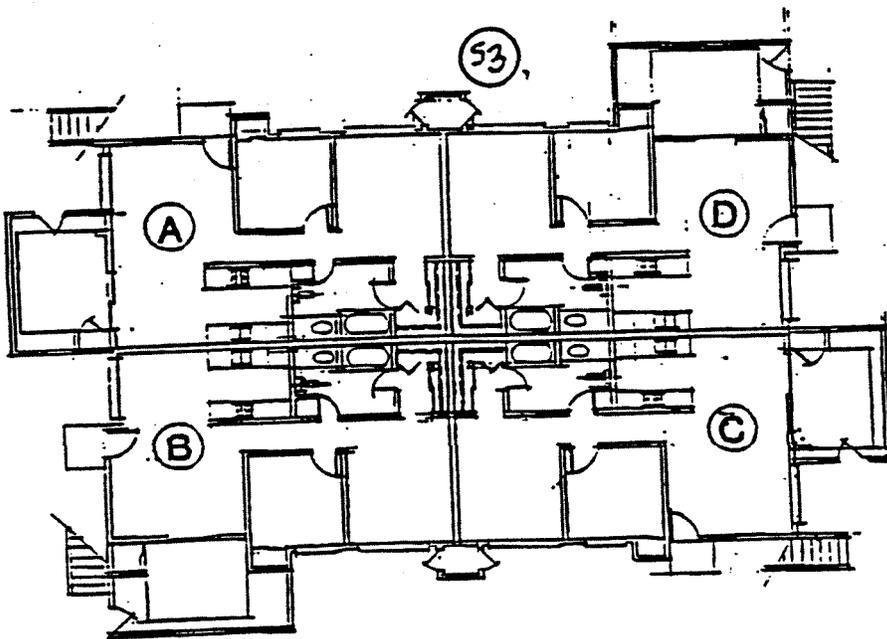
FIRST FLOOR PLAN
 SC: 1/16" = 1'-0"

- S1 - Vertical members of built up end trusses have stapled connections. Reinforce per Sketch S-1.
- S2 - Access panel cracked at scuttle. Replace with new.
- S3 - Large birdnest in heater storage room. Remove debris and seal off access.
- S4 - Carport: Splits in 4X10 beams. Install lag screws per Sketch S-3.

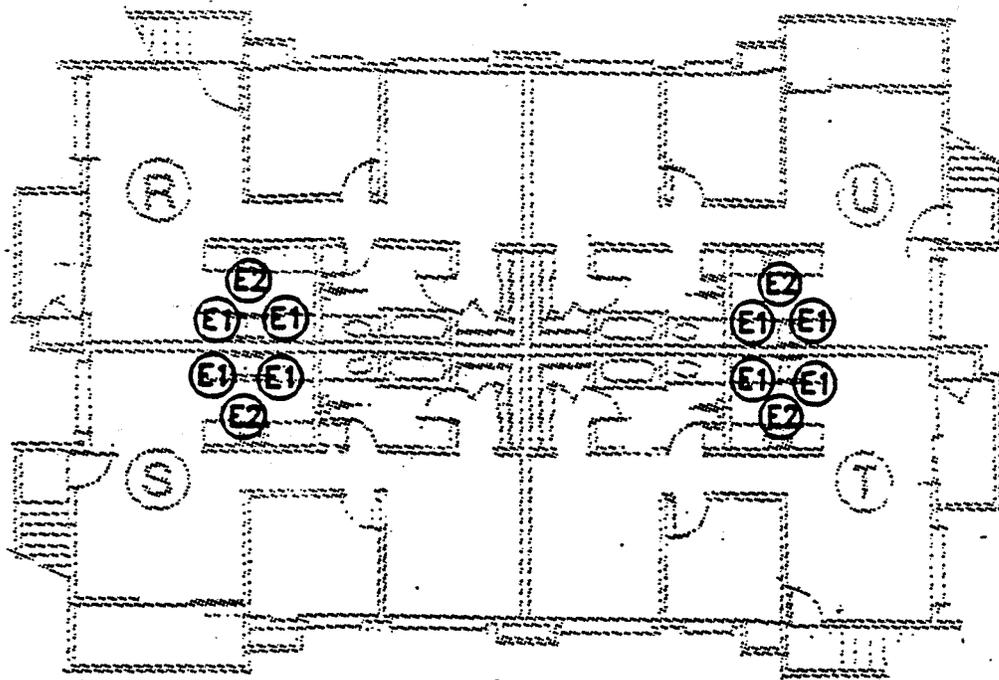
SECOND FLOOR PLAN
 SC: 1/16" = 1'-0"

- E-1 Replace duplex receptacle with new GFI type.
- E-2 Replace polycarbonate diffusers (two 2 X 4) with new acrylic prismatic diffusers.
- E-3 Provide blanking cover for missing breakers (2).

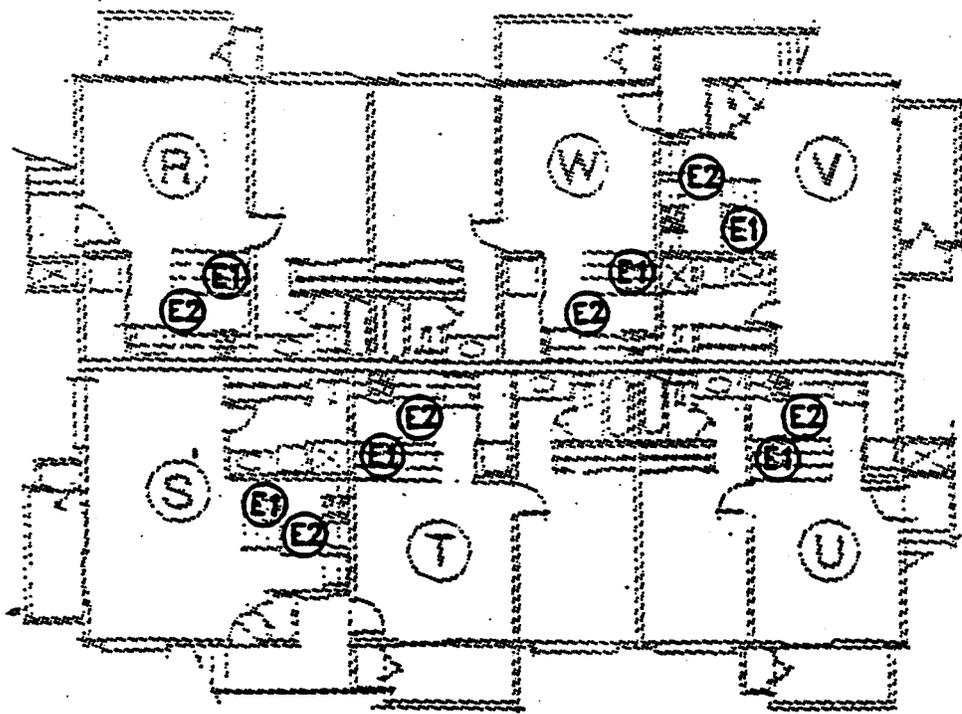
SECOND FLOOR PLAN
 SC: 1/16" = 1'-0"

- E-1 Replace duplex receptacle with new GFI type.
- E-2 Replace polycarbonate diffusers (two 2 X 4) with new acrylic prismatic diffusers.
- E-4 Provide new duplex, weatherproof GFI type receptacle at Lanai, if required.

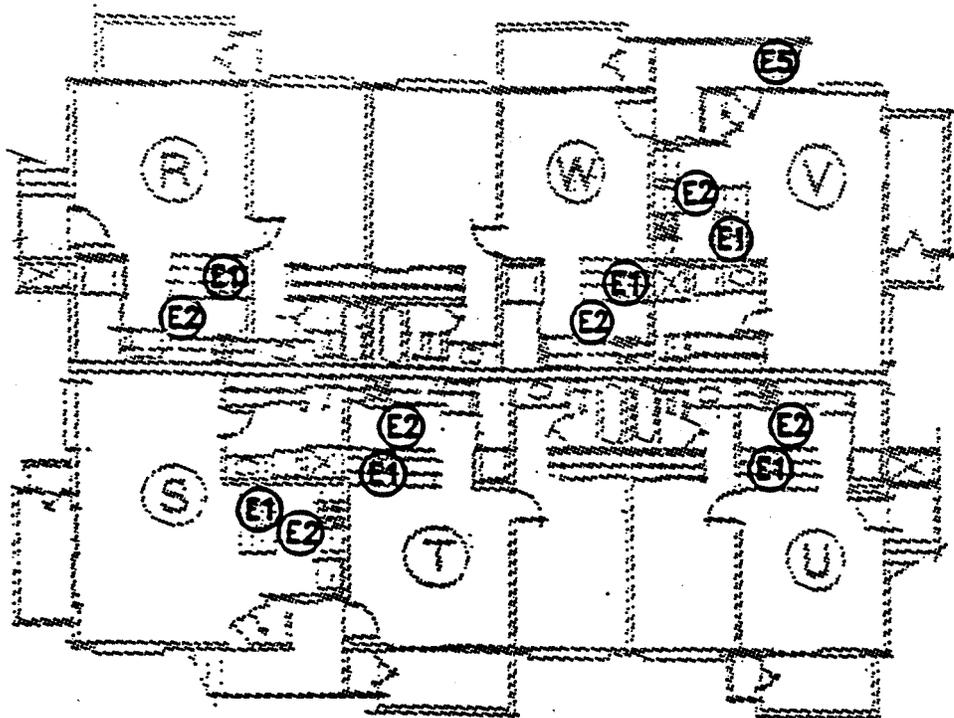
SECOND FLOOR PLAN
 SC: 1/16" = 1'-0"

- E-1 Replace duplex receptacle with new GFI type.
- E-2 Replace polycarbonate diffusers (two 2 X 4) with new acrylic prismatic diffusers.
- E-4 Provide new duplex, weatherproof GFI type receptacle at Lanai, if required.
- E-5 Resupport existing wall mounted luminaire.

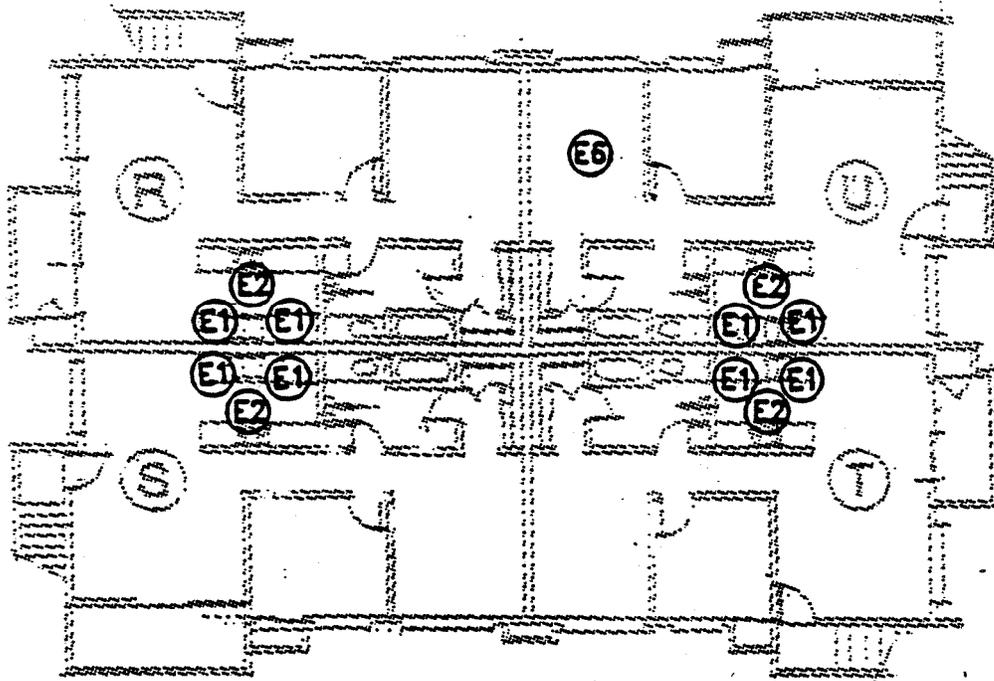
SECOND FLOOR PLAN
 SC: 1/16" = 1'-0"

- E-1 Replace duplex receptacle with new GFI type.
- E-2 Replace polycarbonate diffusers (two 2 X 4) with new acrylic prismatic diffusers.
- E-6 Replace ceiling fan.

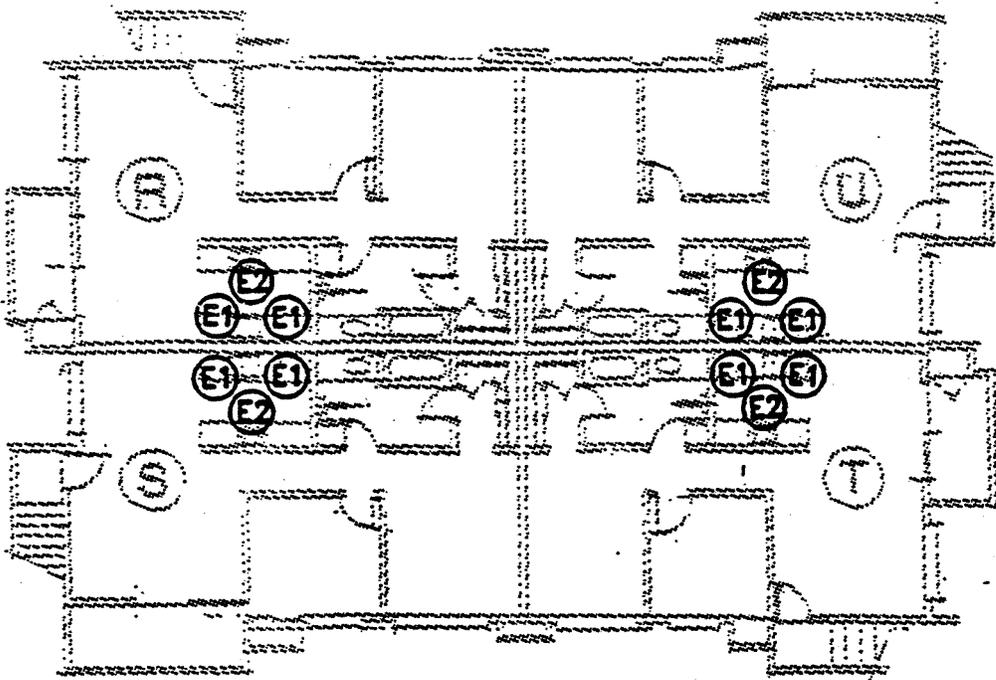
SECOND FLOOR PLAN
 SC: 1/16" = 1'-0"

- E-1 Replace duplex receptacle with new GFI type.
- E-2 Replace polycarbonate diffusers (two 2 X 4) with new acrylic prismatic diffusers.

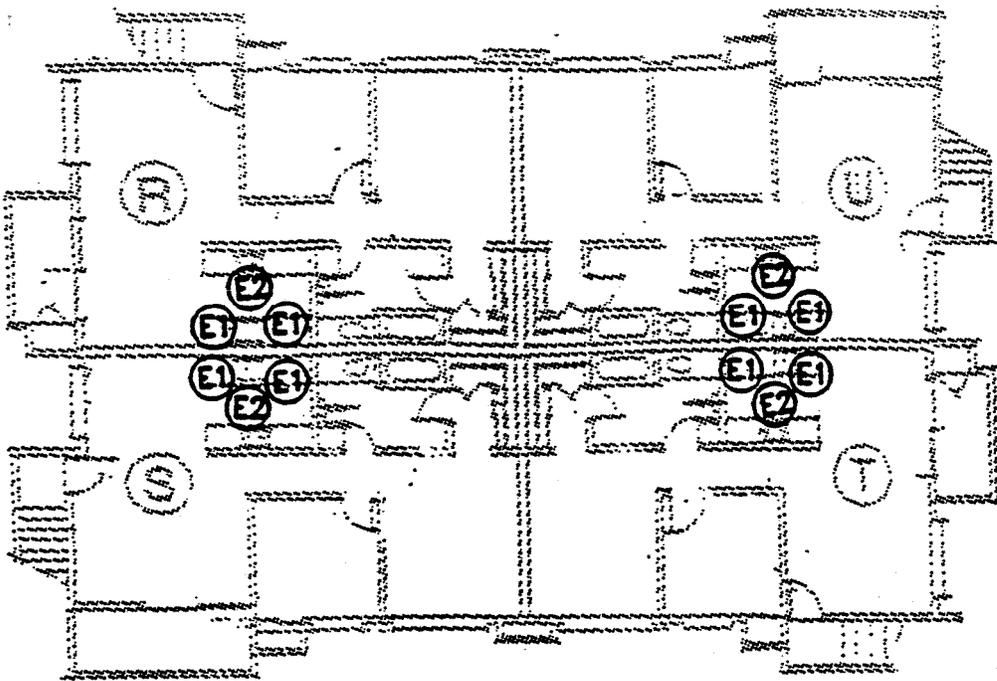
SECOND FLOOR PLAN
 SC: 1/16" = 1'-0"

E-1 Replace duplex receptacle with new GFI type.

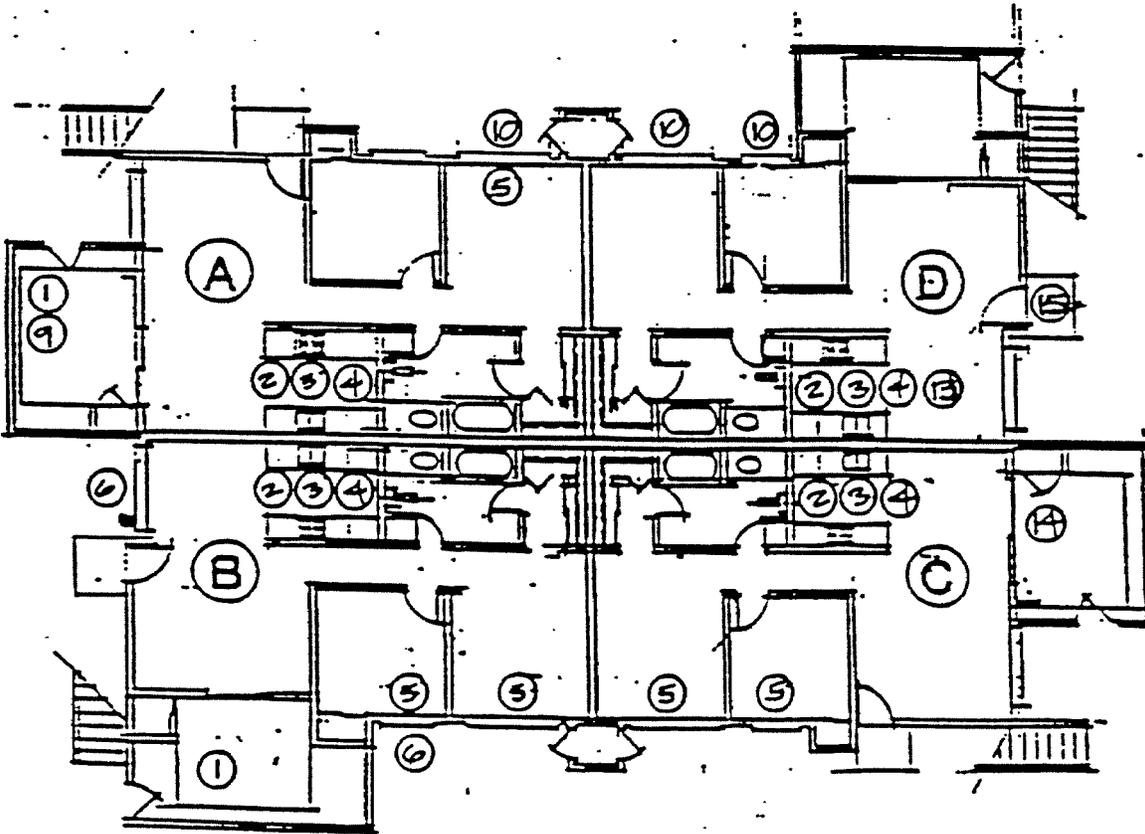
FIRST FLOOR PLAN
 SC: 1/16" = 1'-0"

- A15- Automatic door closer missing. ? new to match existing.
- A16- Screen door latch does not engage. Repair or replace as required.

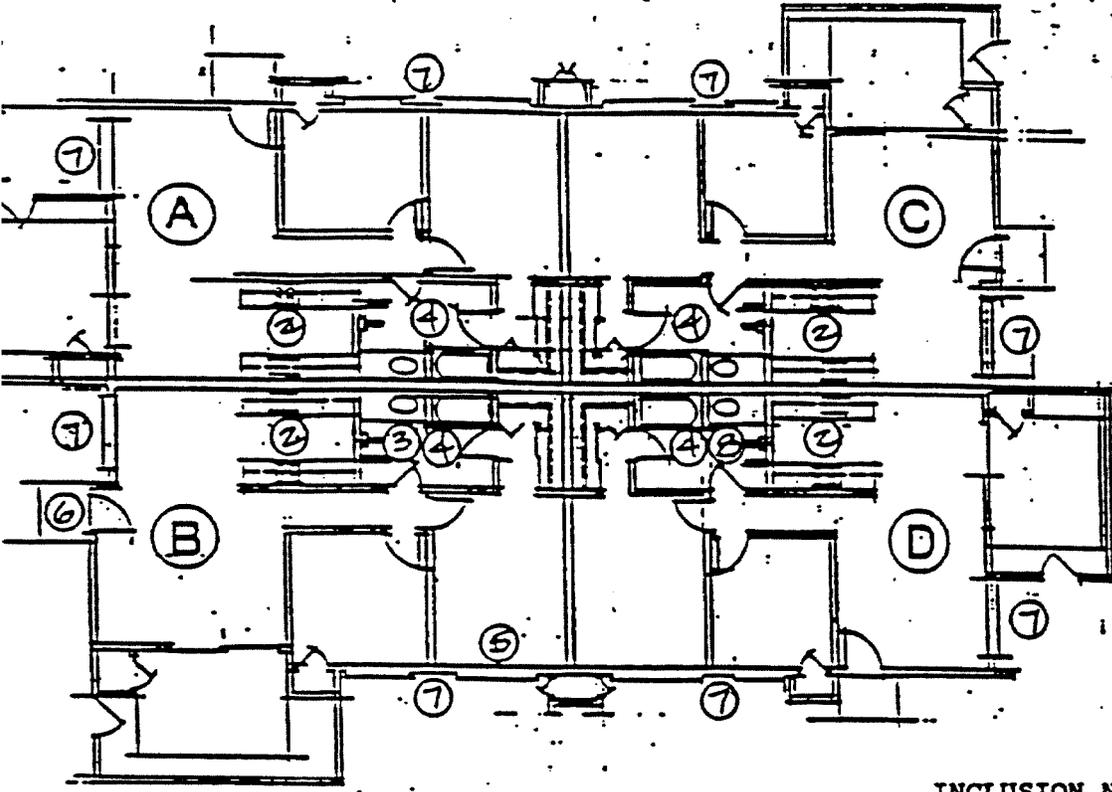
- A1- Deck soffit edge trim separation. Caulk w/Flexible sealant.
- A2- Lower cabinets * water damaged and mismatched at face condition.
- A3- Mirror finish at ** Vanity pitted.
- A4- Towel bar finish * tarnished.
- A5- Window frame trim dented. Correct warped condition o frame.
- A6- Entry door surface chipped. Patch an. touch-up paint.
- A7- Window glass water * stained.
- A8- Toilet paper holder missing. Replace.

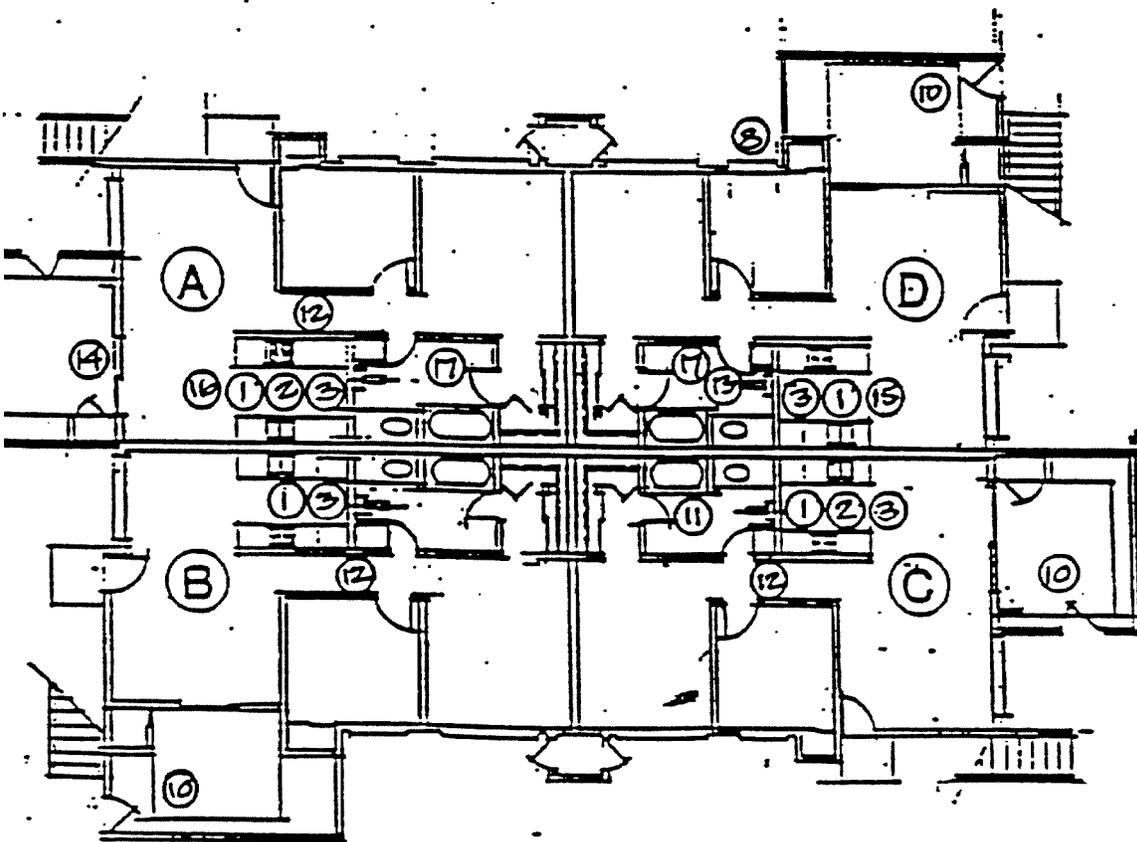
FIRST FLOOR PLAN

- A15- P.Lam counter top surface burned. Replace w/new to match existing.
- A16- P.Lam counter top bull nose chipped.
- A17- Touch-up paint around light switch

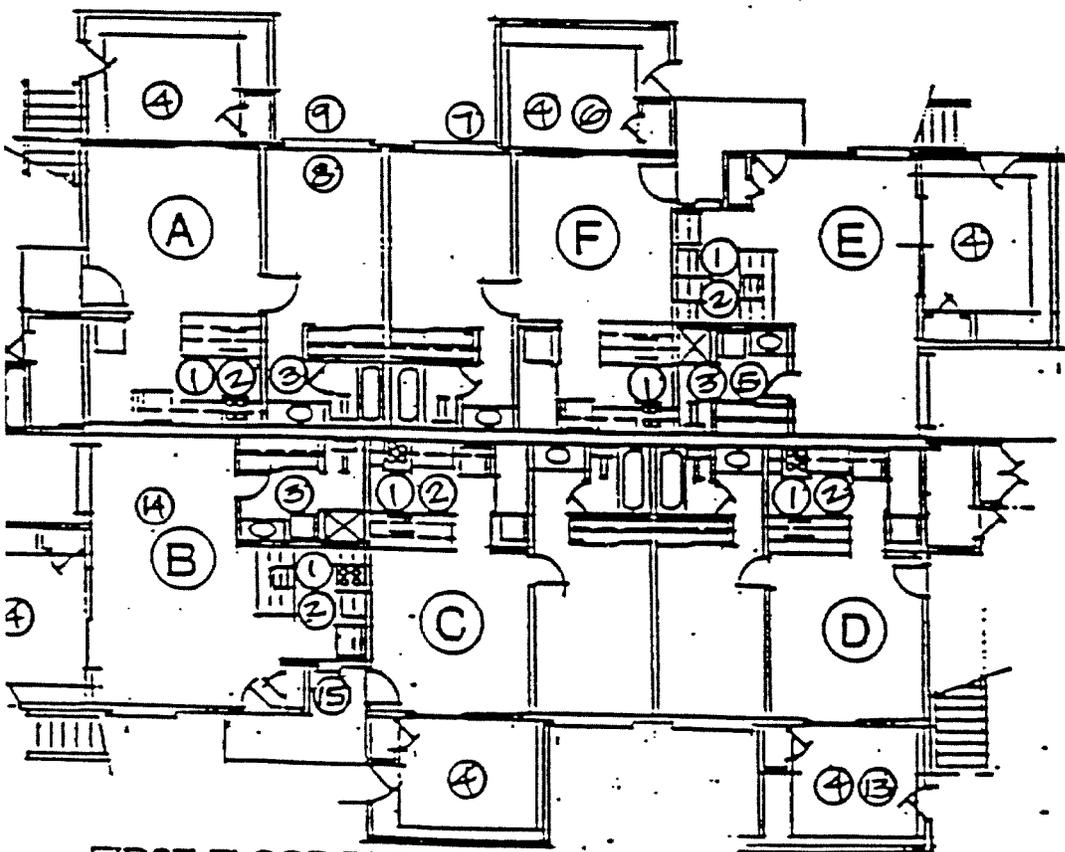
FIRST FLOOR PLAN
SC: 1/16" = 1'-0"

- A13- Sliding screen door operation rough. Repair or replace w/new to match existing.
- A14- Carpet appears worn and dirty.
- A15- Window screen and frame is missing. Replace to match exist.

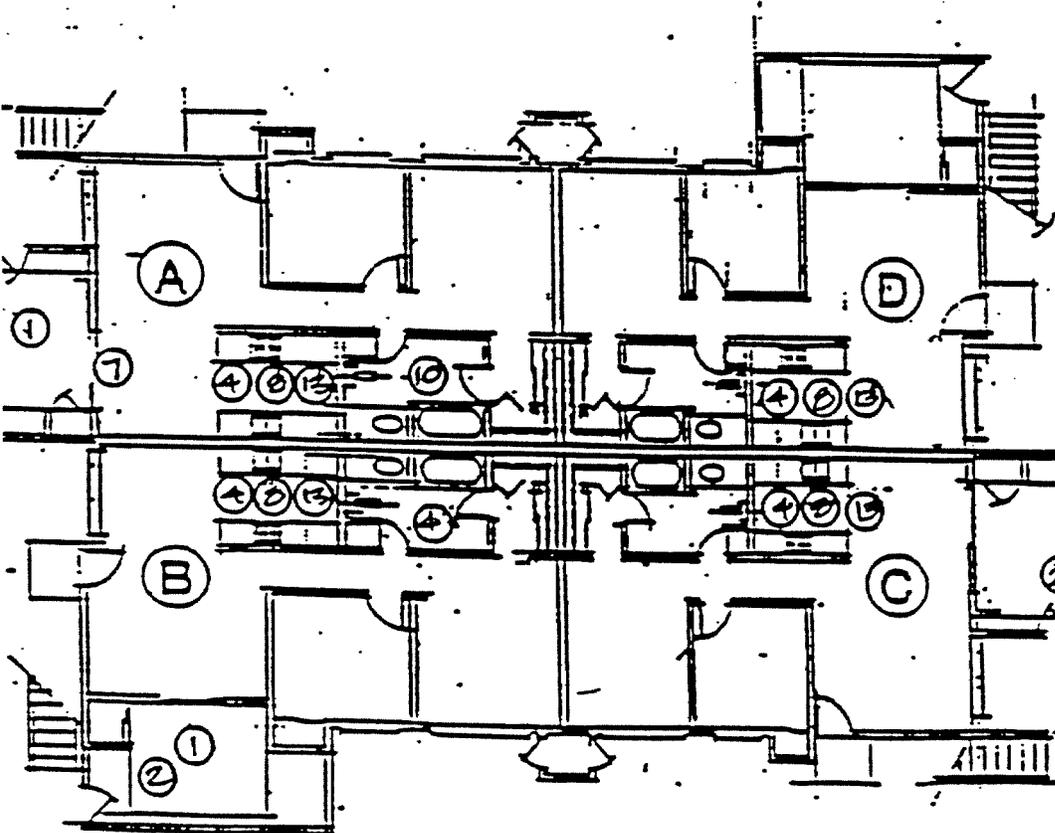
FIRST FLOOR PLAN
SC: 1/16" = 1'-0"

- A13- * P.Lam counter top scarred.
- A14- Patch Gyp. Board wall and touch-up paint to match existing.
- A15- Door stop hardware missing w/hole punctured in Gyp. Board wall. Install door stop and patch Gyp. Board wall to match existing.

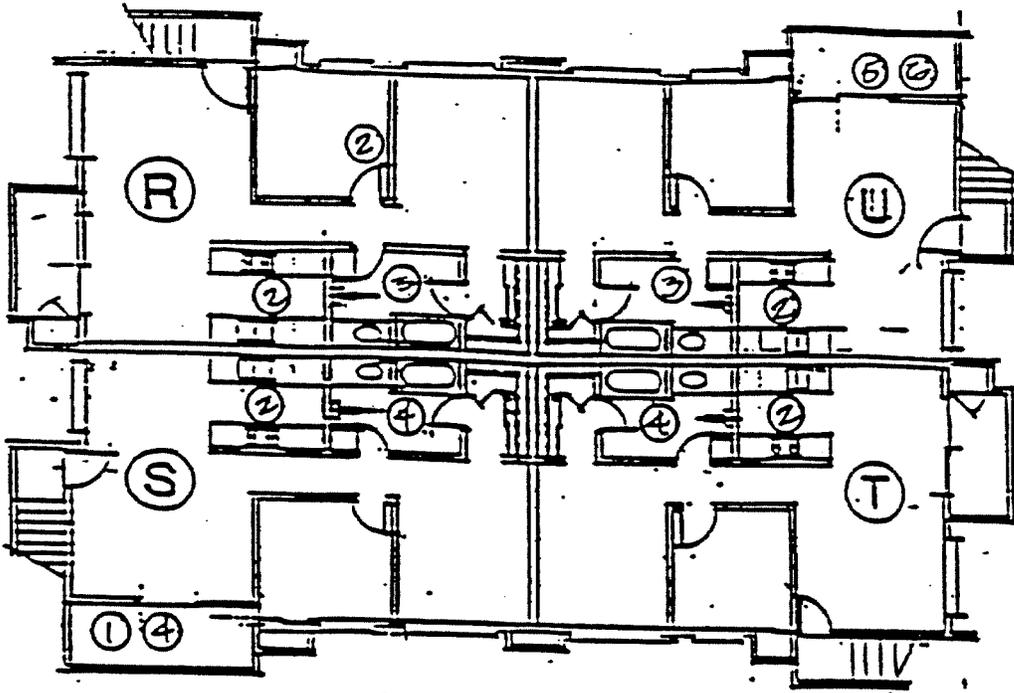
SECOND FLOOR PLAN
SC: 1/16" = 1'-0"

- A1- Lower cabinets
* water damaged and mismatched at face condition.
- A2- Door stop hardware missing with hole punctured in Gyp. Board wall. Install door stop and patch Gyp. Board wall, to match existing.
- A3- Towel bar finish
* tarnished.
- A4- Exterior wall dusty with accumulation of soot and minor paint peeling. Remove dust and loose paint. Prep wall and repaint to match existing.
- A5- Wasp nest on Lanai exterior wall. Remove nest and touch-up paint to match existing.

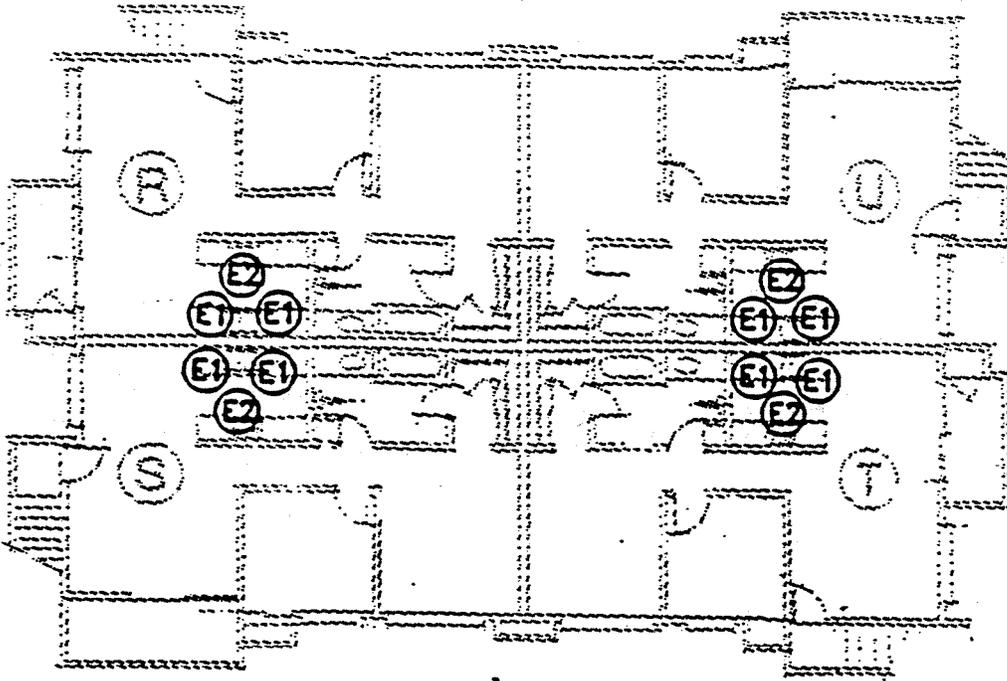
SECOND FLOOR PLAN
 SC: 1/16" = 1'-0"

- E-1 Replace duplex receptacle with new GFI type.
- E-2 Replace polycarbonate diffusers (two 2 X 4) with new acrylic prismatic diffusers.
- E-3 Provide blanking cover for missing breakers (2).

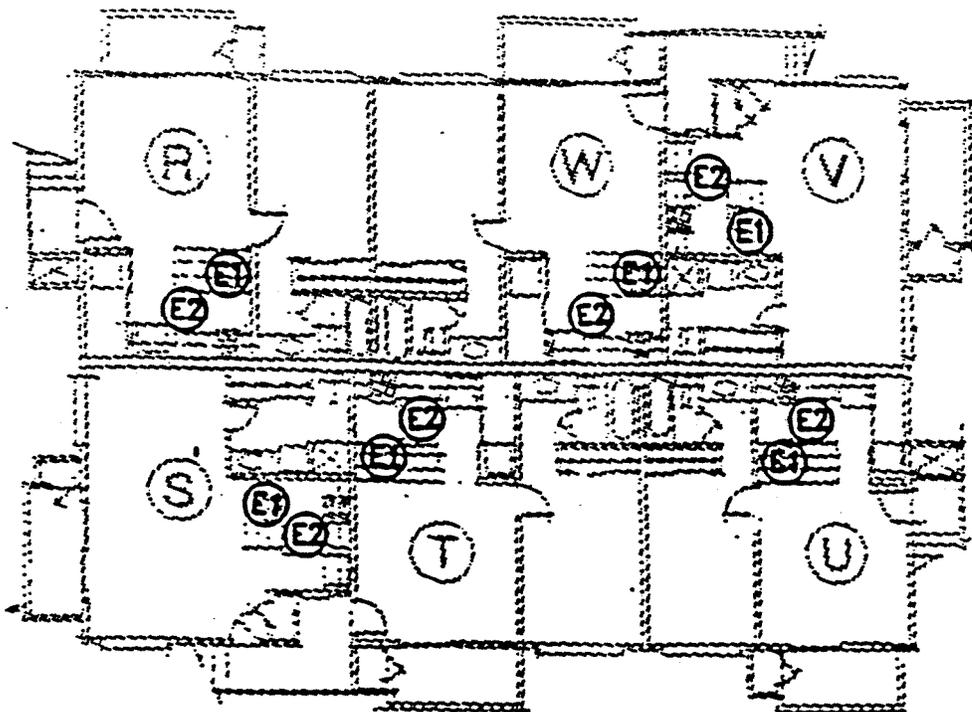
SECOND FLOOR PLAN
 SC: 1/16" = 1'-0"

- E-1 Replace duplex receptac with new GFI type.
- E-2 Replace polycarbonate diffusers (two 2 X 4) with new acrylic prisma diffusers.
- E-4 Provide new duplex, weatherproof GFI type receptacle at Lanai, if required.

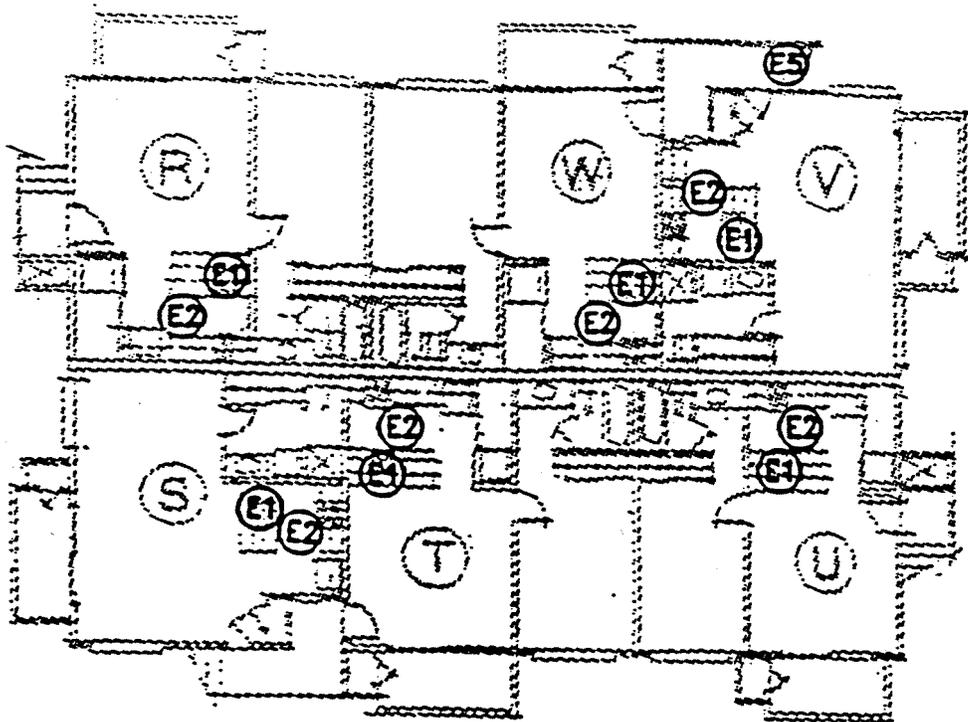
SECOND FLOOR PLAN
 SC: 1/16" = 1'-0"

- E-1 Replace duplex recepta with new GFI type.
- E-2 Replace polycarbonate diffusers (two 2 X 4) with new acrylic prism diffusers.
- E-4 Provide new duplex, weatherproof GFI type receptacle at Lanai, 1 required.
- E-5 Resupport existing wall mounted luminaire.
