CONDOMINIUM PUBLIC REPORT

Project Name(*): THE ROYAL PALM AT WAIPIO - PHASES II & III
Address: See attached page 1a
(Conversion)

Registration No. 3653 Effective date: February 27, 2001
Expiration date: March 27, 2002

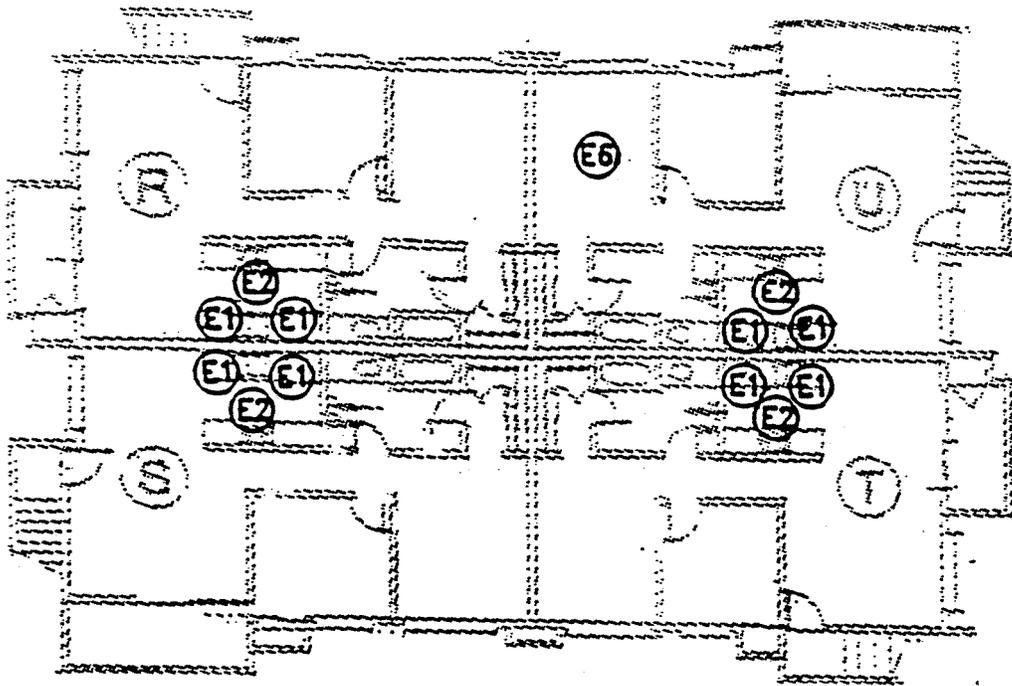
SECOND FLOOR PLAN
 SC: 1/16" = 1'-0"

- E-1 Replace duplex receptacle with new GFI type.
- E-2 Replace polycarbonate diffusers (two 2 X 4) with new acrylic prismatic diffusers.
- E-6 Replace ceiling fan.

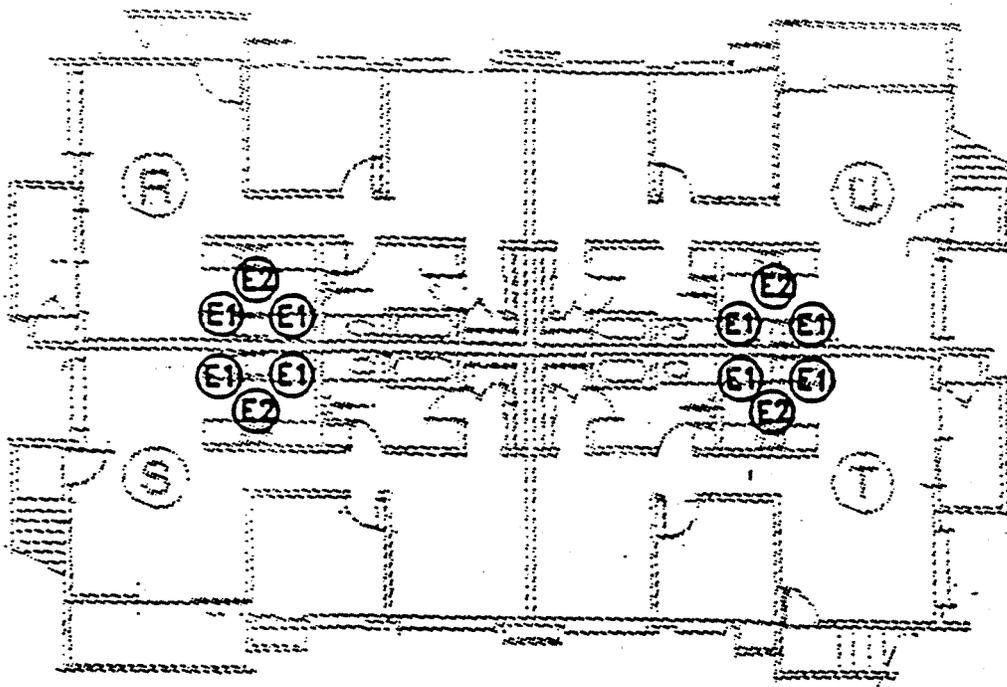
SECOND FLOOR PLAN
 SC: 1/16" = 1'-0"

- E-1 Replace duplex receptacle with new GFI type.
- E-2 Replace polycarbonate diffusers (two 2 X 4) with new acrylic prismatic diffusers.

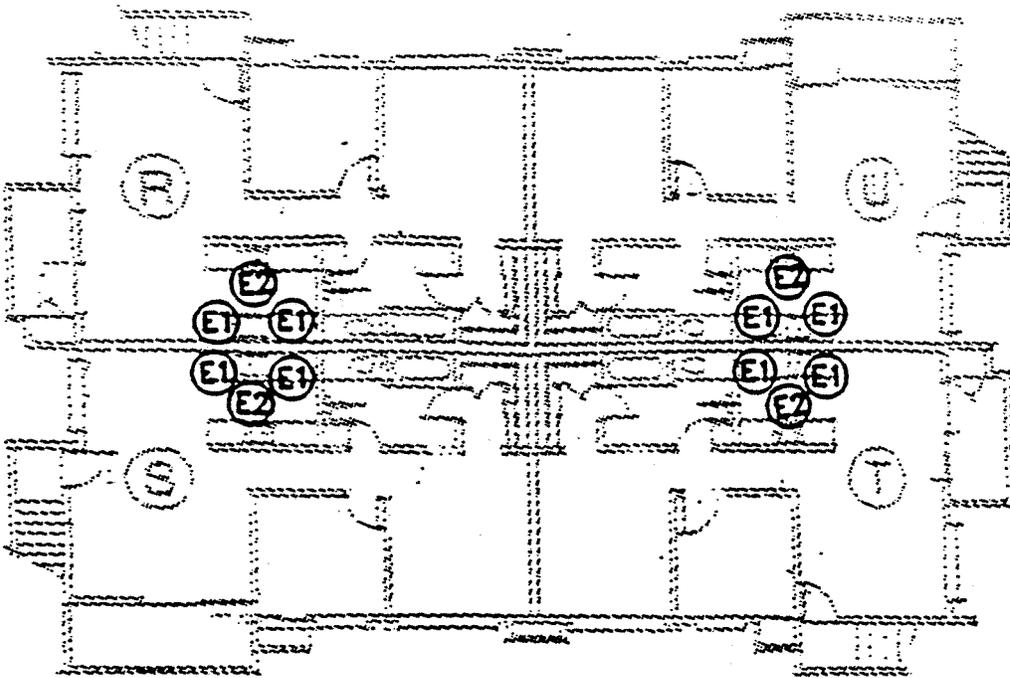
SECOND FLOOR PLAN
 SC: 1/16" = 1'-0"

E-1 Replace duplex receptacle with new GFI type.
