**STATE OF HAWAII**  
**DEPARTMENT OF LAND AND NATURAL RESOURCES**  
**OFFICE OF CONSERVATION AND COASTAL LANDS**  
Honolulu, Hawaii

**REGARDING:** After the Fact (ATF) Conservation District Use Application  
(CDUA) MA-3543 for Hale Kai AOA Seawall

**SUBJECT: After-The-Fact Conservation District Use Application for Repair and Maintenance Improvements to Existing Seawall/Revetment at TMK (2) 4-4-001:042, Honokowai, Maui, Hawaii (CDUA: MA-3543)**

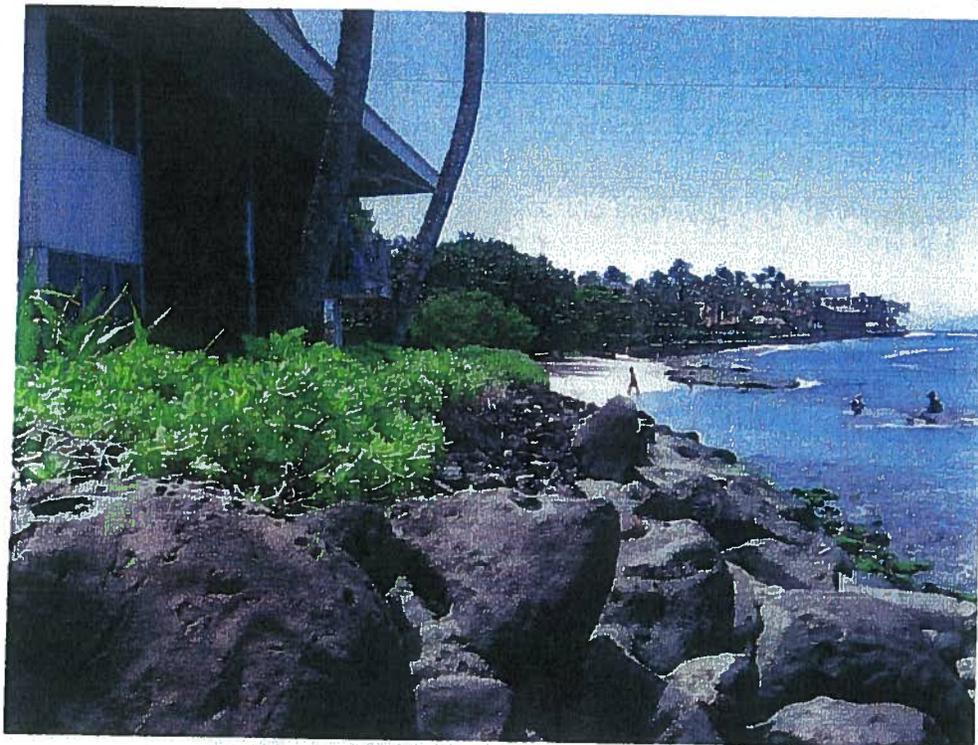
**Existing Revetment Structure**

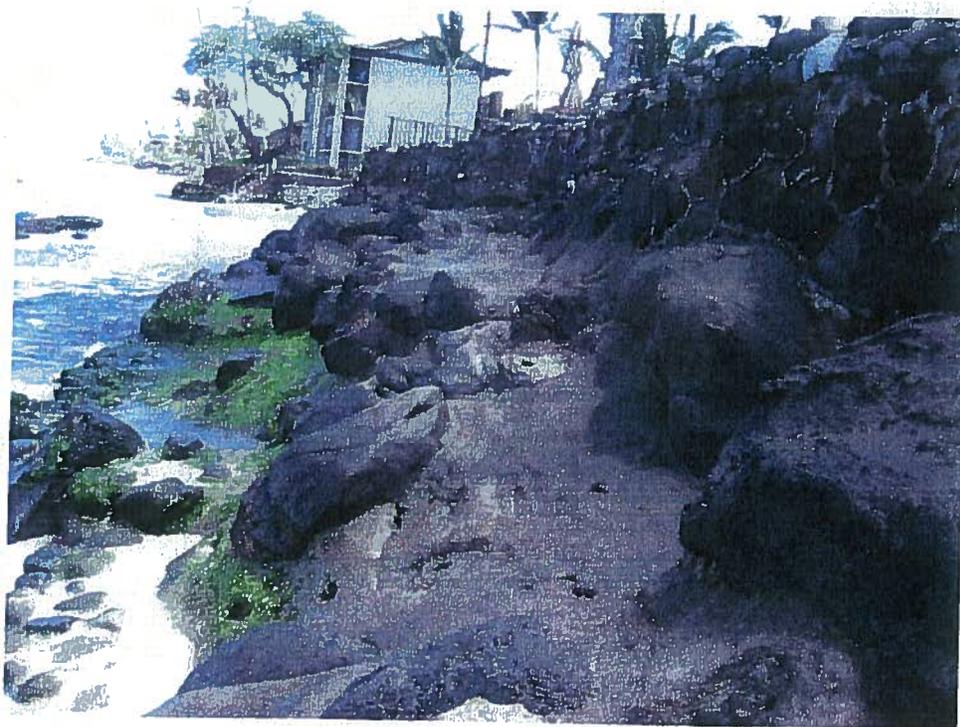
**Existing Seawall Structure**

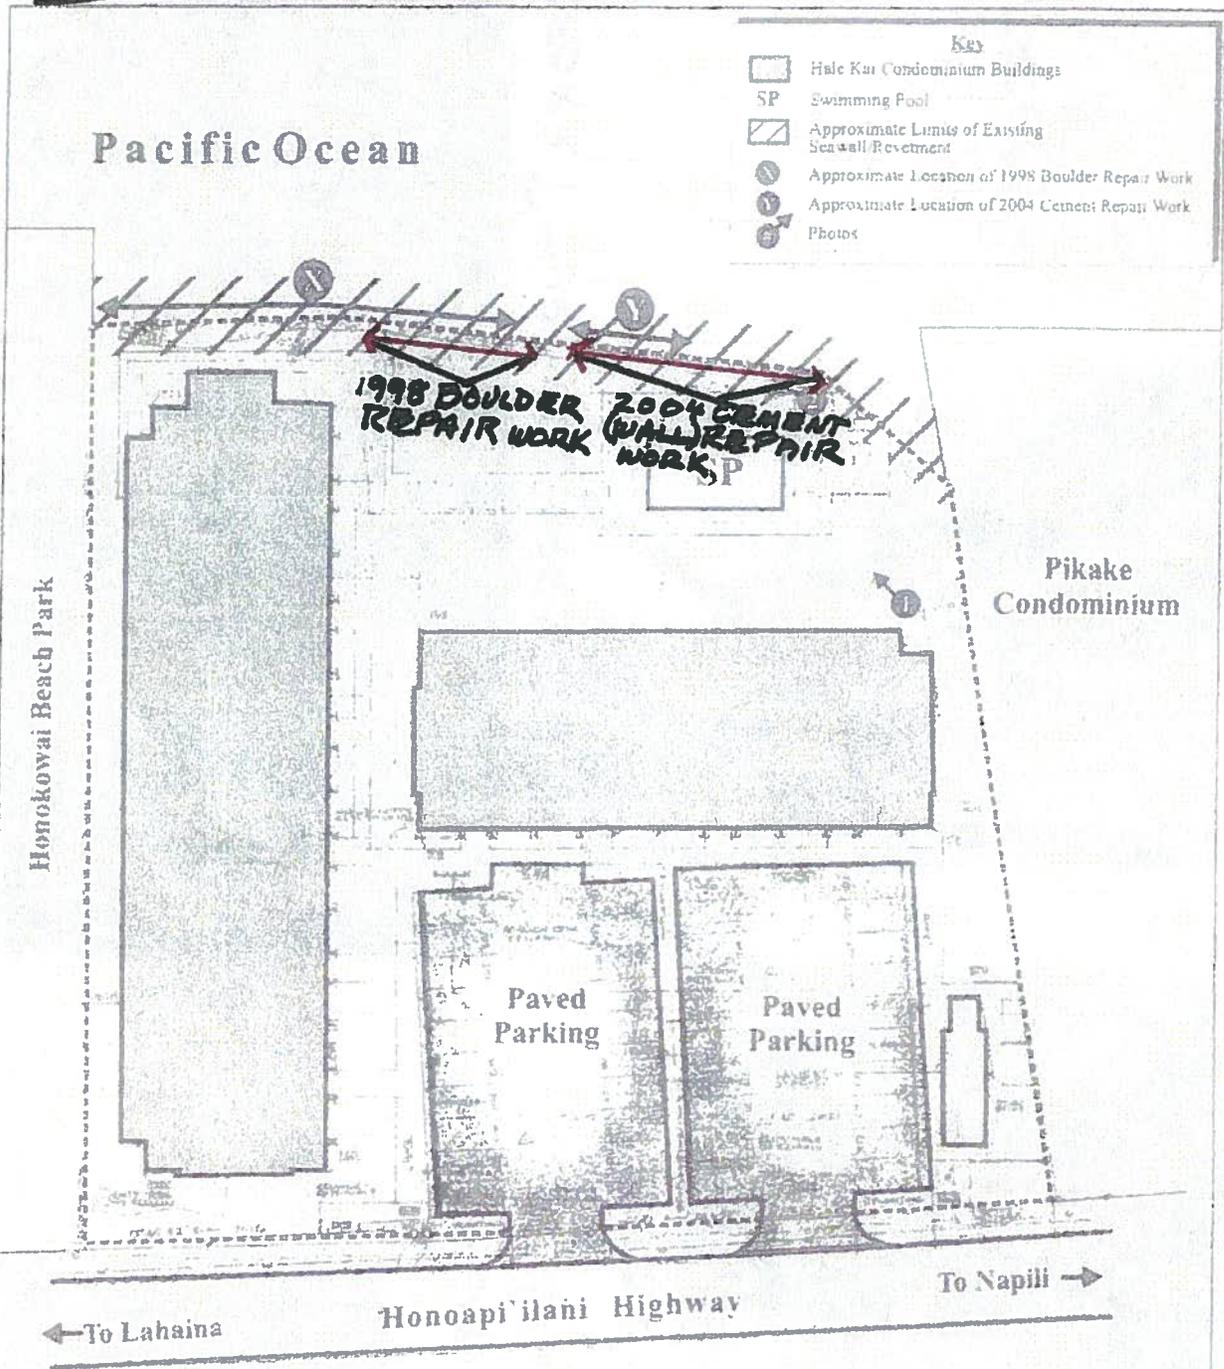
# ATTACHMENT 13.

Exhibit "B" is incorrect and misleading. See ATTACHMENT 13. REVISED Exhibit "B". The actual location of the 1998 BOULDER REPAIR WORK and 2004 CEMENT WALL REPAIR WORK is shown.

ATTACHMENT 13. REVISED Exhibit "B" INDICATING ACTUAL 1998 BOULDER REPAIR WORK AND 2004 CEMENT (WALL) REPAIR WORK

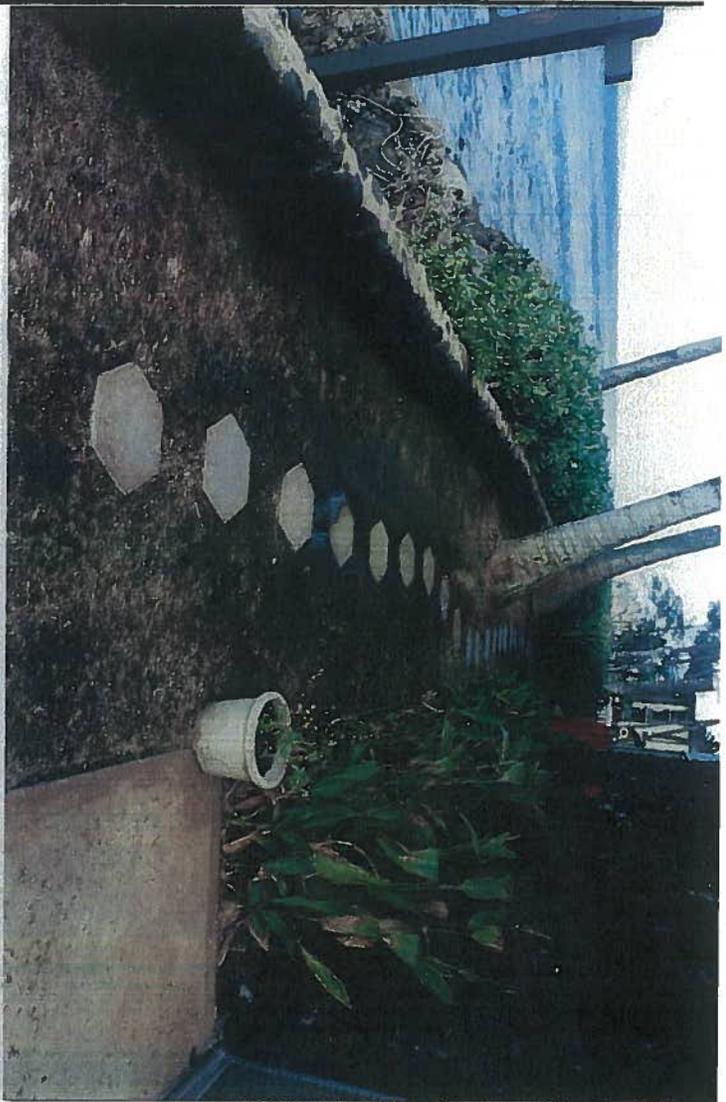
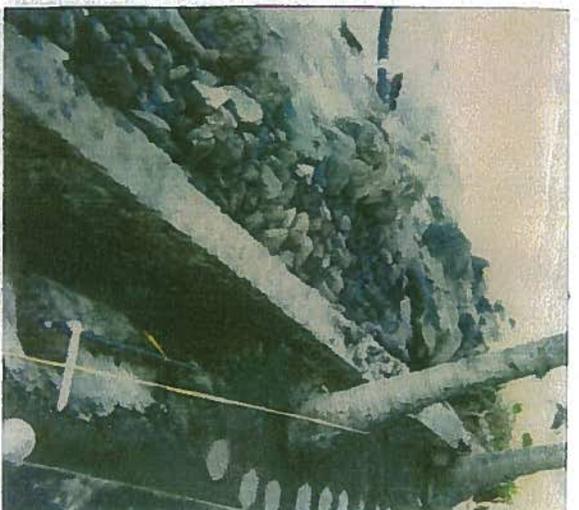
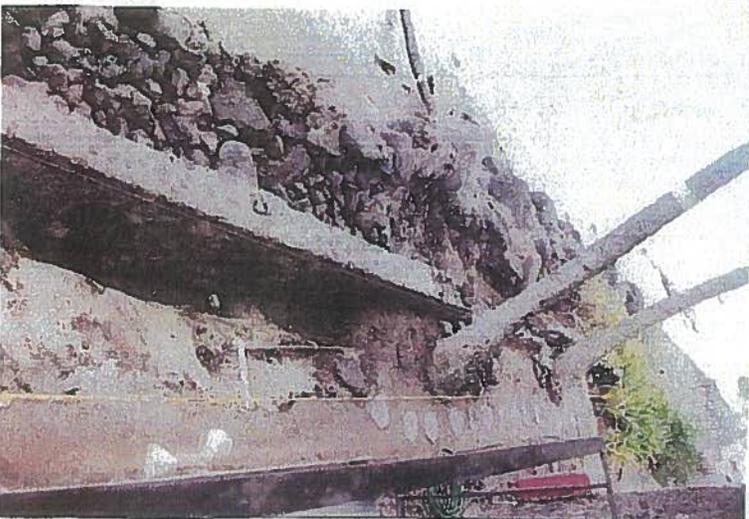
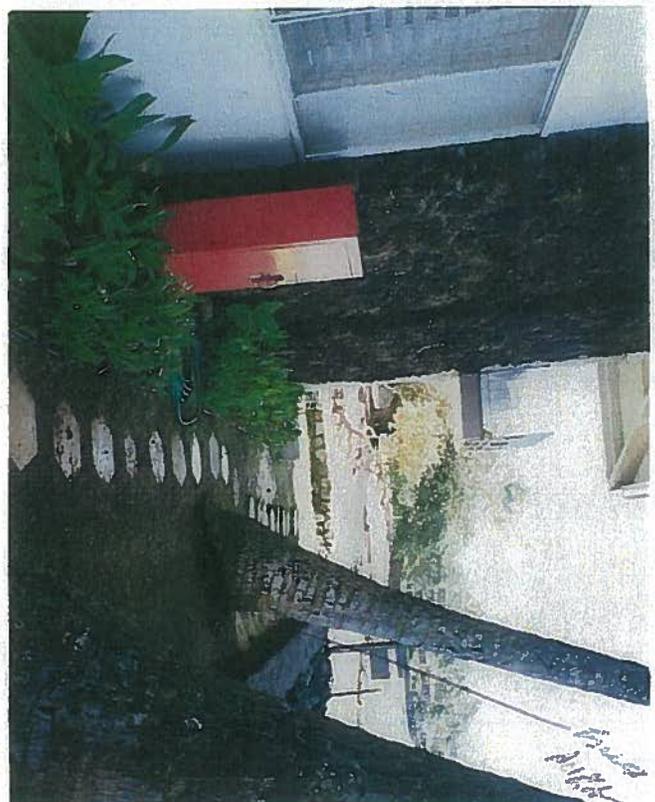
ATTACHMENT  
1. A.

See: ATTACHMENT 1.A The photos, lower left and upper right "During 1993 Repairs" show the wall repair and "Gravel and Geotextile Filter" construction on the building side of the wall as approved in the January 1993 SMA/SS approval, not seaward side of the wall as shown in Figure 1. Photo upper left is before 1993 repair, photo lower right is after 1993 repair.

BEFORE ↑ DURING ↓ 1993 REPAIR

DURING 1993 REPAIR

AFTER 1993 REPAIR

We acknowledge the information provided on the repairs that were undertaken in 1993 by the Hale Kai AOA to a garden wall on the property that runs along the mauka side of the top of the existing seawall/revetment. An SMA approval was issued in 1993 by the County of Maui, Department of Planning prior to the completion of this work, which is separate and distinct from the 1998 boulder repair work and 2004 cement grouting repair work that is the subject of the CDUA currently being processed by OCCL.

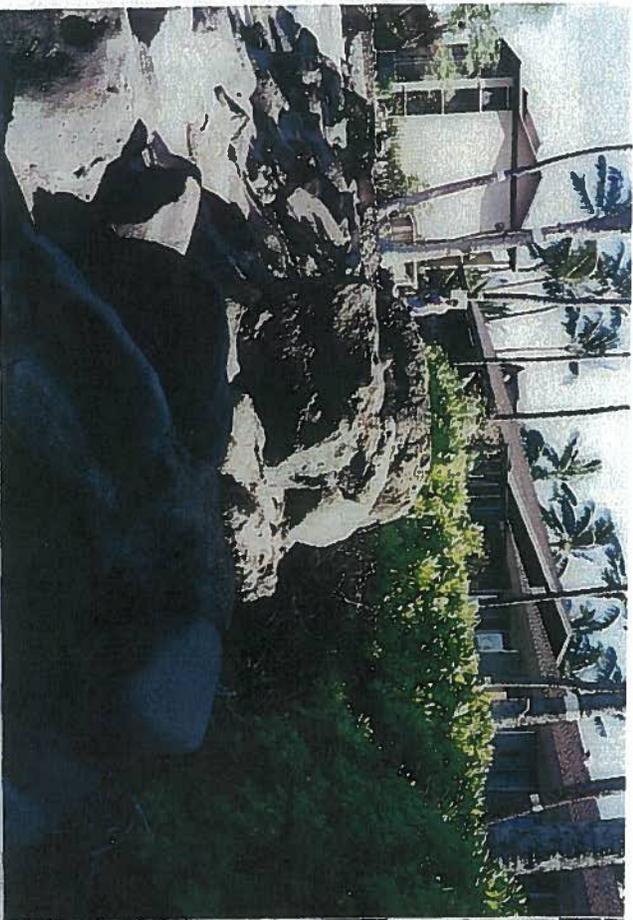
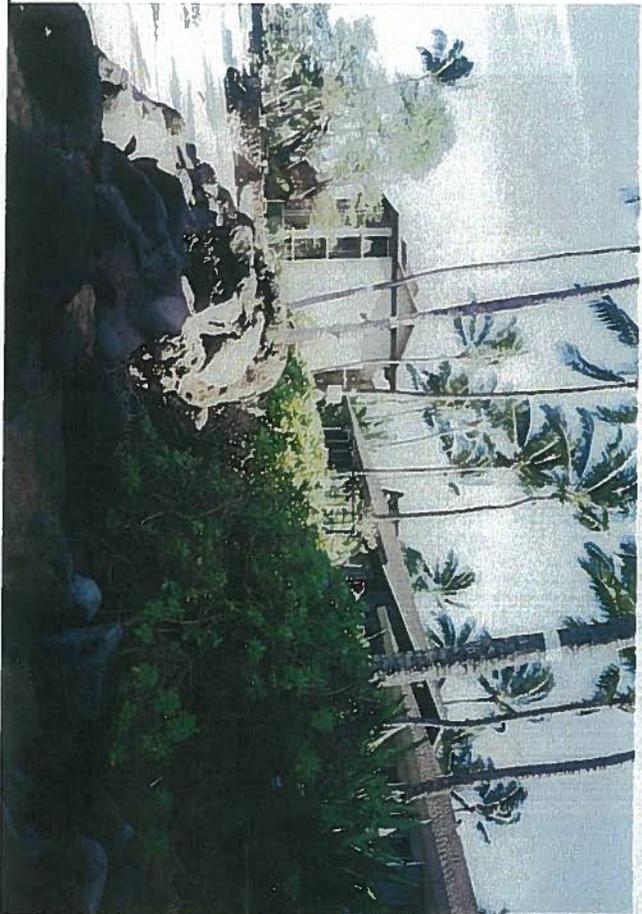
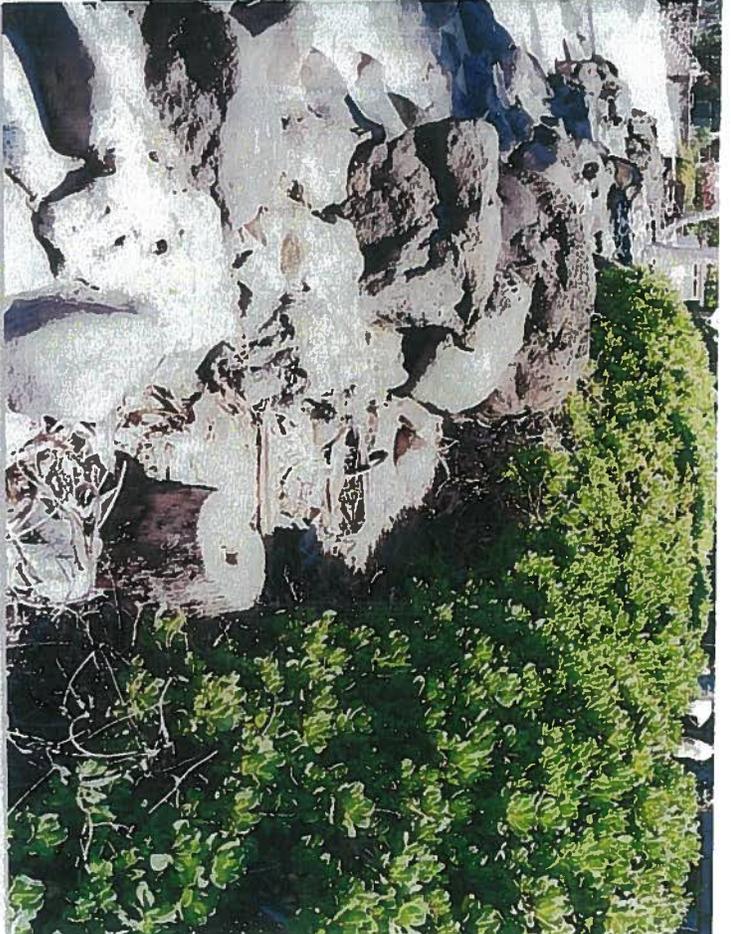
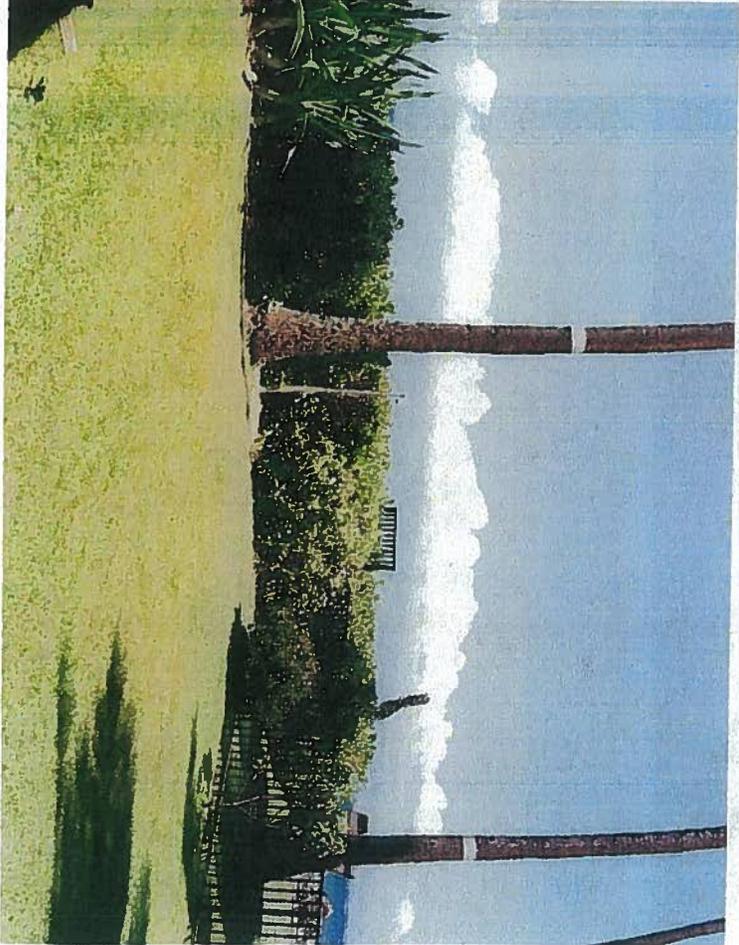
ATTACHMENT BEFORE 1998 REPAIR  
I. B.

See ATTACHMENT 1. B. BEFORE 1998 REPAIRS. Photos show the naupaka growing along the wall to the pool fence.

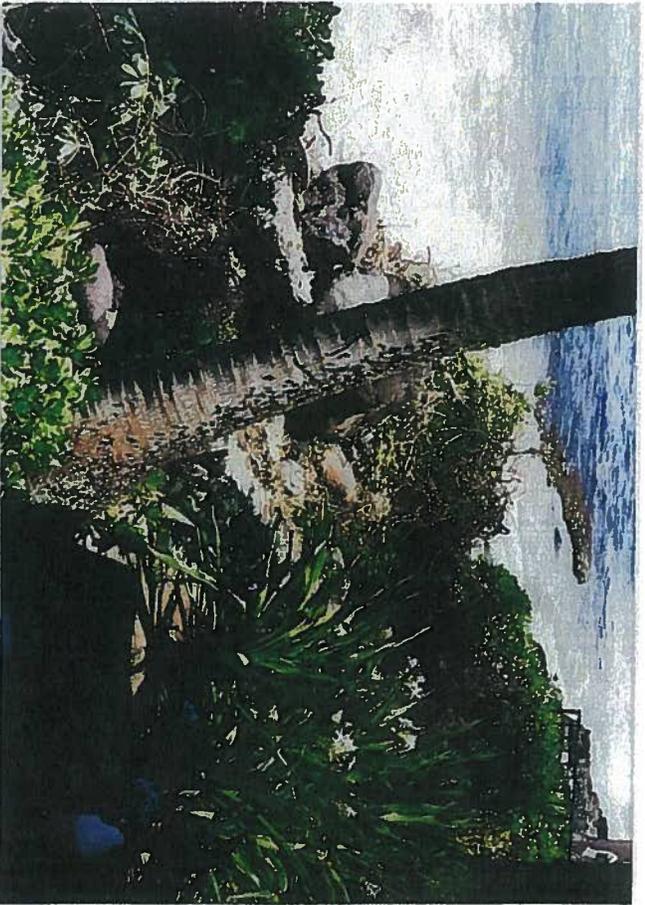
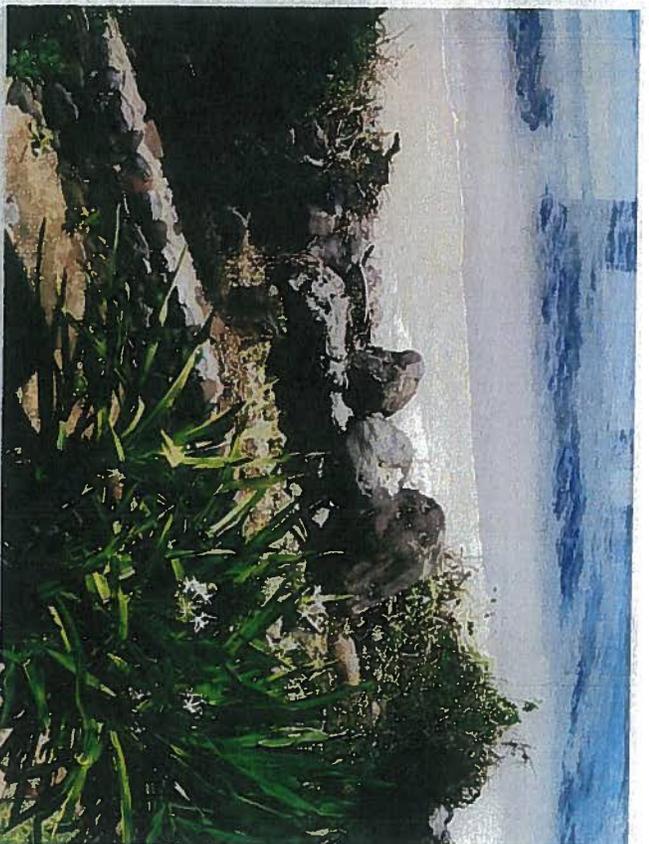
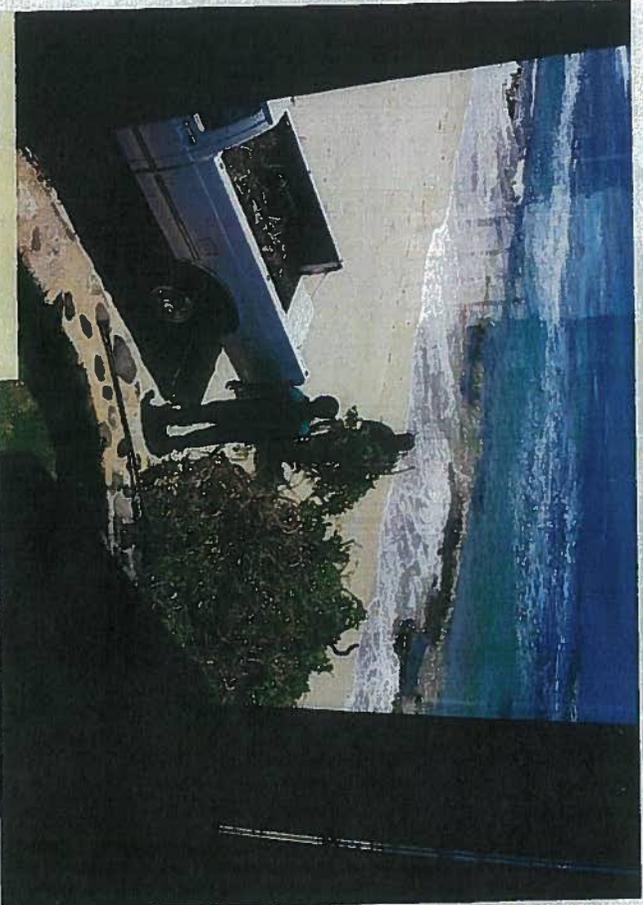
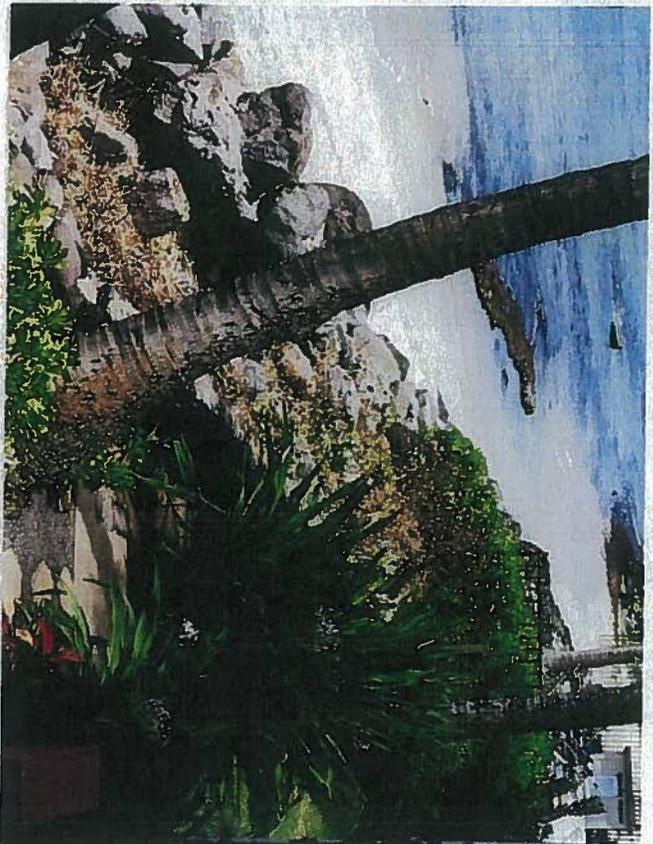
ATTACHMENT  
1. C.

NAUPAKA VEGETATION BEING REMOVED

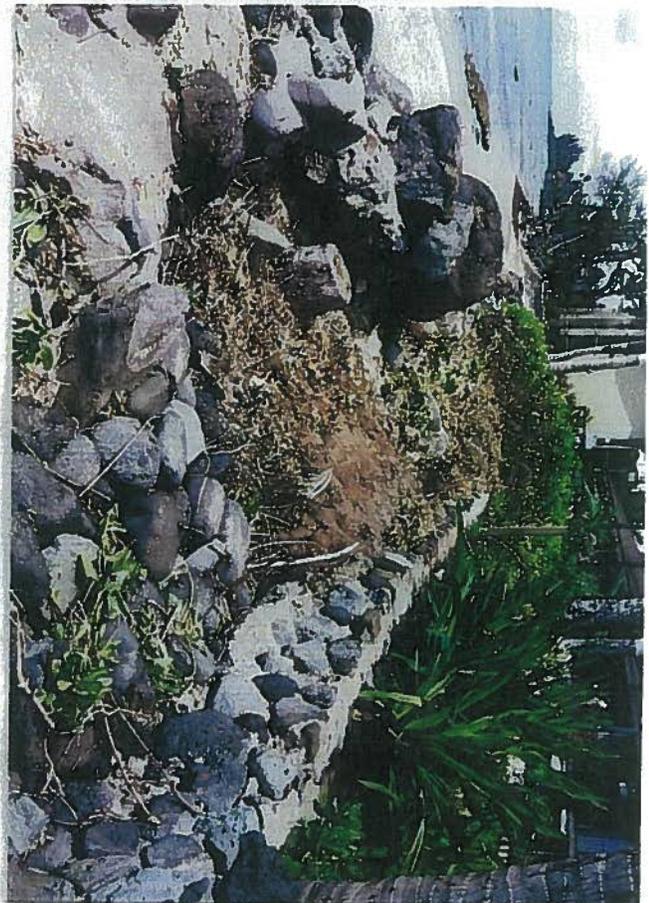
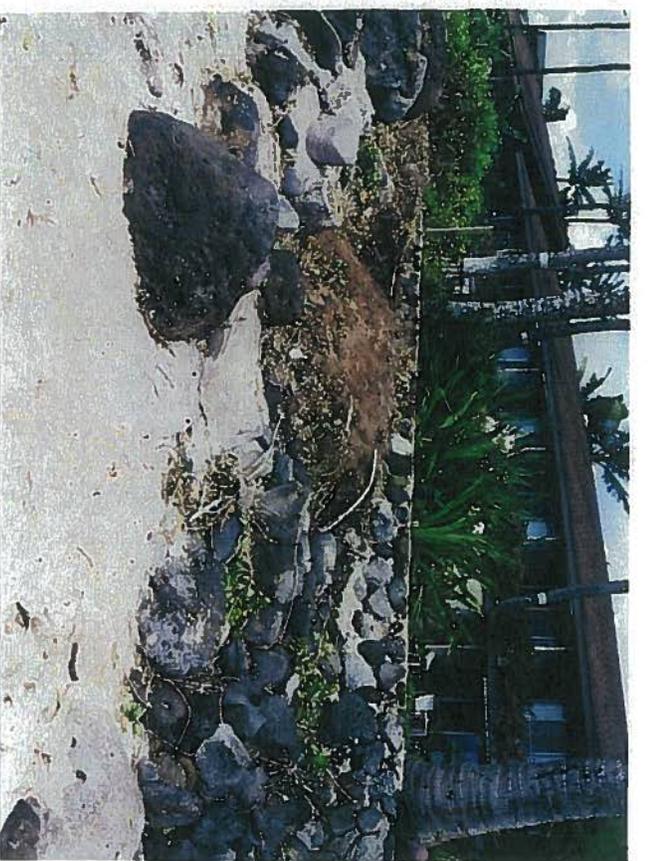
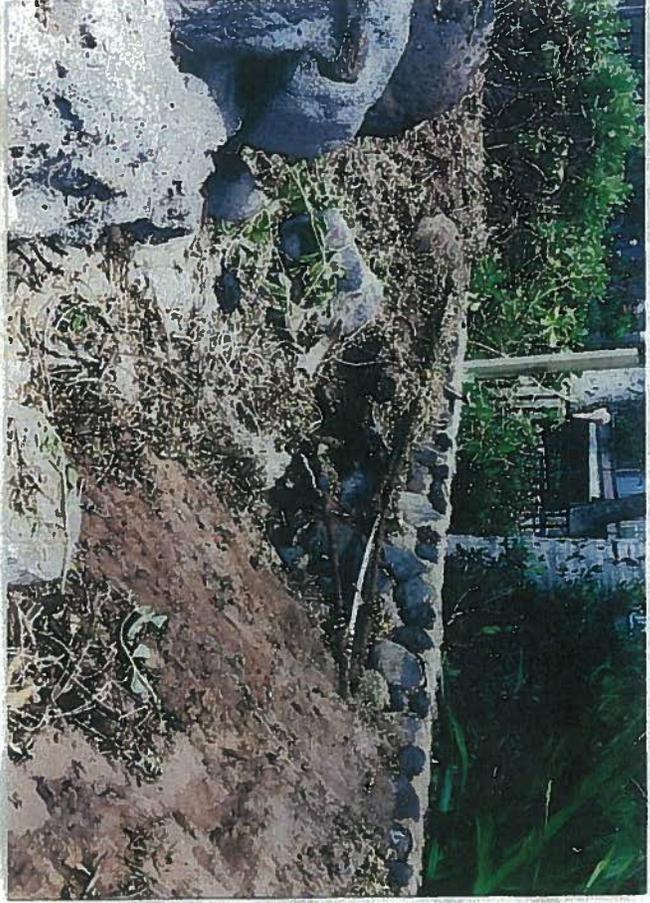
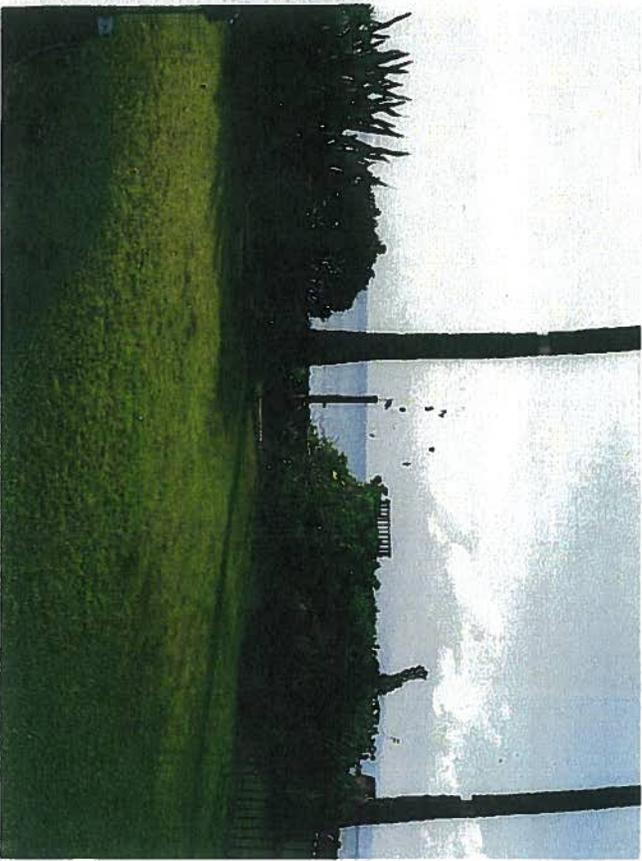
ATTACHMENT  
1. D.

NAUPAKA VEGETATION REMOVED

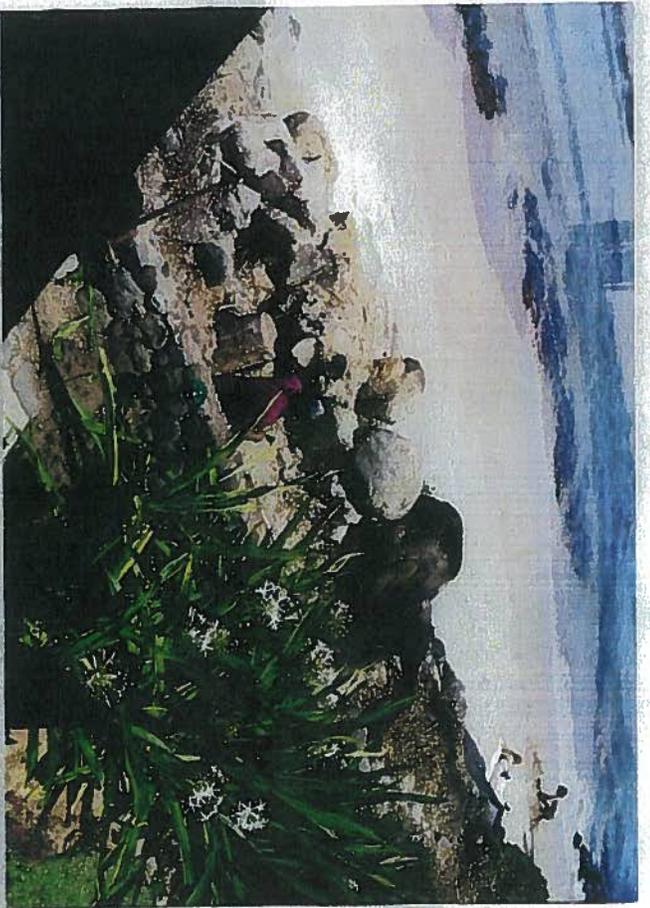
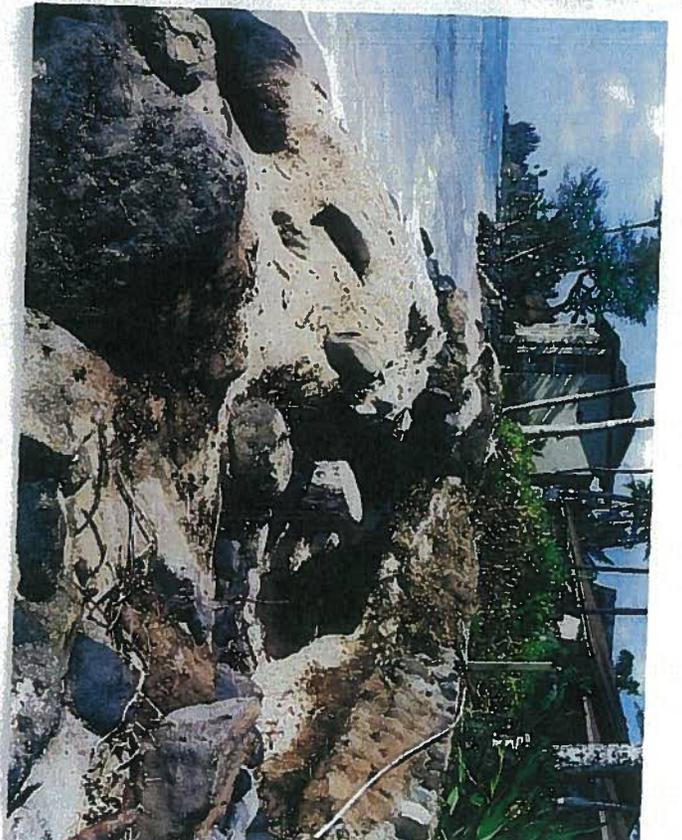
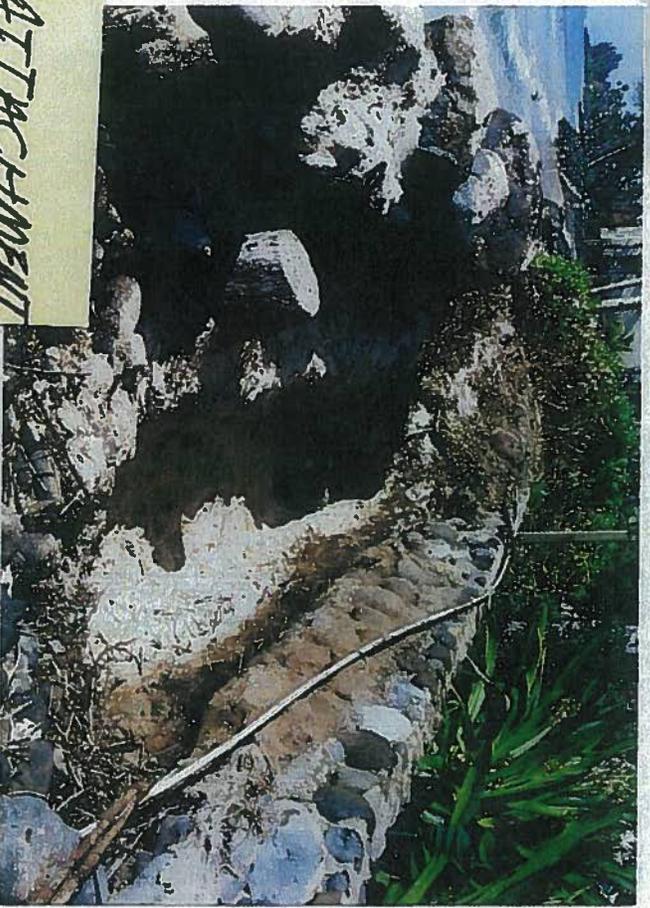
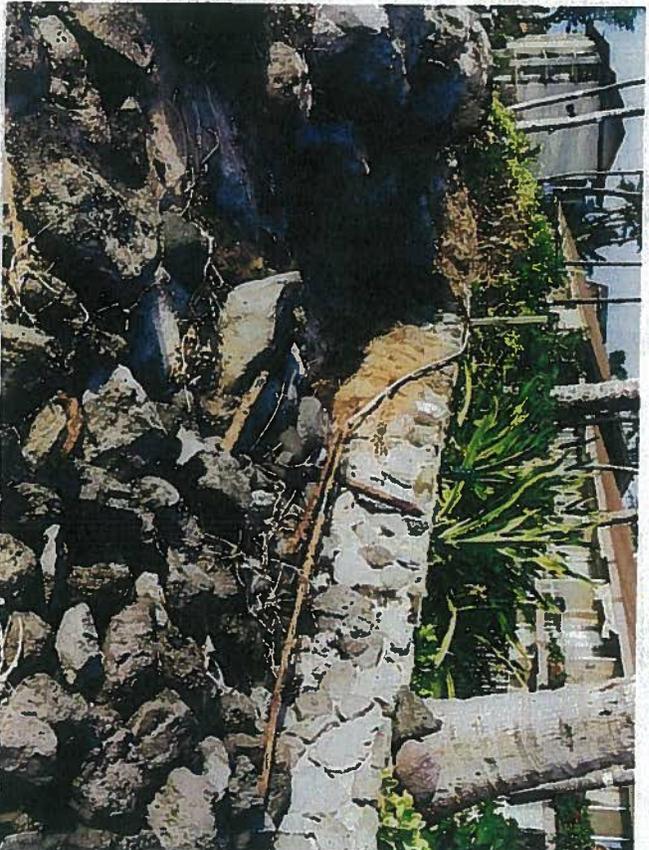
ATTACHMENT  
1. E.

TRENCH DUG TO REMOVE NAUPAKA ROOTS

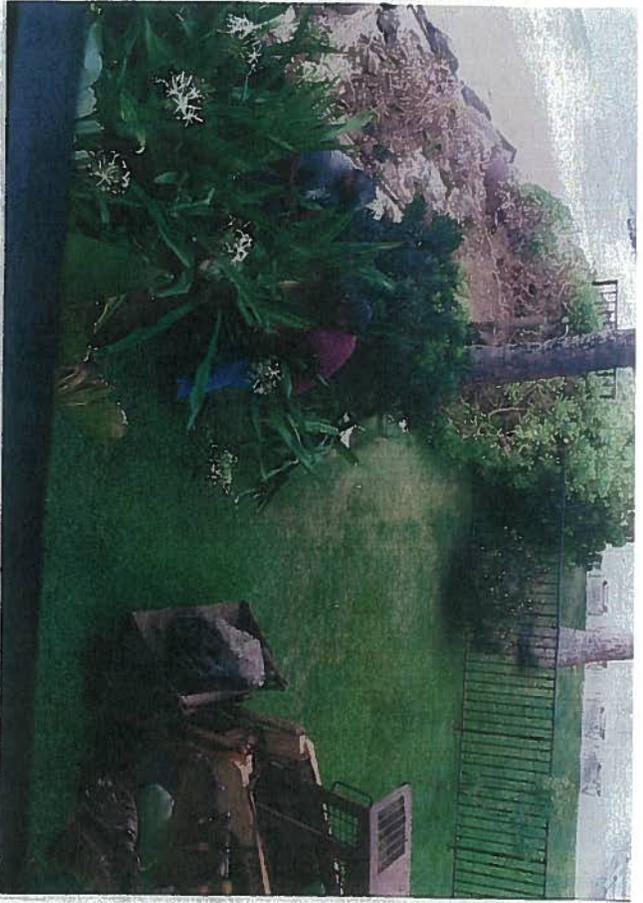
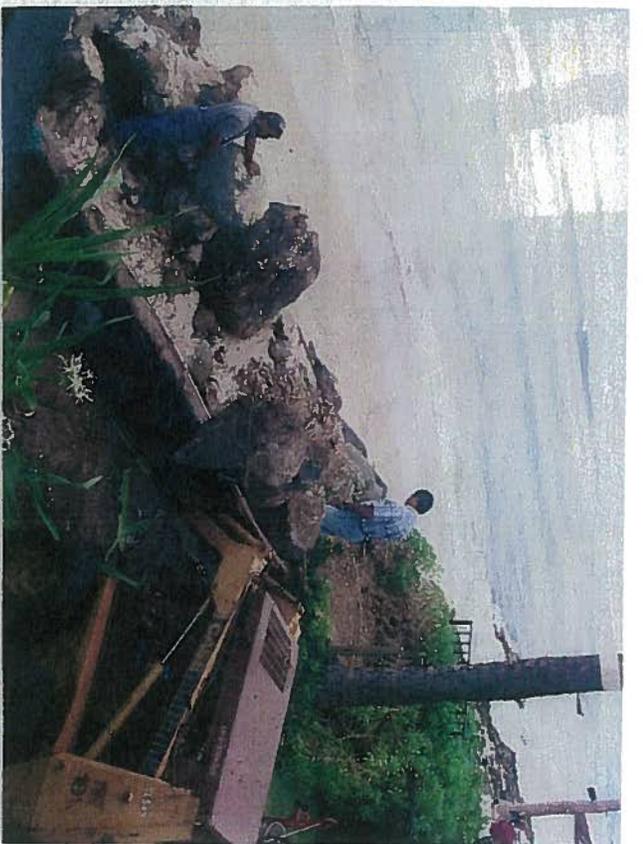
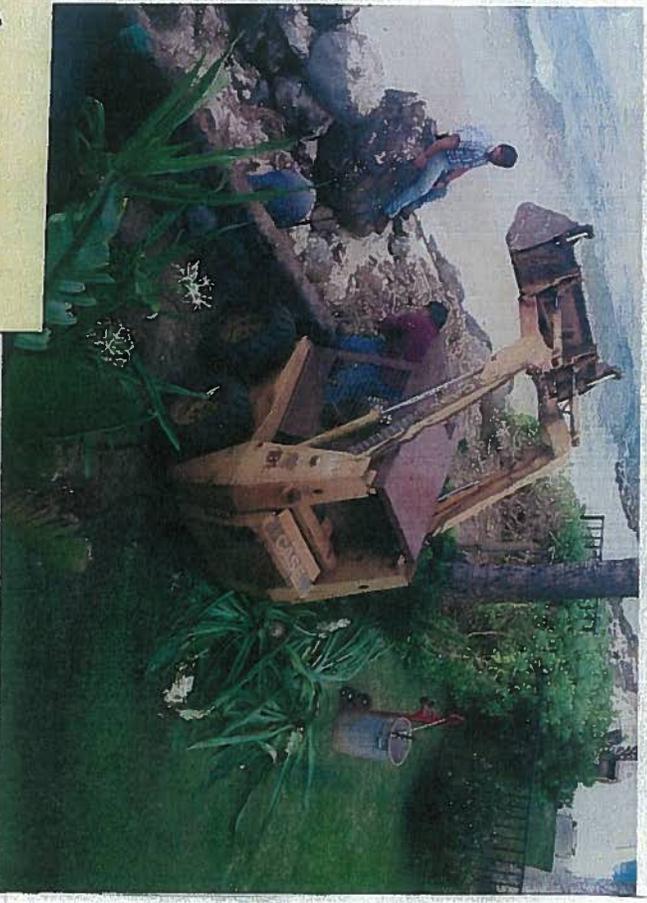
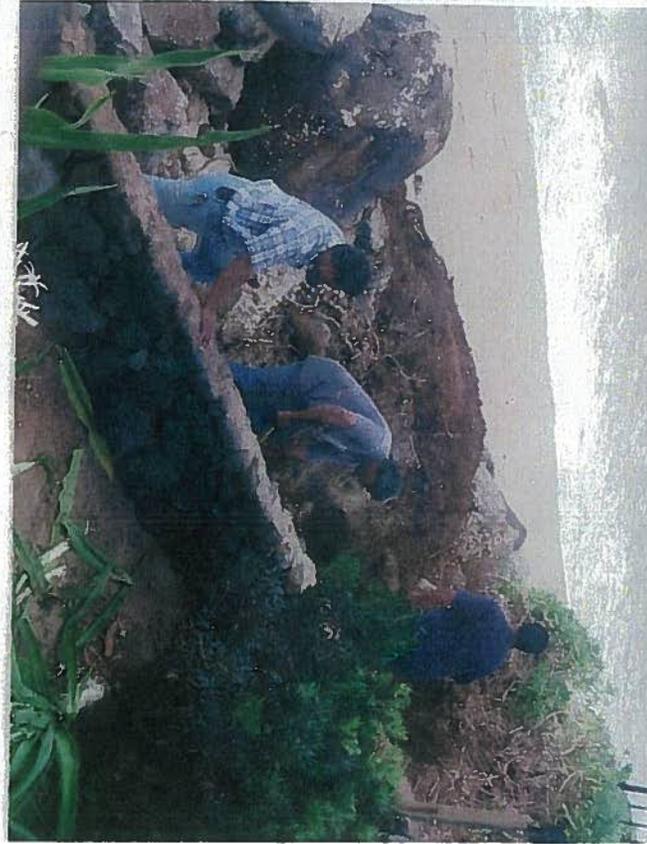
ATTACHMENT  
1. F.

PLACING BOULDERS IN ROOT TRAIL

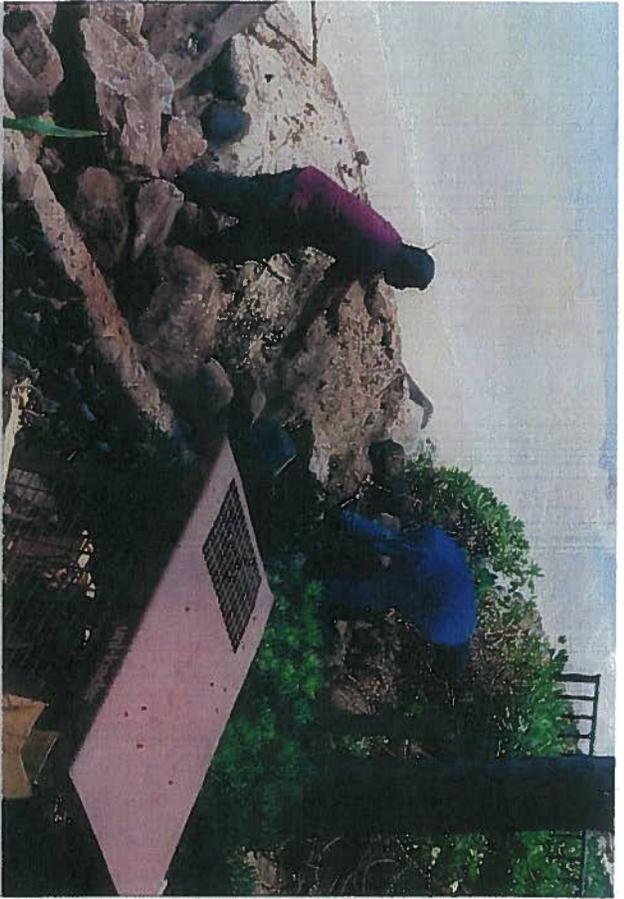
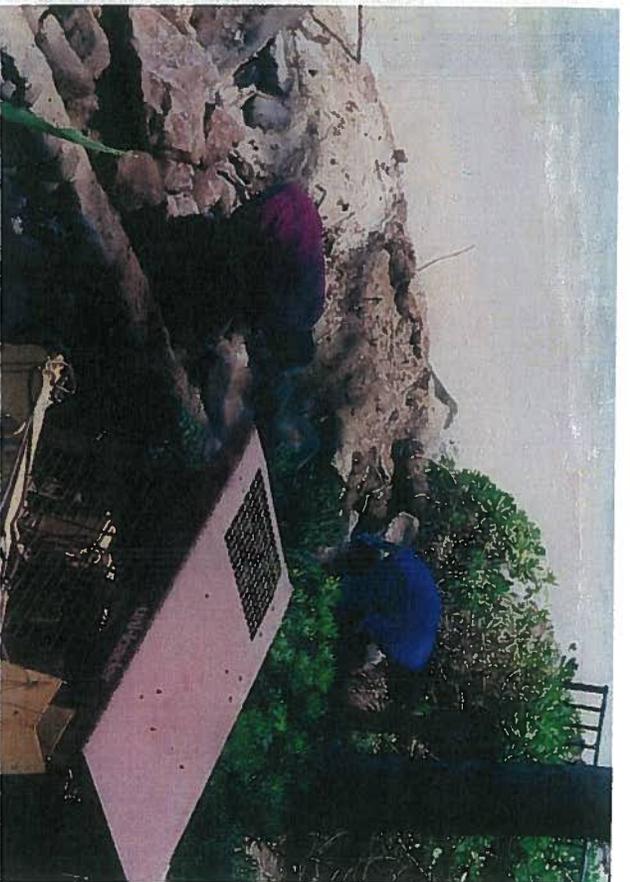
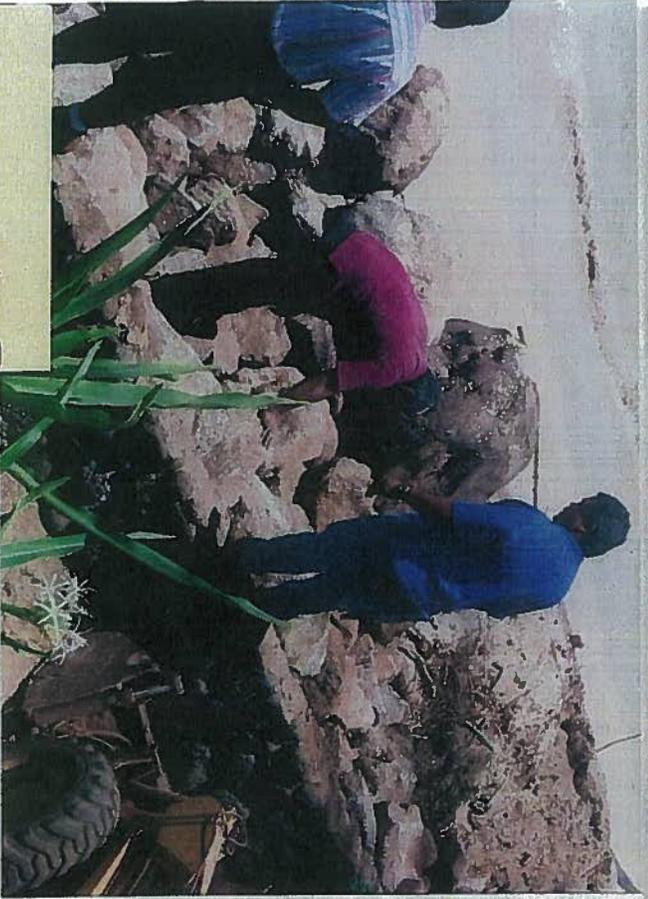
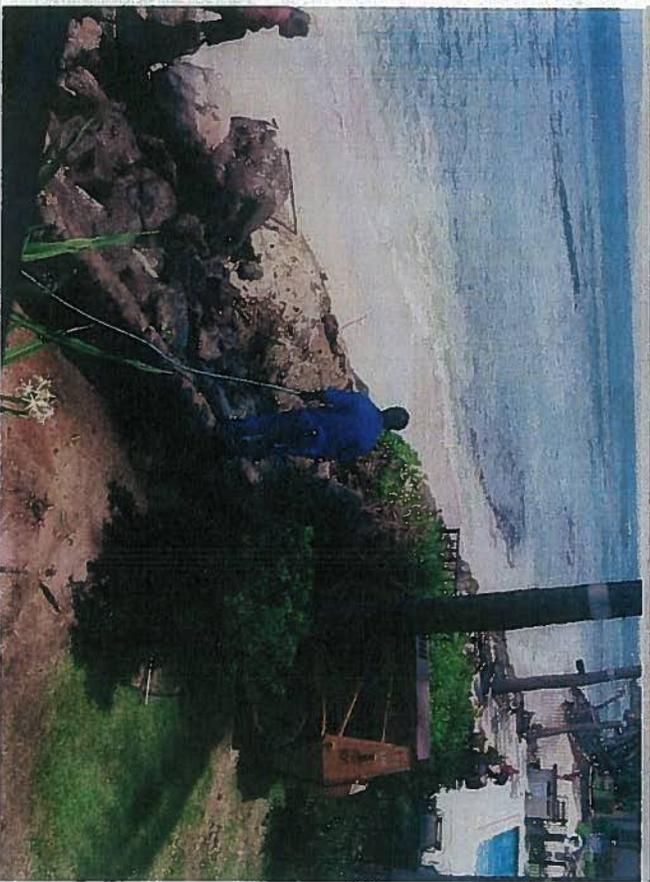
ATTACHMENT  
1. G.

MORE BOULDERS TO FILL ROBT  
TRENCH

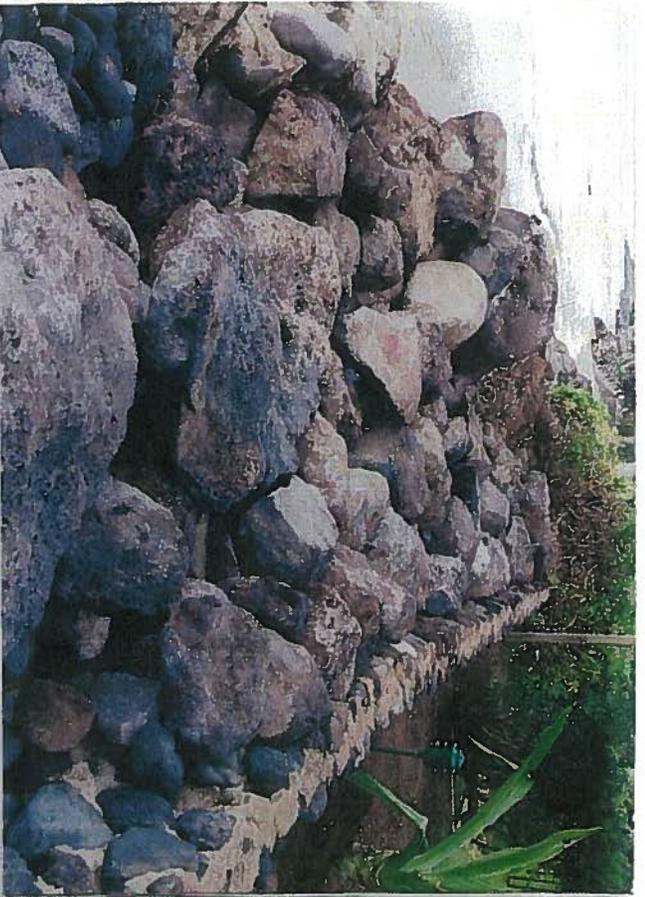
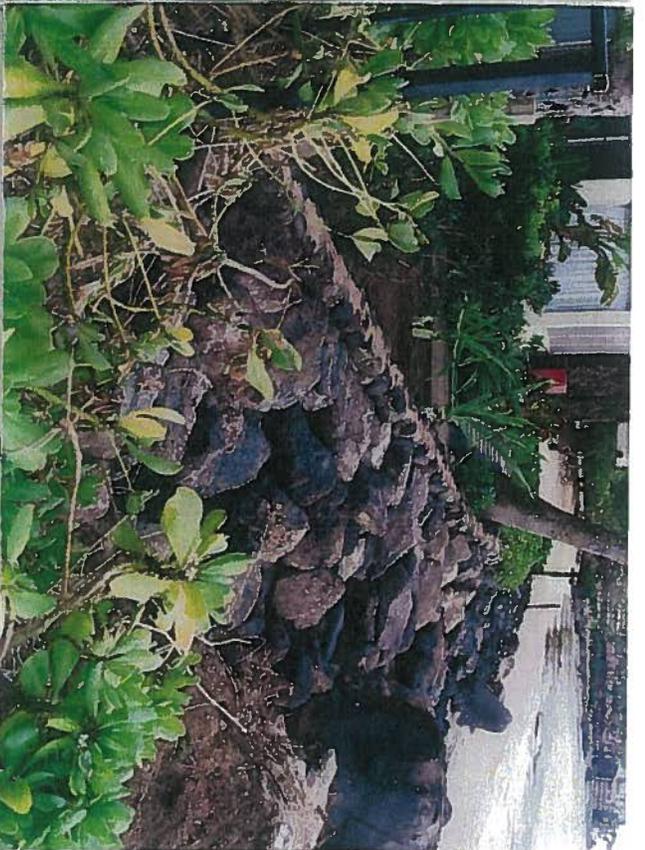
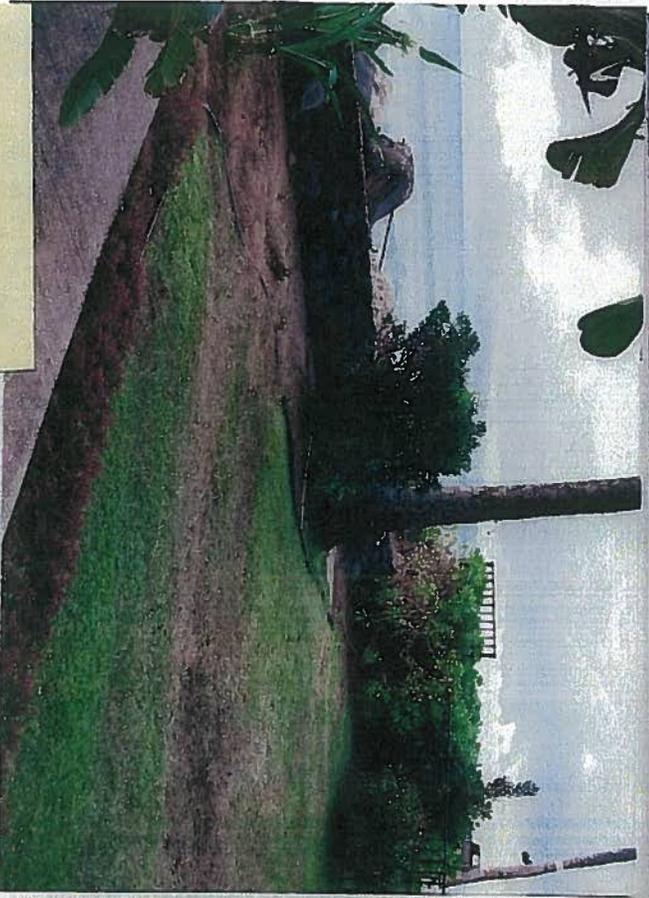
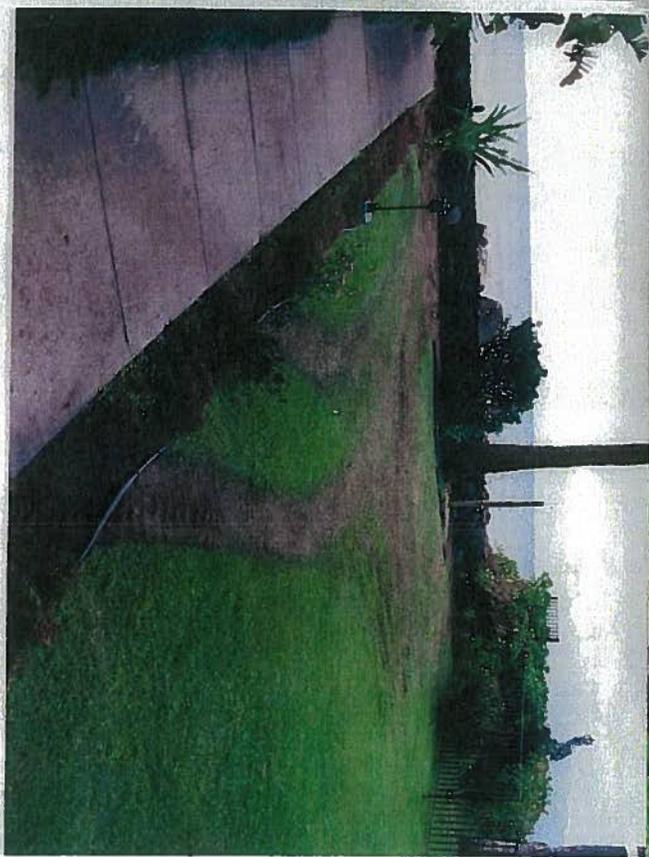
See ATTACHMENT 1. H. COMPLETED PLACEMENT OF BOULDERS AND ROCKS TO TOP OF WALL Photos show the completed 1998 repair on both sides of the wall. All of the 1998 repairs were made in front of the grass area. The south building is to the left of the walk way and 20 feet way from the closest 1998 repaired location. At the time the 1998 repairs were made there were no "wave related damage and building maintenance issues" with the south building. The Hale Kai AOA was more interested in a new wall at the entrance to the property which was included as a free wall for the \$24,400 1998 seawall repair.

Figure 5. is misleading. As shown in ATTACHMENT 1. H. the rocks are to the top of the wall. There is some erosion caused by the drainage of the ocean water that collected behind the wall, flowing south beyond the pool fence. The erosion under the pool fence extends north approximately four (4) feet. See ATTACHMENT 4. PHOTOS OF POOLING OCEAN WATER BEHIND SEAWALL AND PHOTOS OF EROSION UNDER POOL FENCE.

COMPLETED PLACEMENT OF BOULDERS  
AND ROCKS TO TOP OF WALL

This recommendation corrective action will put this area back to its original condition (see ATTACHMENT 1. H.) except for having a geotextile filter fabric around the stones placed in the 3 ft. deep trench.
