**STATE OF HAWAII**  
**DEPARTMENT OF LAND AND NATURAL RESOURCES**  
**OFFICE OF CONSERVATION AND COASTAL LANDS**  
Honolulu, Hawaii

**REGARDING:** After the Fact (ATF) Conservation District Use Application  
(CDUA) MA-3543 for Hale Kai AOA Seawall

**SUBJECT: After-The-Fact Conservation District Use Application for Repair and Maintenance Improvements to Existing Seawall/Revetment at TMK (2) 4-4-001:042, Honokowai, Maui, Hawaii (CDUA: MA-3543)**

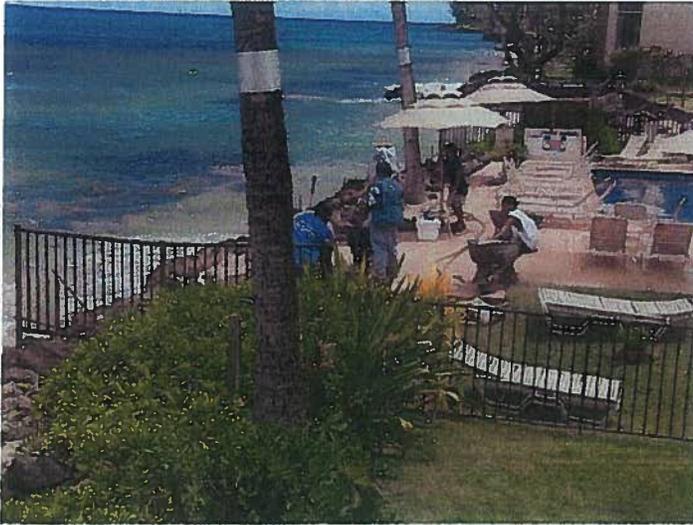
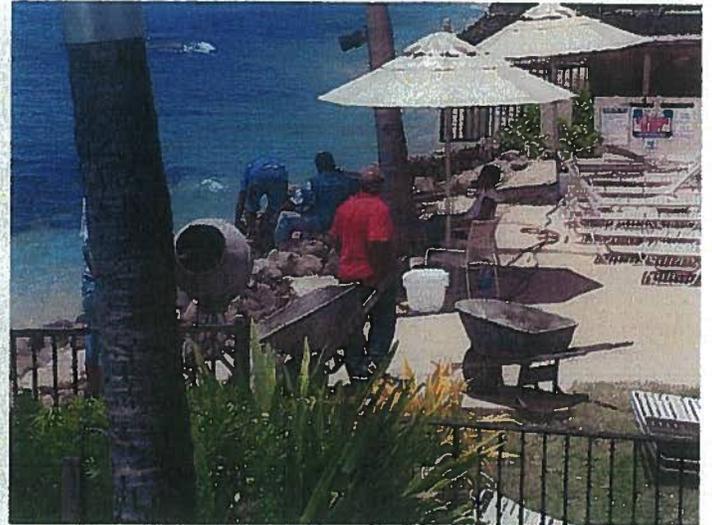
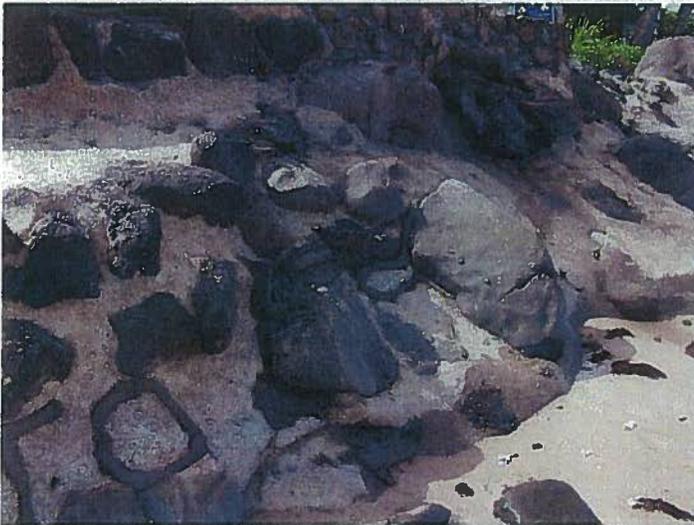
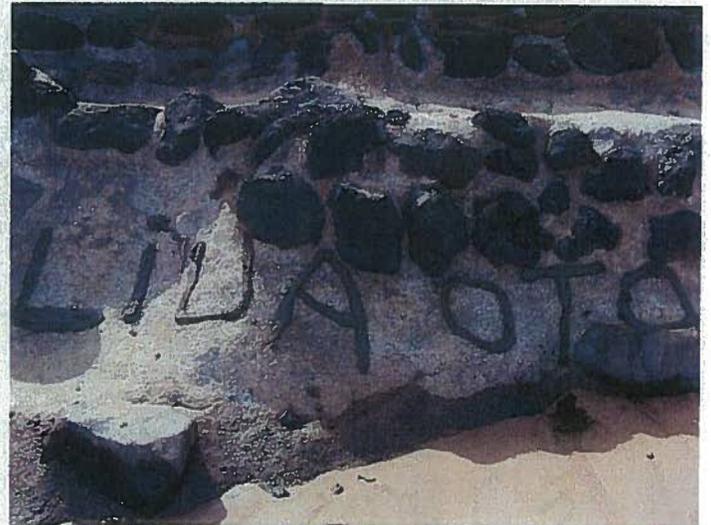
The “seawall structure raised approximately 16 inches” took five (5) workers three (3) days to complete. (4/26/04 to 4/28/04) The “grout repair done around selected wall sections and individual stones” took one (1) worker less than two (2) hours on 4/29/04. He even had time to grout his name.

See ATTACHMENT 2. PHOTOS OF 2004 WALL CONSTRUCTION AND GROUTING REPAIRS. Two photos of workers constructing the “16 inch seawall” and two photos of “grout repairs around selected sections and individual stones”

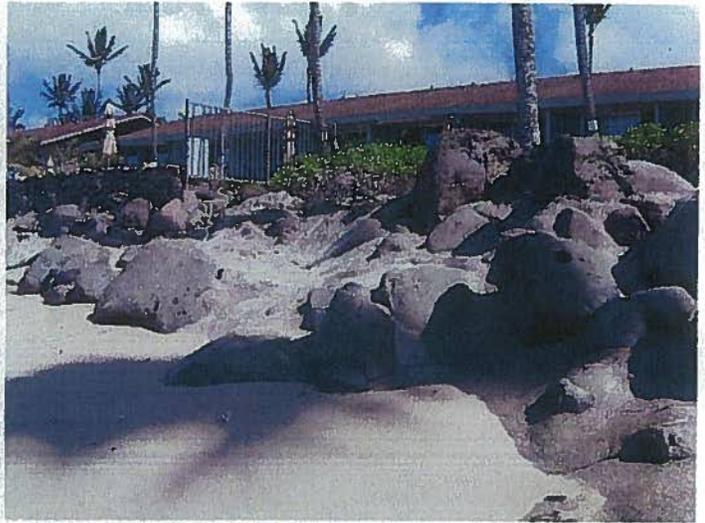
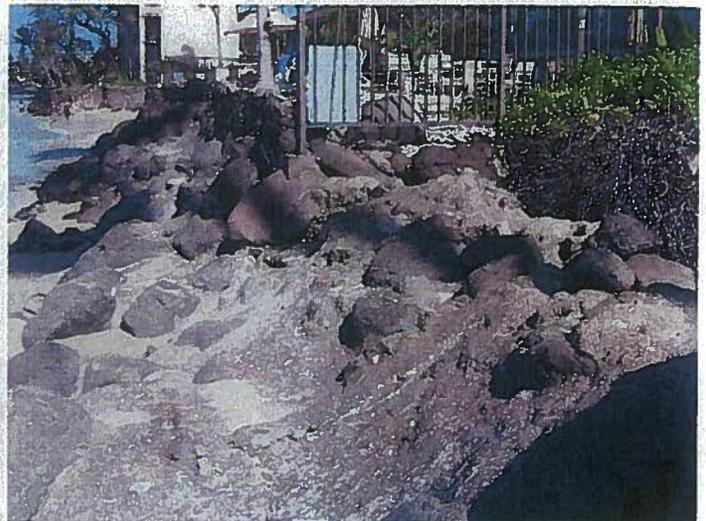
ATTACHMENT  
3,

See ATTACHMENT 3. PHOTOS of LOCATION IN Figure 1. 2007 REPAIR. In the photos note the location of the 16” seawall and pool fence in relation to the location of the 2007 Repair in Figure 1.

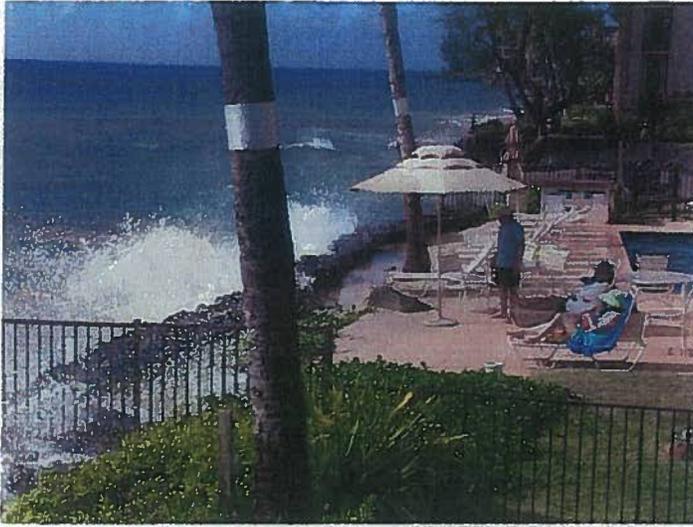
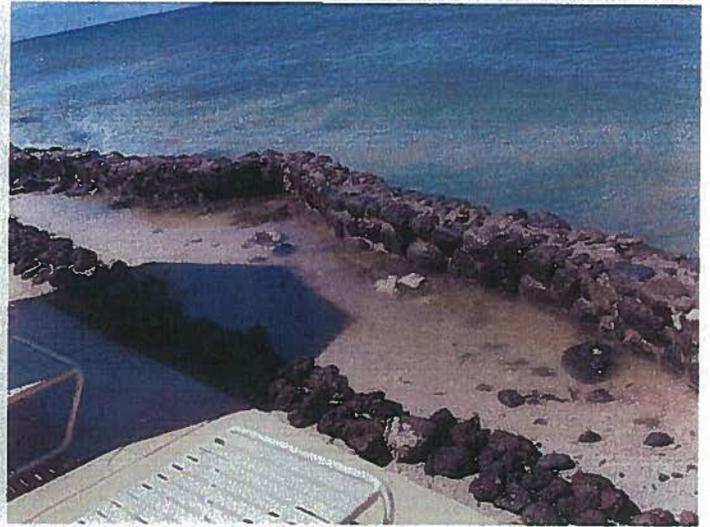
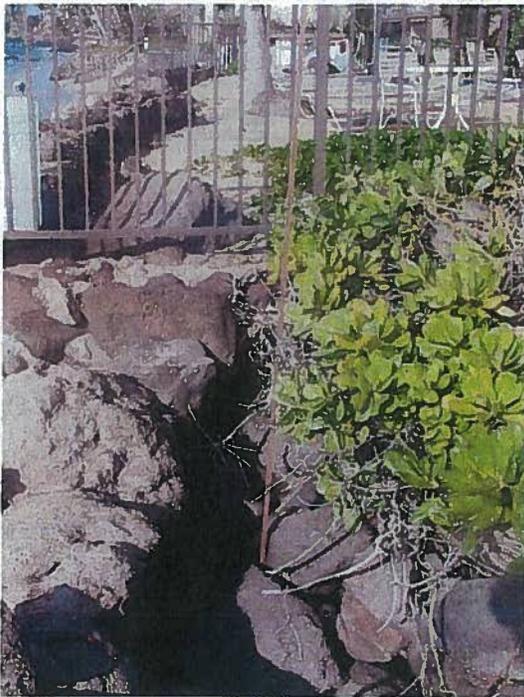
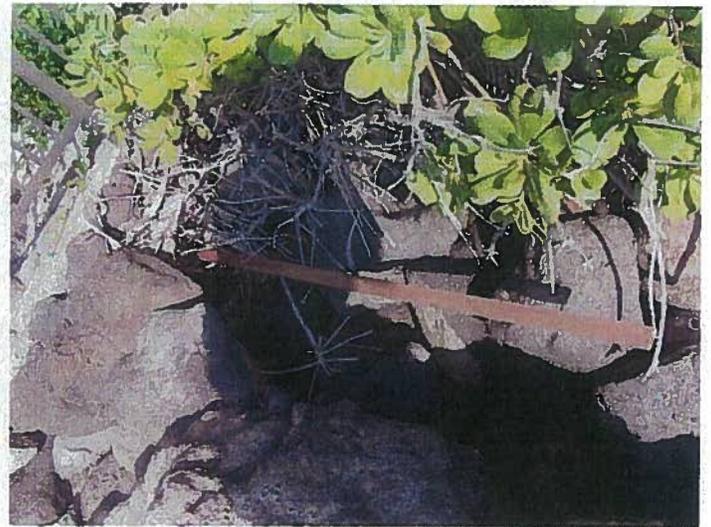
Figure 5. is misleading. As shown in ATTACHMENT 1. H. the rocks are to the top of the wall. There is some erosion caused by the drainage of the ocean water that collected behind the wall, flowing south beyond the pool fence. The erosion under the pool fence extends north approximately four (4) feet. See ATTACHMENT 4. PHOTOS OF POOLING OCEAN WATER BEHIND SEAWALL AND PHOTOS OF EROSION UNDER POOL FENCE.

1. POOLING.JPG

2. POOLING .JPG

3.HOLE 12/30/05.JPG

4.HOLE 12/30/05.JPG

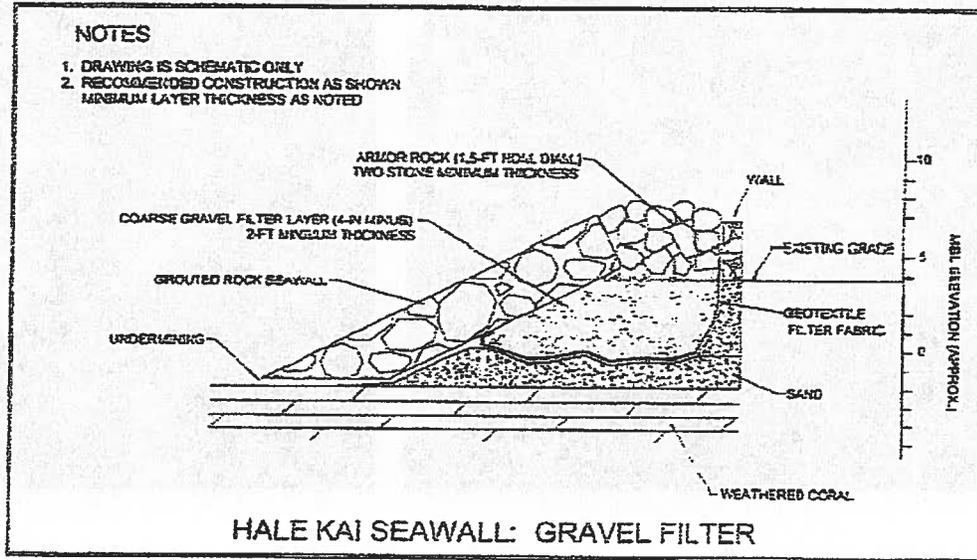
Figure 6. Recommended gravel filter repair

The recommended corrective action is to modify the crest to comply with the schematic representation shown in Figure 6. As follows:

This recommendation corrective action will put this area back to its original condition (see ATTACHMENT 1. H.) except for having a geotextile filter fabric around the stones placed in the 3 ft. deep trench.

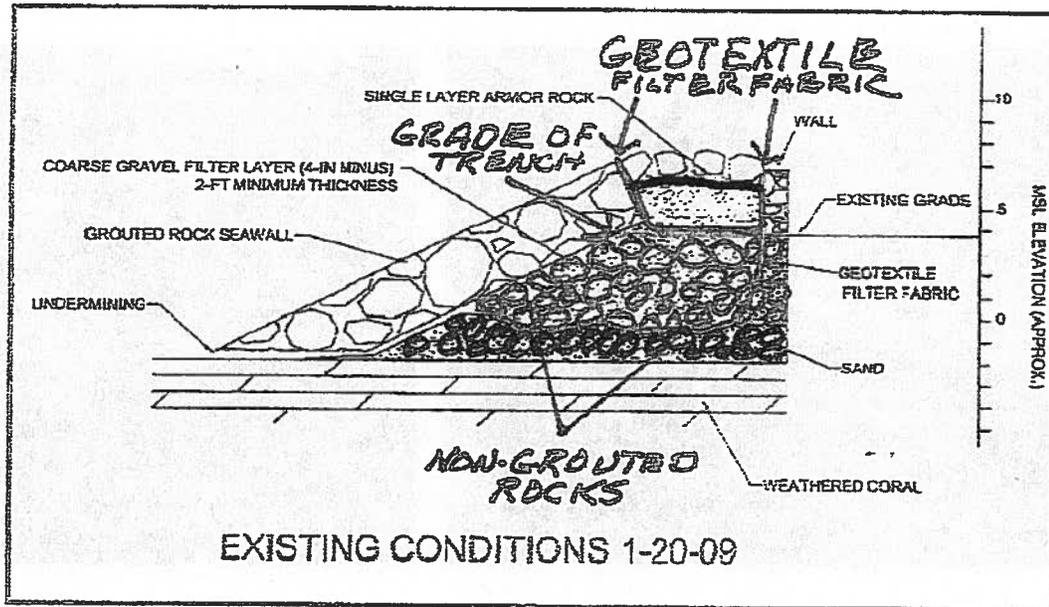
See ATTACHMENT 5. ACTUAL CONDITIONS ON 1-20-09. The filter fabric trench built on 8/4/07, by an unlicensed contractor, was not built to the Sea Engineering Inc. specifications: It was not dug down to weathered coral. See ATTACHMENTS 6. to 10. for photos of the 2007 filter fabric trench construction.

Figure 7. Condition of repaired revetment, January 2009

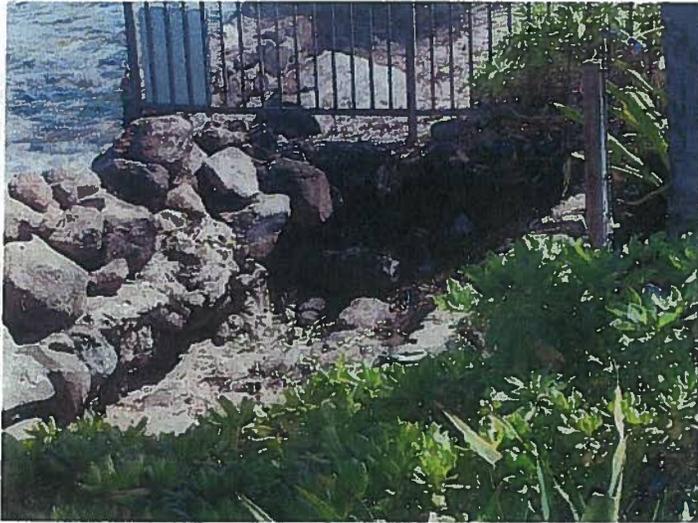
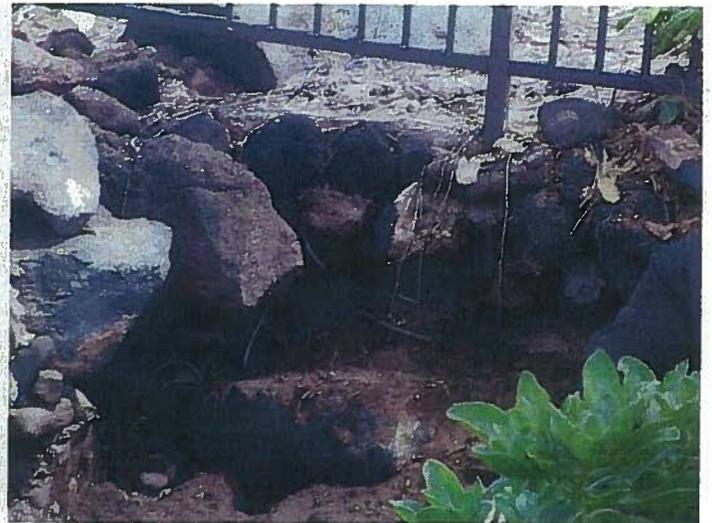
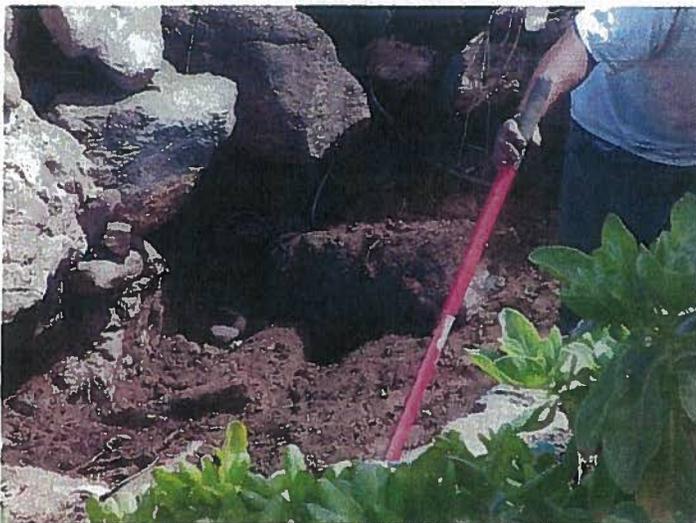
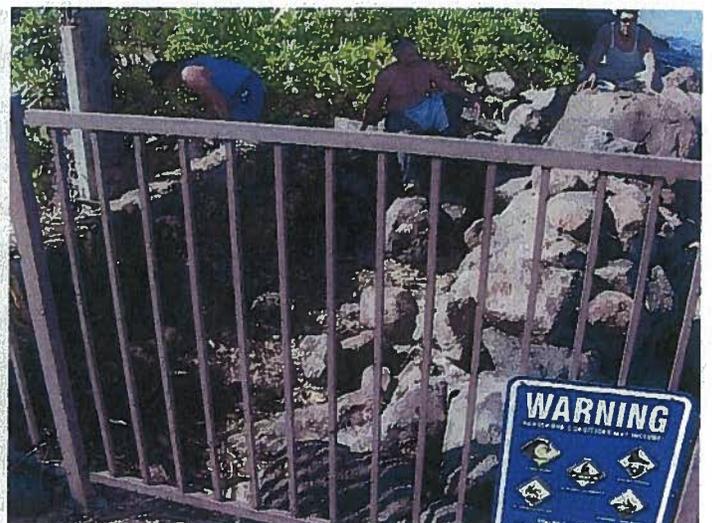
ATTACHMENT  
8.

1. TRENCH.JPG

2. TRENCH.JPG

3. TRENCH.JPG

4. TRENCH.JPG

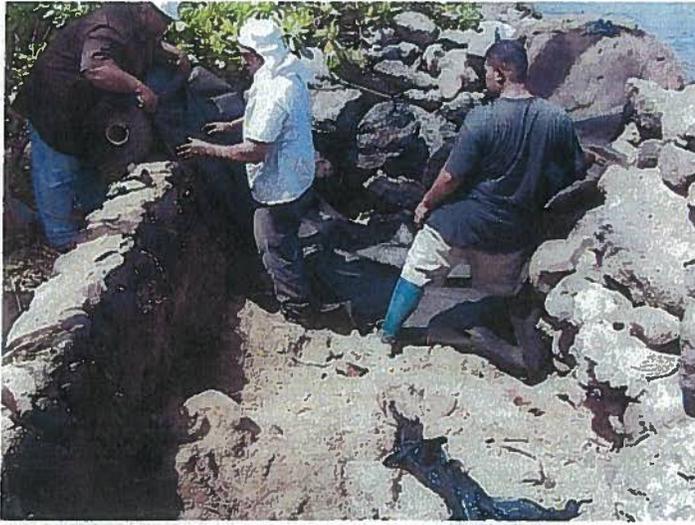
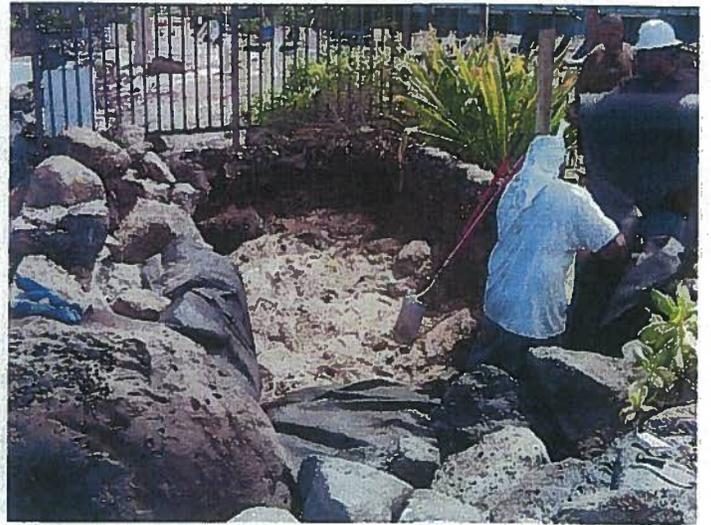
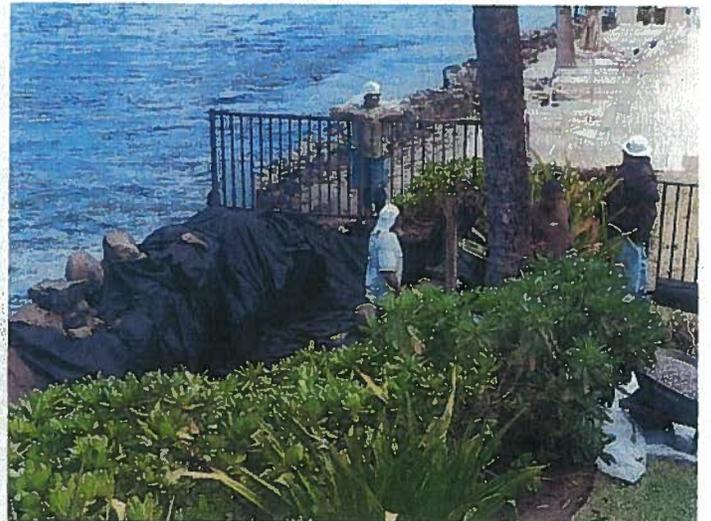
ATTACHMENT  
9.

1. INSTALLING F FABRIC.JPG

2. INSTALLING F FABRIC.JPG

4. INSTALLING F FABRIC.JPG

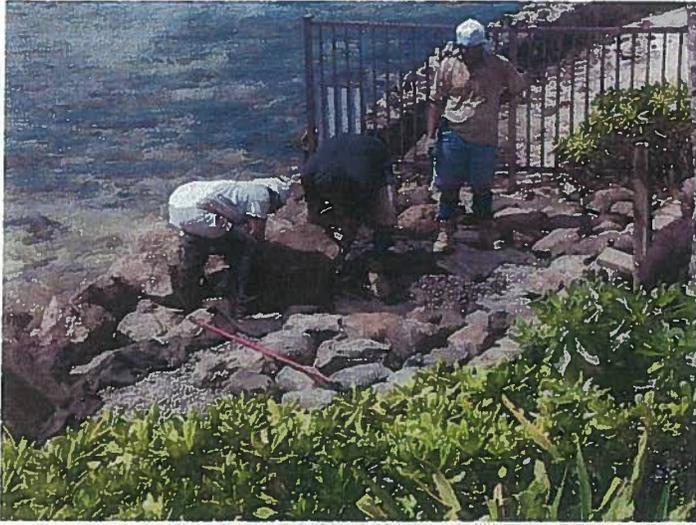
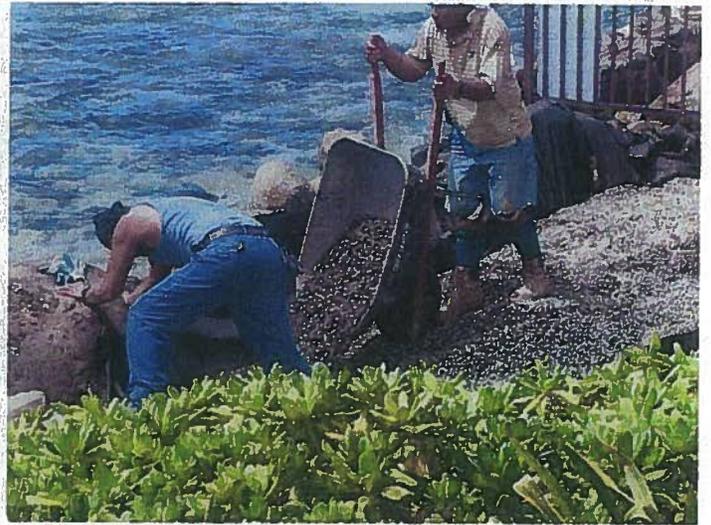
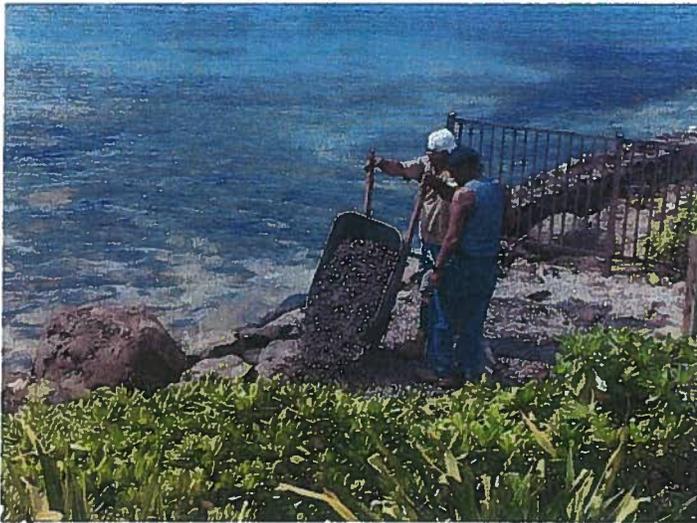
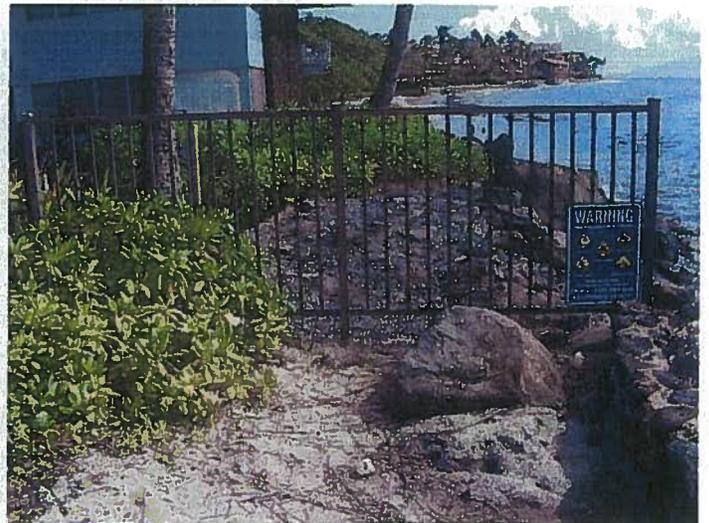
ATTACHMENT  
10.

1. PLACING ROCKS.JPG

2. GRAVEL ON TOP.JPG

3. LAST GRAVEL ON TOP.JPG

4. FINISHED.JPG

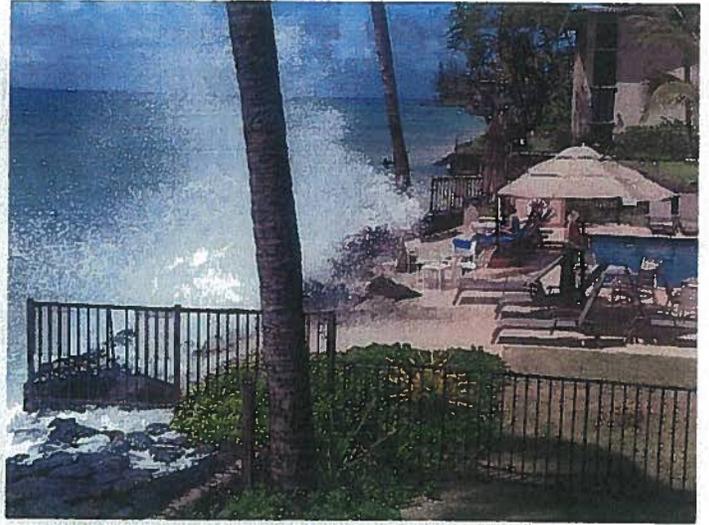
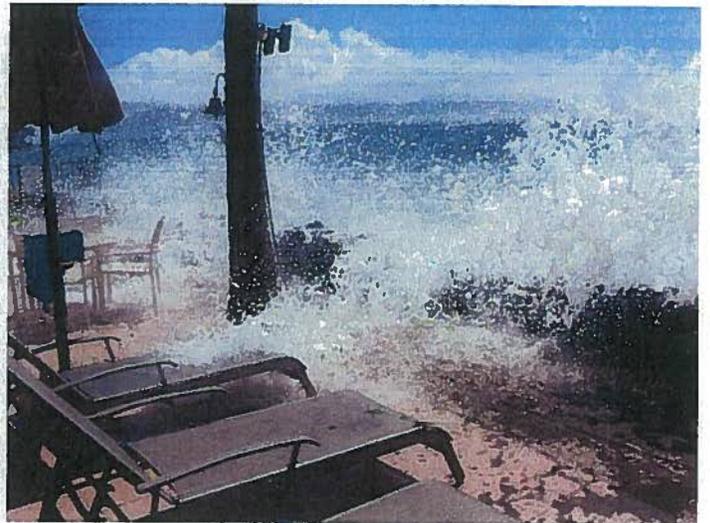
ATTACHMENT  
11.

2.OVERTOPPING.JPG

4.OVERTOPPING.JPG

The recommended "less costly solution" of controlling wave overtopping is to plant naupaka.
