STATE OF HAWAI'I
DEPARTMENT OF LAND AND NATURAL RESOURCES
OFFICE OF CONSERVATION AND COASTAL LANDS
Honolulu, Hawai'i

REGARDING: Conservation District Enforcement File (ENF): HA-10-23
Alleged Conservation District Violation of Coral Damage at Kawaihae
Small Boat Harbor

LOCATION/TMK: Kawaihae Small Boat Harbor, South Kohala, Hawai'i

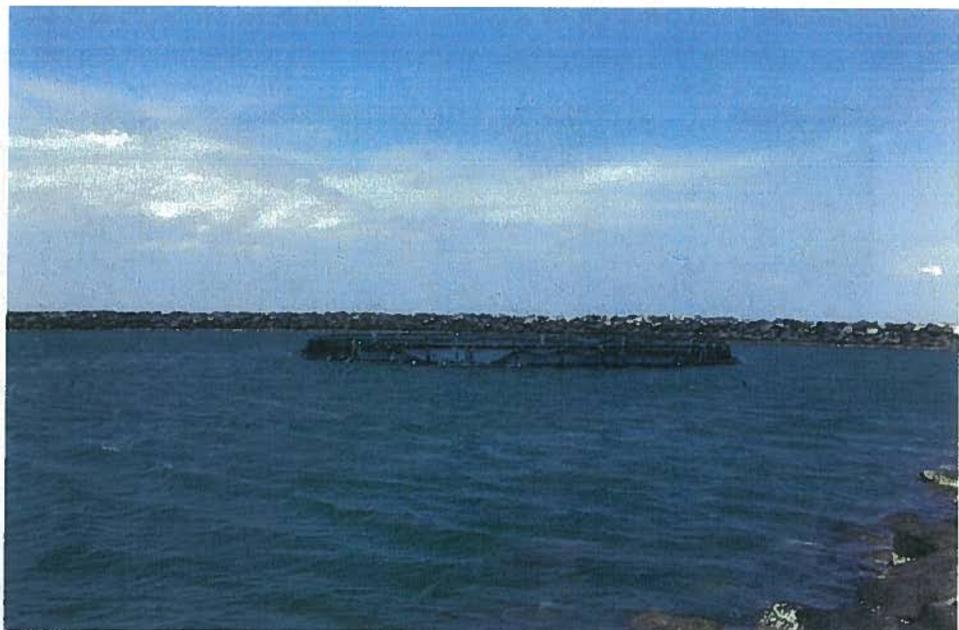
Figure 1 Net pen in Northwest part of Kawaihae Small Boat Harbor on April 1, 2010

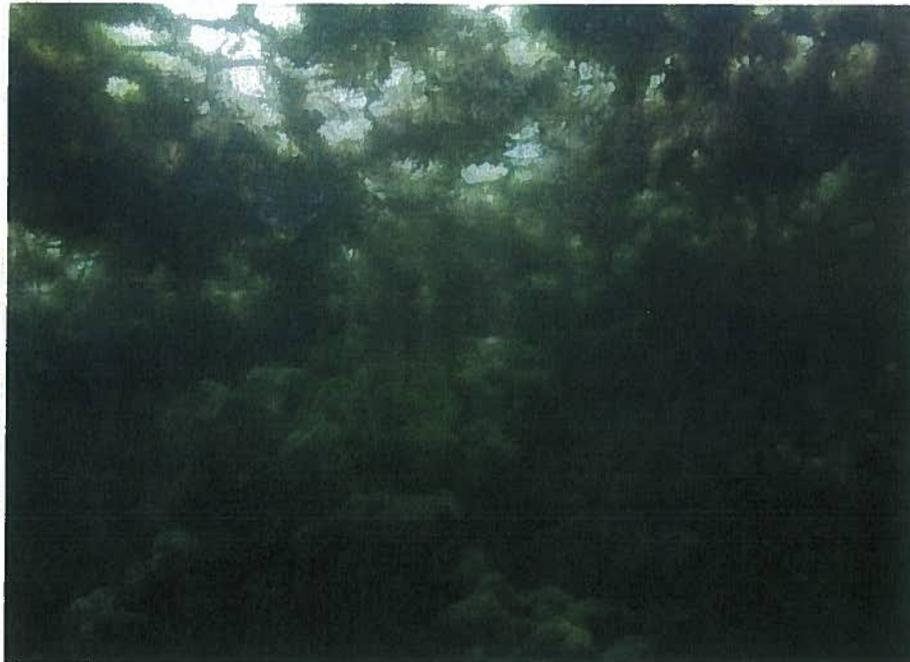
[REDACTED] both put on SCUBA gear at approximately 12:30pm and returned to the water in order to assess if corals were being impacted by the net. Circling approximately 270 degrees counter-clockwise under the net pen, photographs were taken of the net and coral. The net was fouled with hydroids, algae and other organisms, creating a shade canopy. Living and small amounts of broken and dead coral were observed. The net was found to be sitting on *Porites compressa*, *Porites lobata*, and *Montipora capitata*. *Pocillopora meandrina* was also observed under the net. This assessment and photographs were sufficient to determine the net was impacting coral (Figure 2).

Figure 2. Fouled net over *Porites* and *Montipora* coral heads.

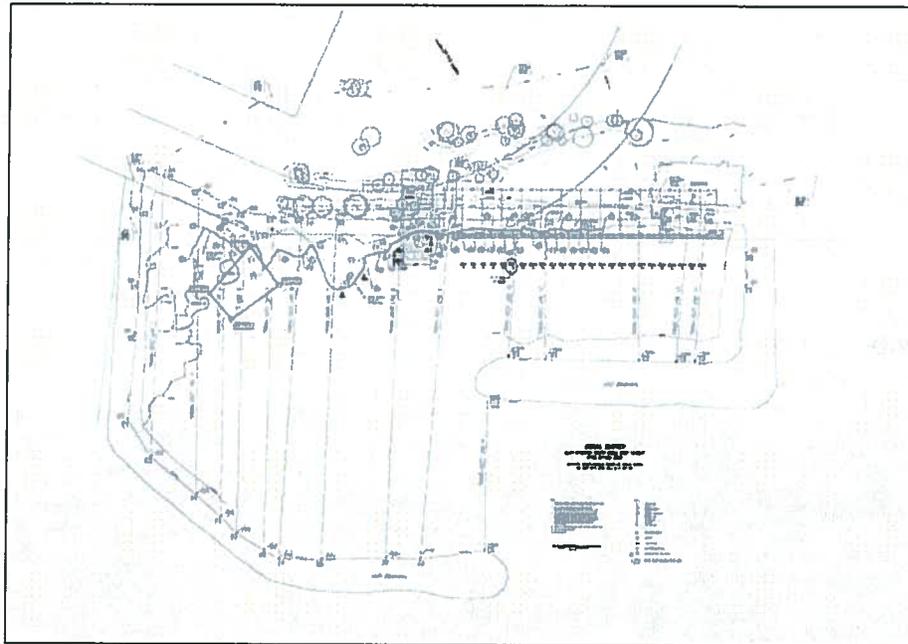
Figure 3. Map of Kawaihae Small Boat Harbor showing net pen location (points in red).

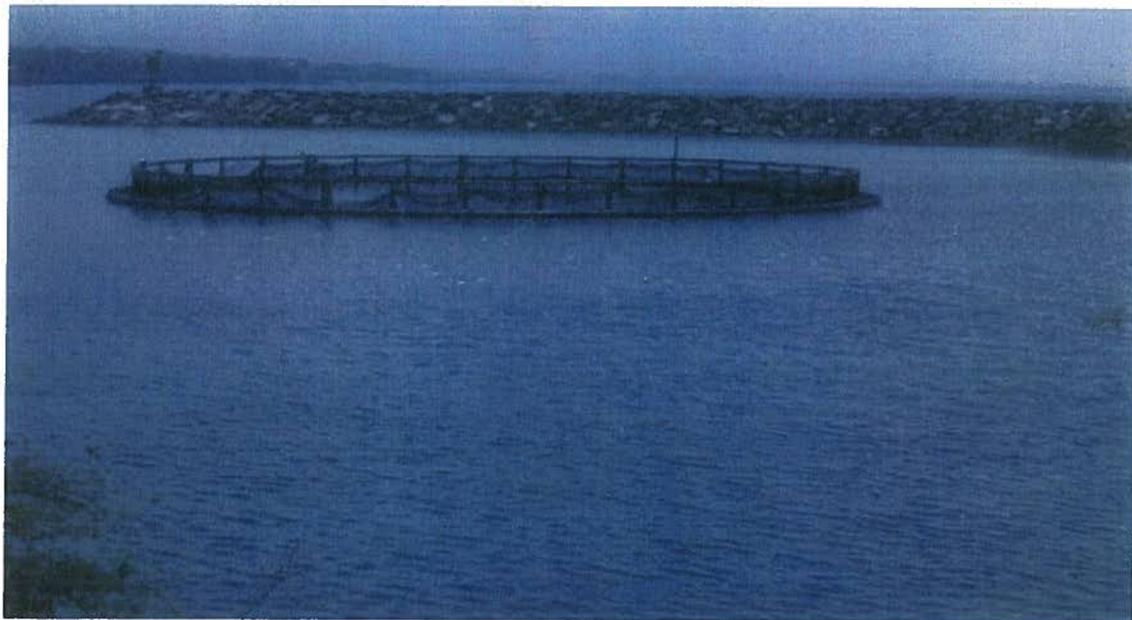
Figure 4. Redeployed net pen with yellow Pelican floats marking damaged coral heads.

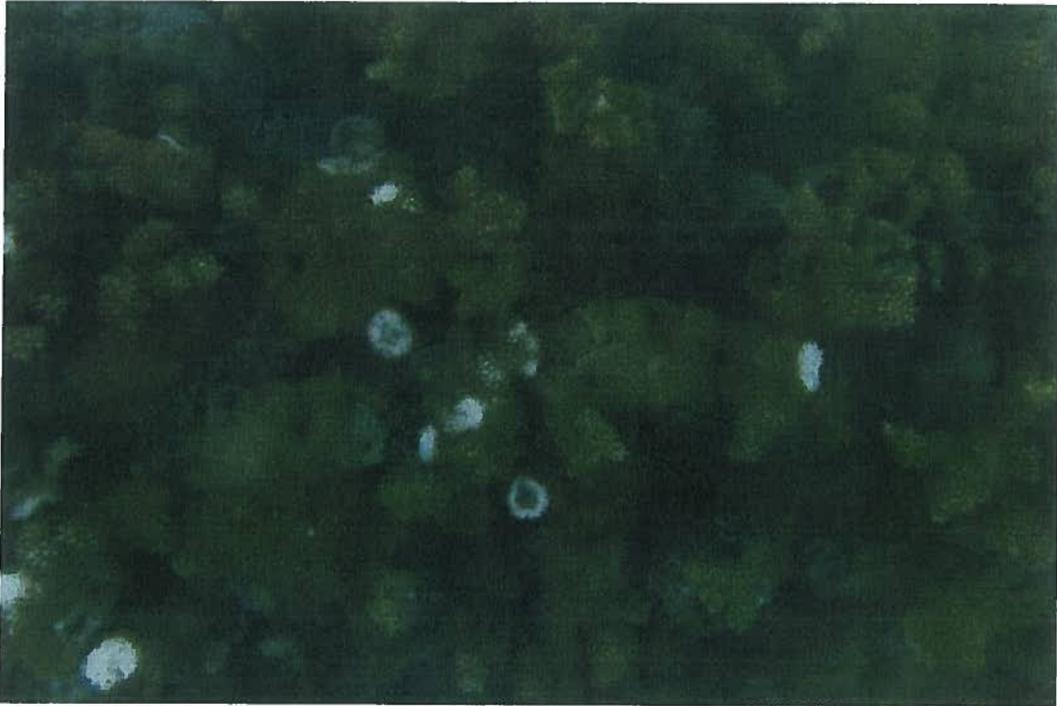
1. "Fingers," or protrusions, of *Porites compressa* and *Montipora capitata* were broken off or leveled usually evidenced by white break marks dusted over with fine sediment (**Exhibit 4, Figure 5**).
2. Coral heads, primarily *Porites lobata*, were dislodged and rolled onto their sides, into the soft sediment resulting in the death of the coral on the underside of the head (**Exhibit 4, Figure 6**).
3. Coral colonies with leveled, dead tops were also observed. Dark materials resting on top of dead coral were indicative of direct contact with fouled netting (**Exhibit 4, Figure 7**).

1. "Fingers", or protrusions, of *Porites compressa* and *Montipora capitata* were broken off or leveled usually evidenced by white break marks dusted over with fine sediment. These breaks were not yet overgrown by algae (Figure 5),
2. Coral heads, primarily *Porites lobata*, were dislodged and rolled onto their sides, into the soft sediment resulting in the death of the coral on the underside of the head (Figure 6),
3. Coral colonies with leveled, dead tops were also observed. Dark materials resting on top of dead coral were indicative of direct contact with fouled netting (Figure 7).

Figure 5. Recently broken fingers of the rice coral *Montipora capitata*.

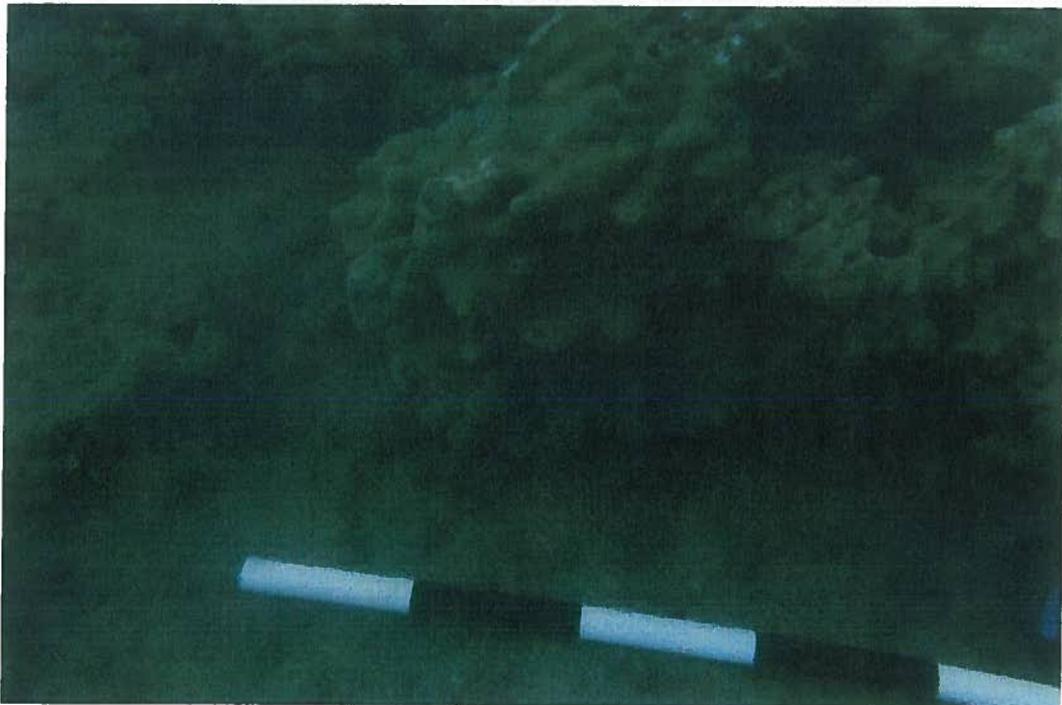
Figure 6. Toppled head of the lobe coral *Porites lobata*.

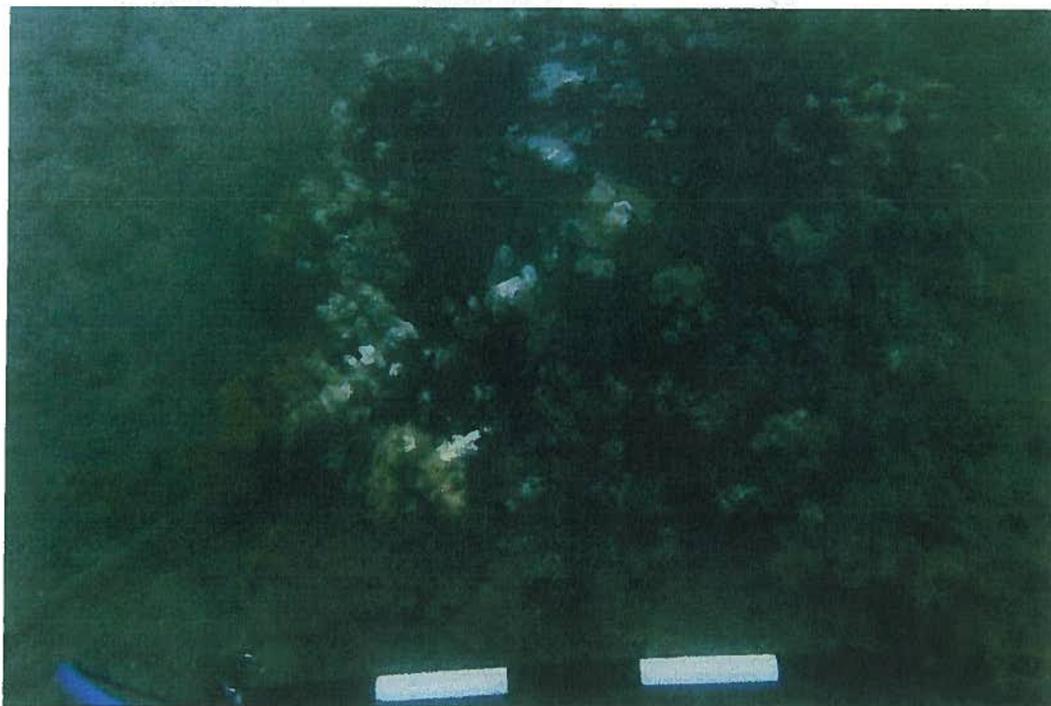
Figure 7. Head of rice coral, *Montipora capitata* with upper dead surface.
