HECO Report

March 3, 2004

Pukele Substation Outage

Dated May 11, 2004

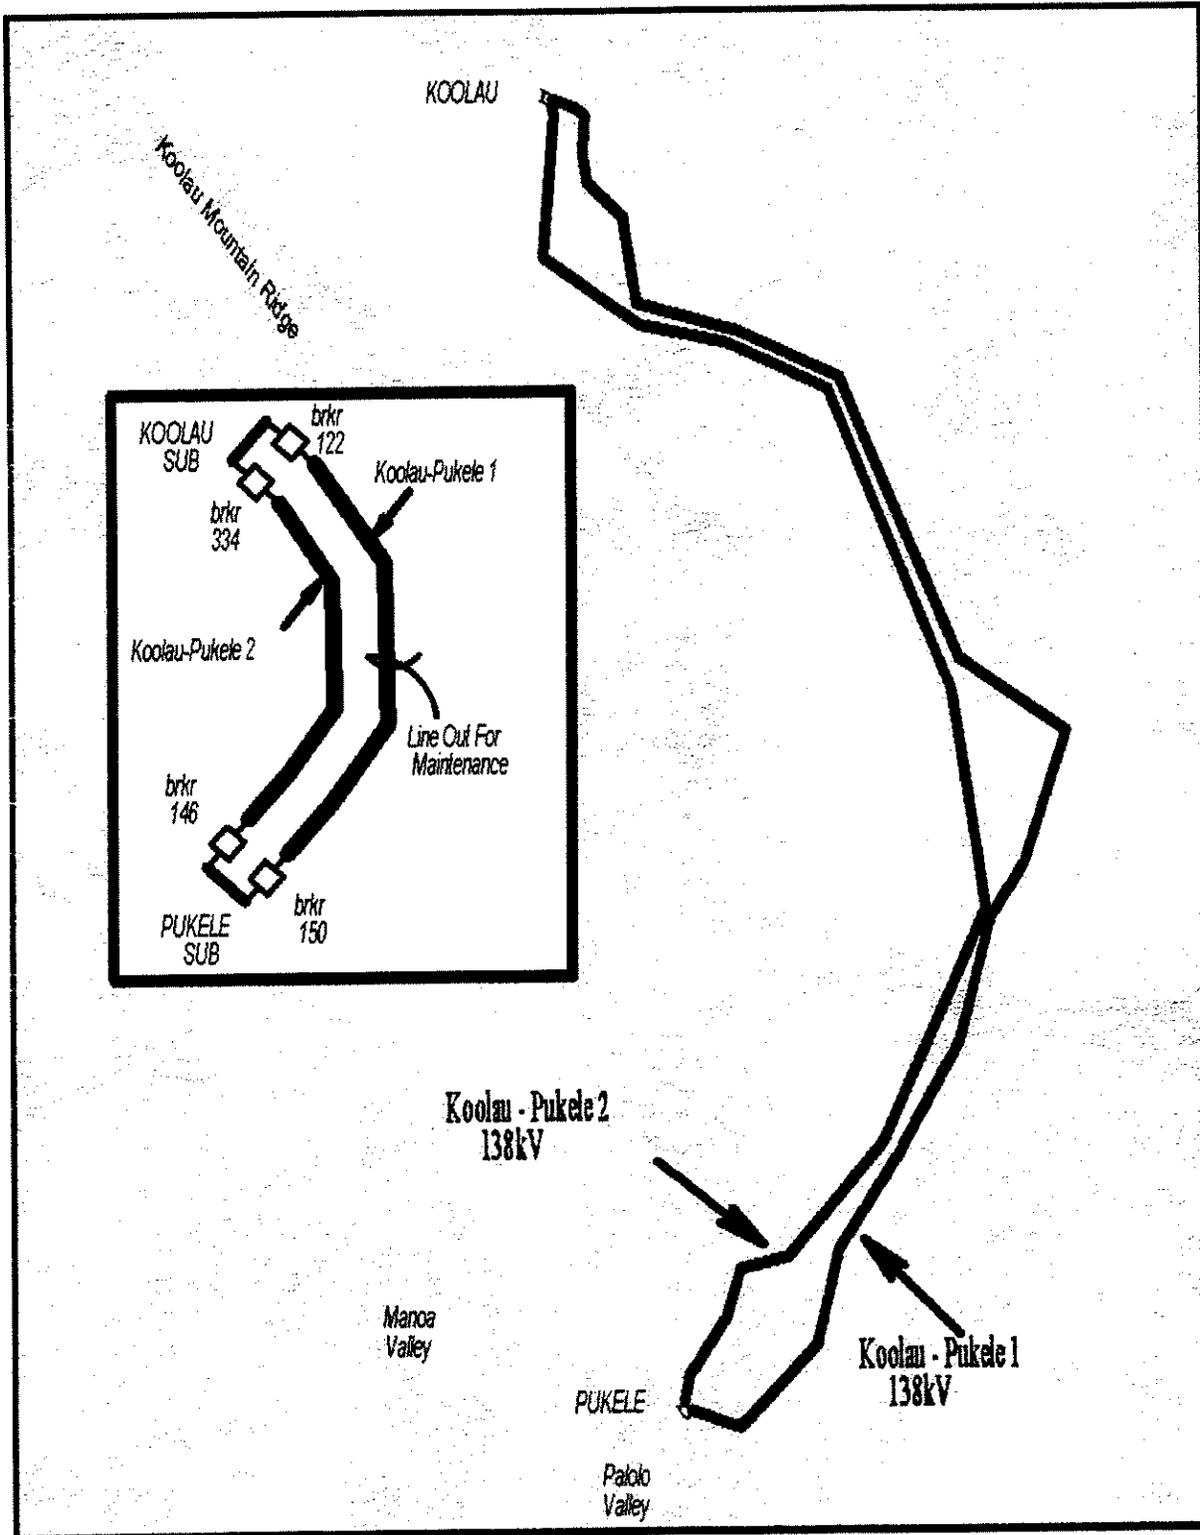
Figure 2 Koolau-Pukele 138kV Transmission Lines

At 6:03 a.m. the Koolau-Pukele No. 1 138-kilovolt transmission line was de-energized by opening circuit breakers 150 and 122 to support planned work (See Figure 2). The scheduled work involved the upgrading of Structure 18 on this line from a wooden pole to a new steel pole. The Pukele Substation is being powered from the remaining Koolau-Pukele No. 2 138-kilovolt transmission line.

The Koolau-Pukele No. 1 138-kilovolt transmission line will be used as an example (refer to Figure 2). Assuming Koolau Breaker No. 122 is tripped due to a protective system action or manual intervention, the relay protection scheme uses a "fast trip" function to immediately trip the corresponding breaker at the Pukele Substation (Breaker No. 150) to de-energize the transmission line.

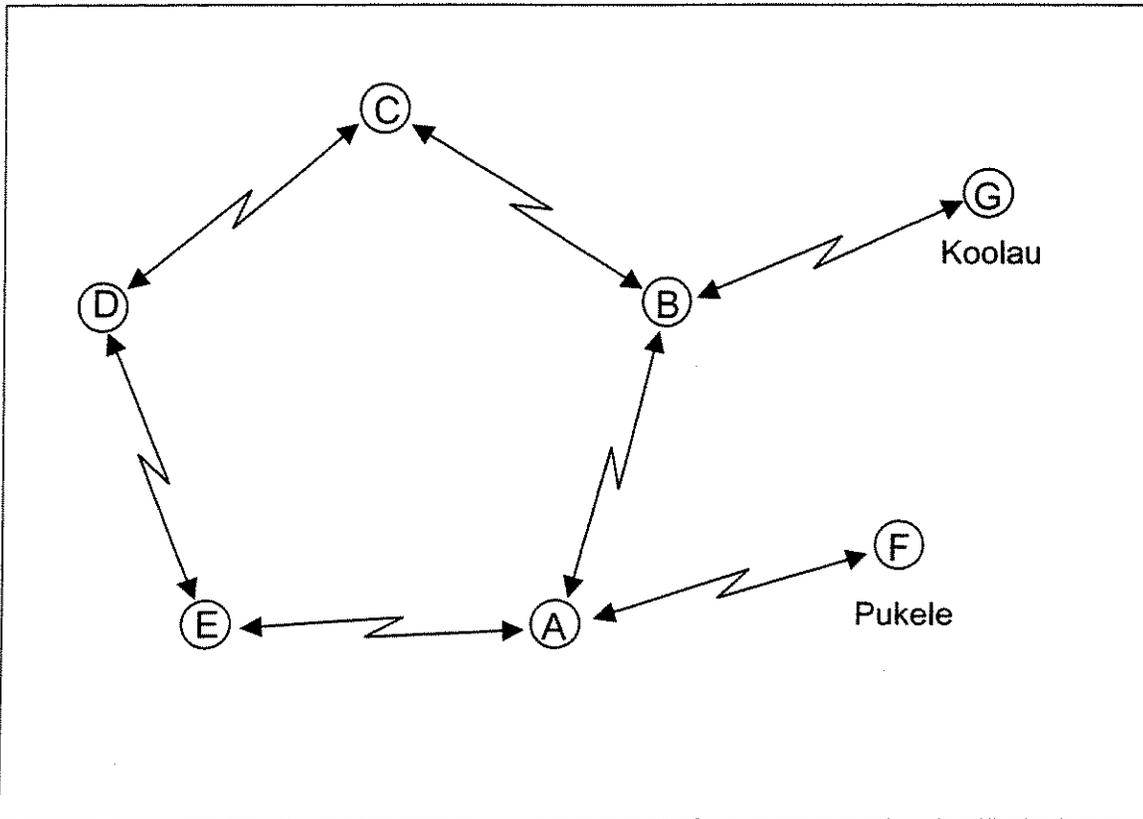
Figure 3 Sample Communications Path

The multiplexers that interface with the microwave communications system are configured in a “ring” topology with several radial legs similar to that shown on Figure 3². The system is designed with several redundant features. For example, if communications flow were to travel counterclockwise along path A-B-C-D-E and a communications link failure were to occur between sites A and B, the communications would automatically switch to an alternate communications system and path; i.e., A-E-D-C-B to ensure all necessary information is communicated. Information at the radial nodes F and G would be communicated as well. This is an industry standard design.

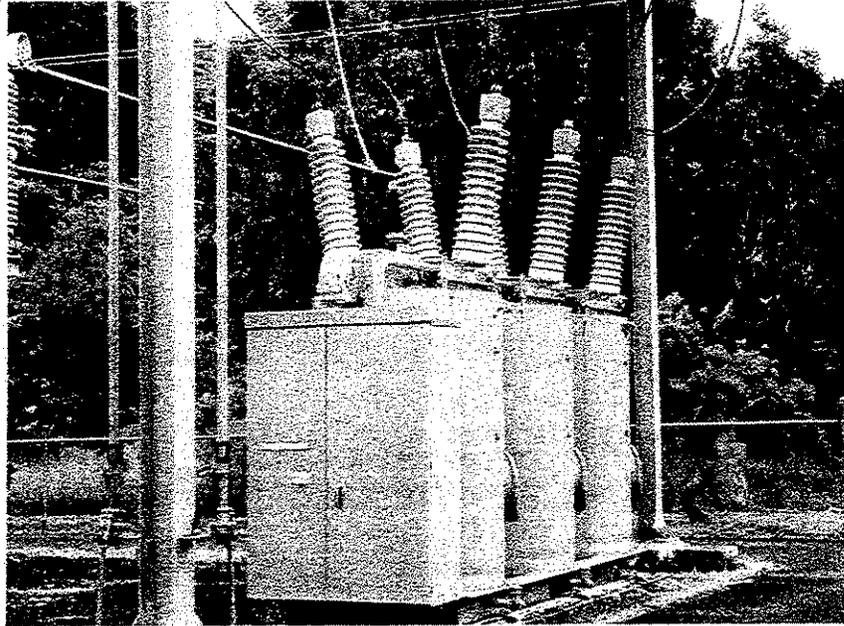
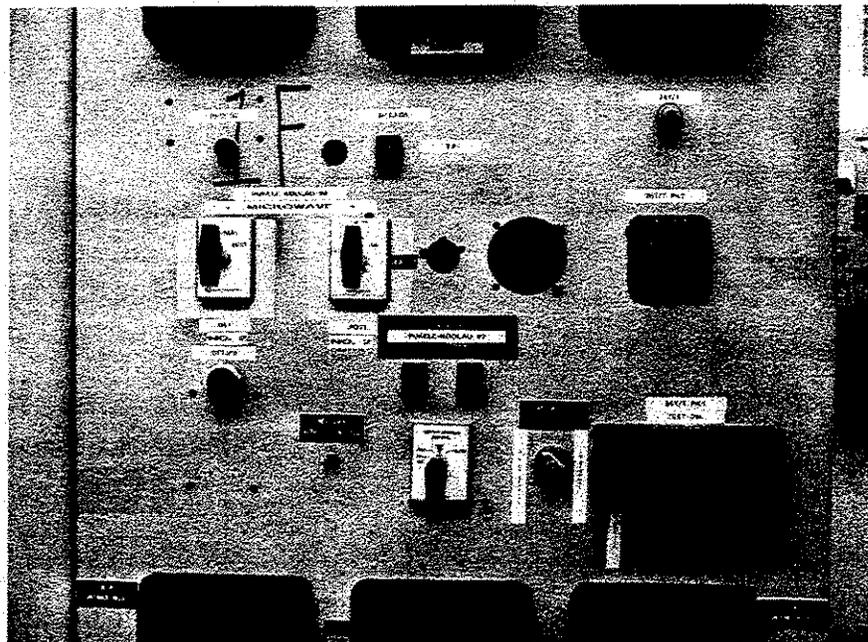
Figure 5 Relay Panel - Direct Transfer Trip Device

At the same time, the breaker failure relay at the Koolau Substation initiates a trip signal that is directed to the Koolau Direct Transfer Trip (DTT) device, which then sends a trip signal, via the communications system, to the Pukele Substation DTT (See Figure 4 for reference). Figure 5 is a picture of a breaker and DTT.

Breaker 146 at Pukele Substation

Relay Panel - Direct Transfer Trip
