Subject: Docket No. 2006-0431
October 15-16, 2006 Outage Investigation

***A Summary Report of
The Public Meeting Held by Hawaiian Electric Company, Inc., Hawaii Light
Company, & Maui Electric Company Regarding the Outage & Restoration of
Electric Power Systems Following the October 15, 2006 Earthquakes
October 23, 2006
Hawaii State Capitol Auditorium***

Earthquake Event

October 15 and 16, 2006

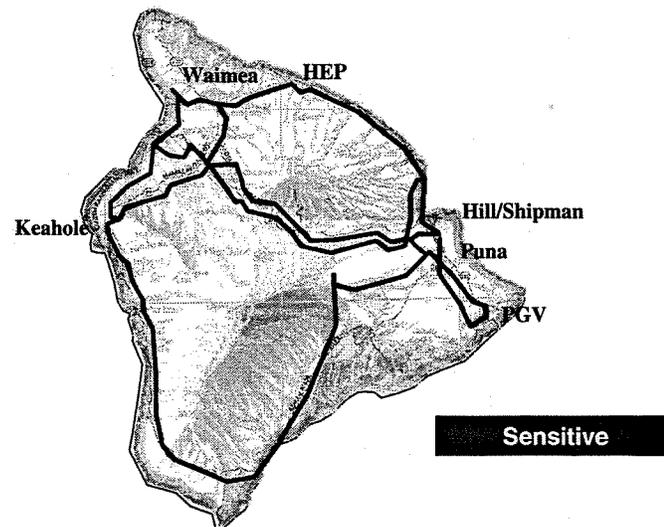
Transmission System

Incident – 0708 Hrs

- Earthquake occurs at 7:08 a.m.
- 19 transmission circuits trip open
- 60 distribution circuits to trip open
- 10 substation transformers fuses open
- Capacitor bank at Ouli Switching Station damaged
- Ten (10) spans on 3200 line (34 kv transmission line from Honokaa serving Paauilo substation) fail
- Insulator on 3300 line (34 kv transmission line from Waimea serving North Kohala) fails
- Transmission switches at Honokaa Substation damaged
- CT-5 generator locks out
- Waimea diesel generators locked out
