Subject: In the Matter of the Investigation of Hawaiian Electric Company, Inc.,  
Hawaii Electric Light Company, Inc., and Maui Electric Company, Limited,  
Related to the Major Power Outages of October 15-16, 2006  
Docket No. 2006-0431

## **HAWAII ELECTRIC LIGHT COMPANY**

Investigation of 2006 Hawaii Island Power Outage  
PUC Docket Number 2006-0431

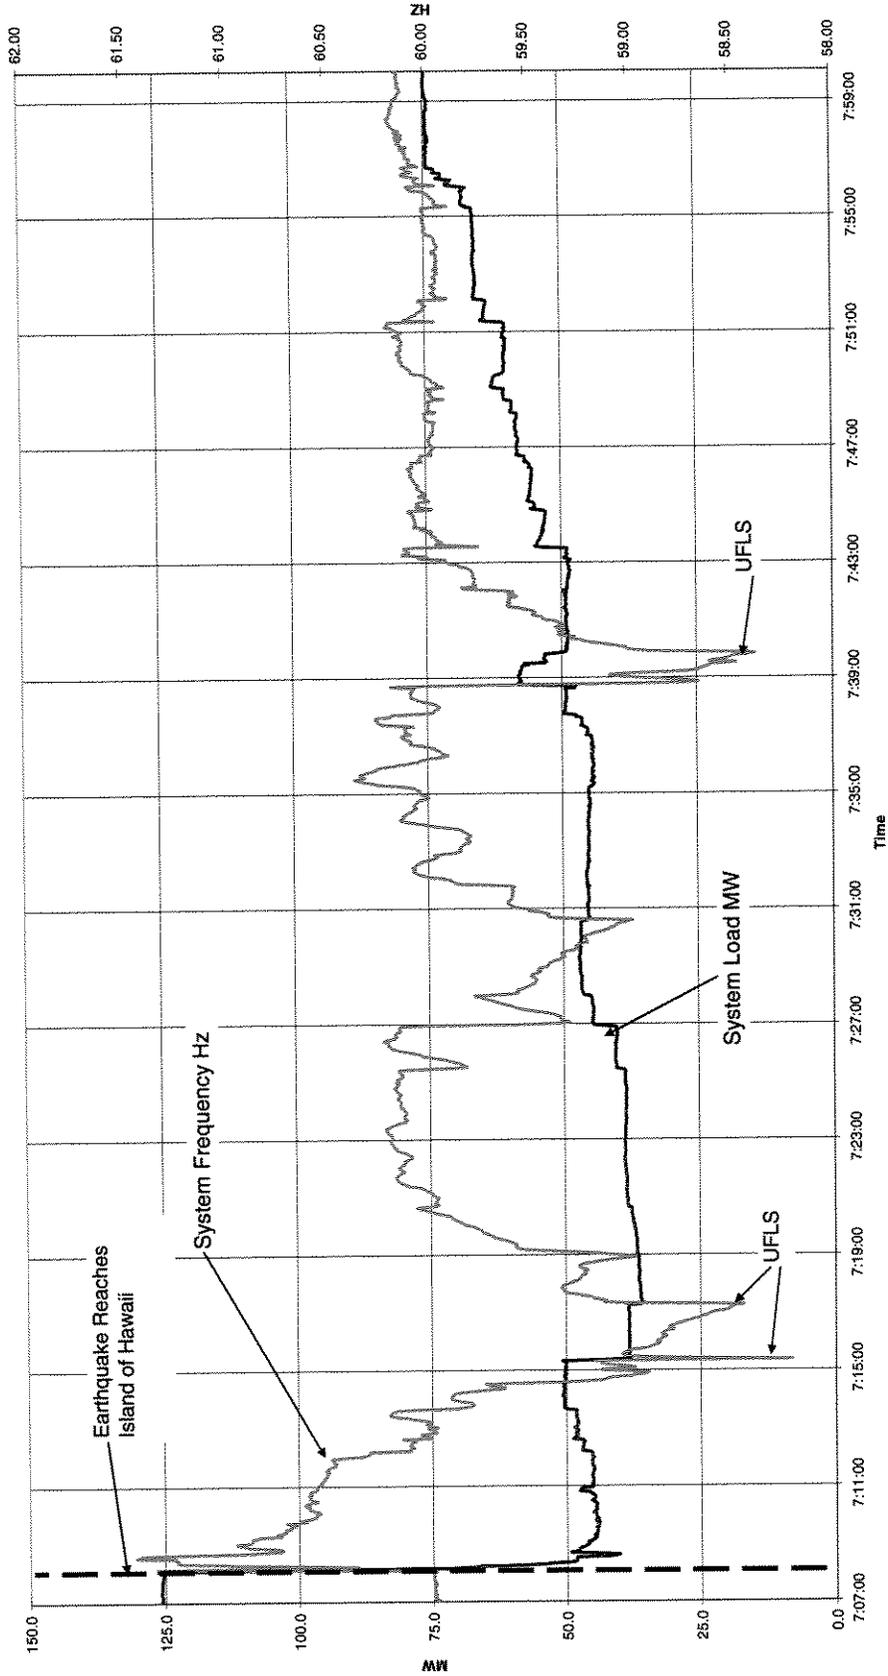
Figure 1: System Load versus Frequency Timeline October 15<sup>th</sup>, 2006

This report was reviewed against information from the EMS, supervisory control and data acquisition (SCADA) reports, and relay event reports. This sequence of events coincides with the information displayed in the following figures. Figure 1 shows the system generation and frequency on the HELCO system from the time of the earthquake until 0800 hours when the frequency stabilized. Figures 2 shows the megawatt output of the separate generating units and the system frequency, with the timing of significant events, from 07:07:00 to 07:21:00 to provide an expanded view of the generator operation events.

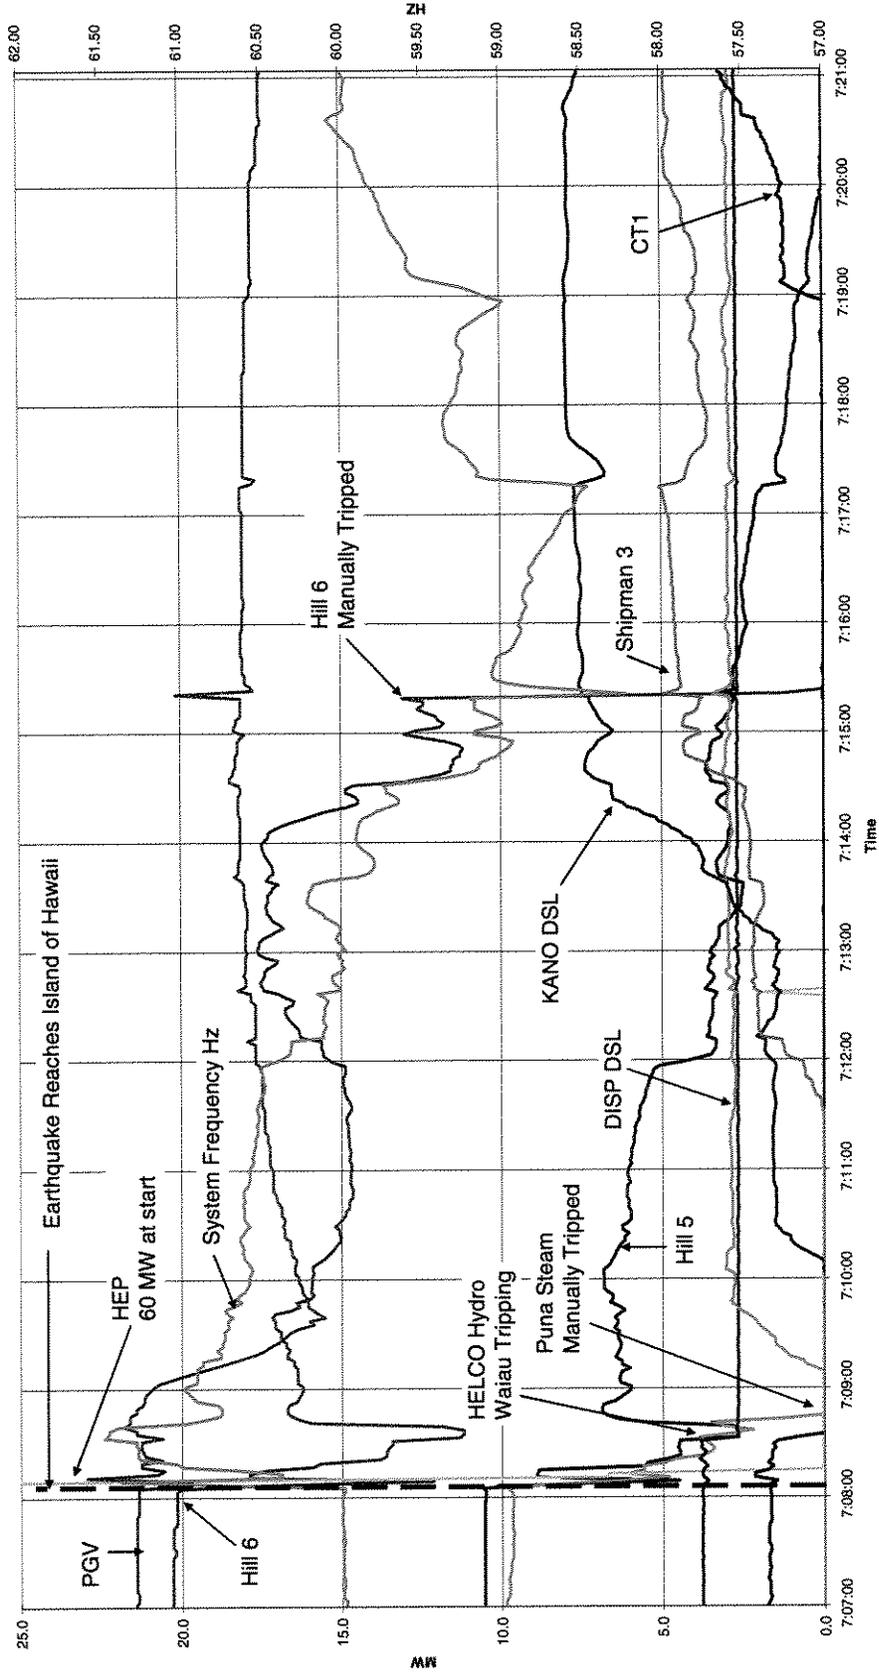
Figure 2: Individual Generator Output Timeline - October 15, 2006, 07:07:00 to 07:21:00

Trips of the transmission circuits blacked out the system from Pepekeo around the north and down the west side of the island to Kealia. The initial loss of load resulted in over frequency with generation exceeding load on the east side of Hawaii. The Hill 5, Hill 6, PGV and Puna units reduced output to match generation with load as indicated in Figure 2. Waiau and Wailuku hydros tripped off-line.

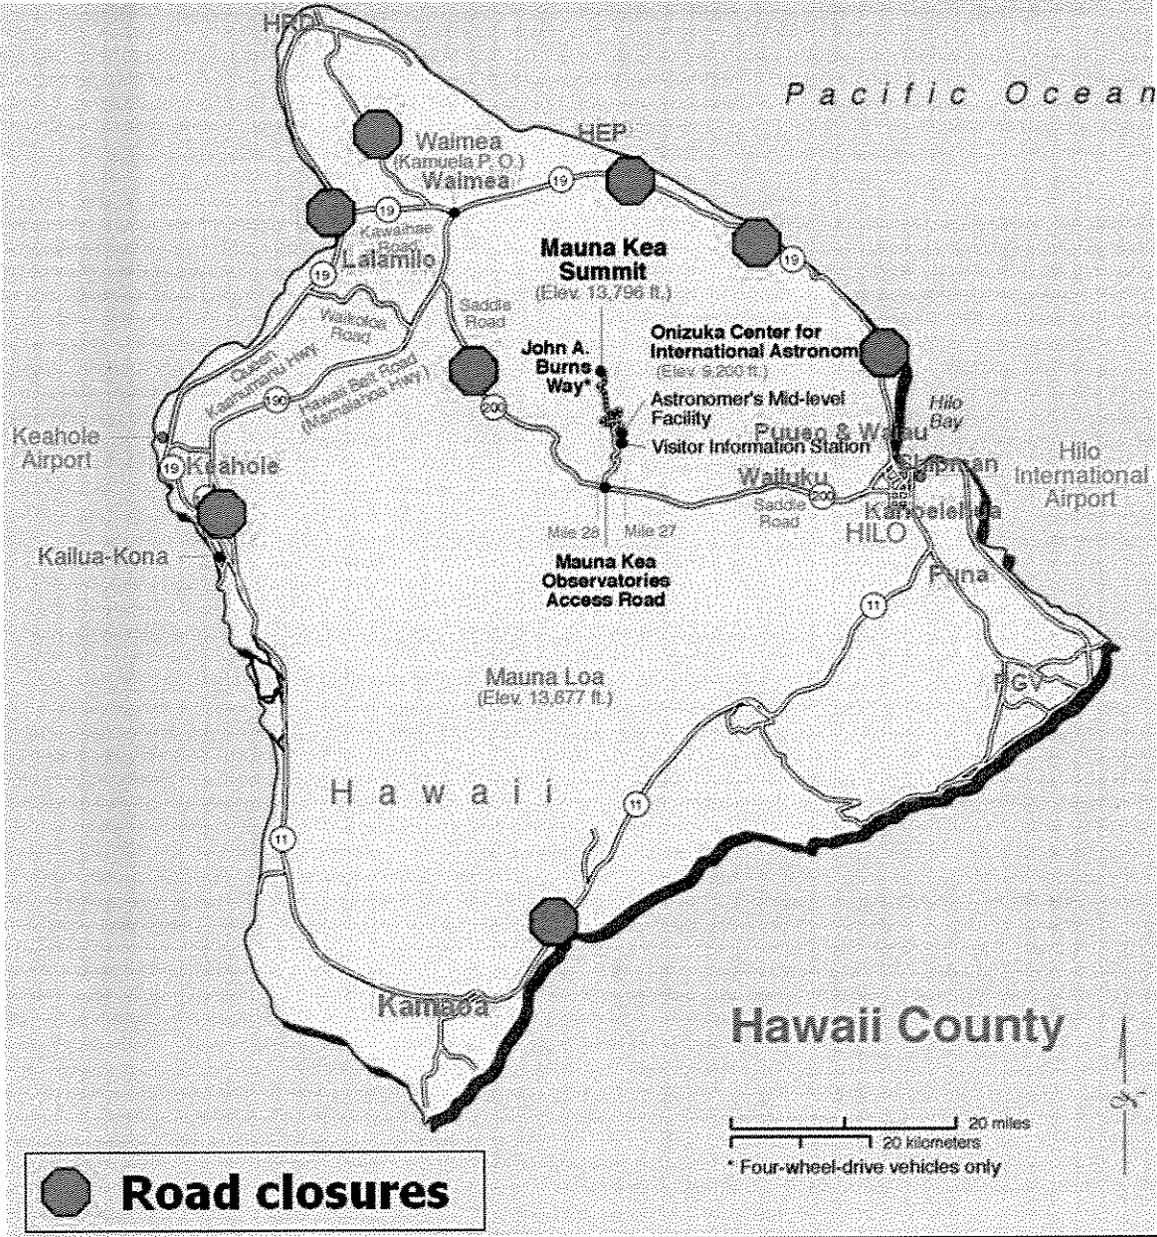
Figure 3: Initial Hawaii Road Closures Due to the Earthquake

of the island to travel to the west side to assist with reenergizing the substations and transformers. Restoration activities were hampered by road closures as shown in Figure 3.

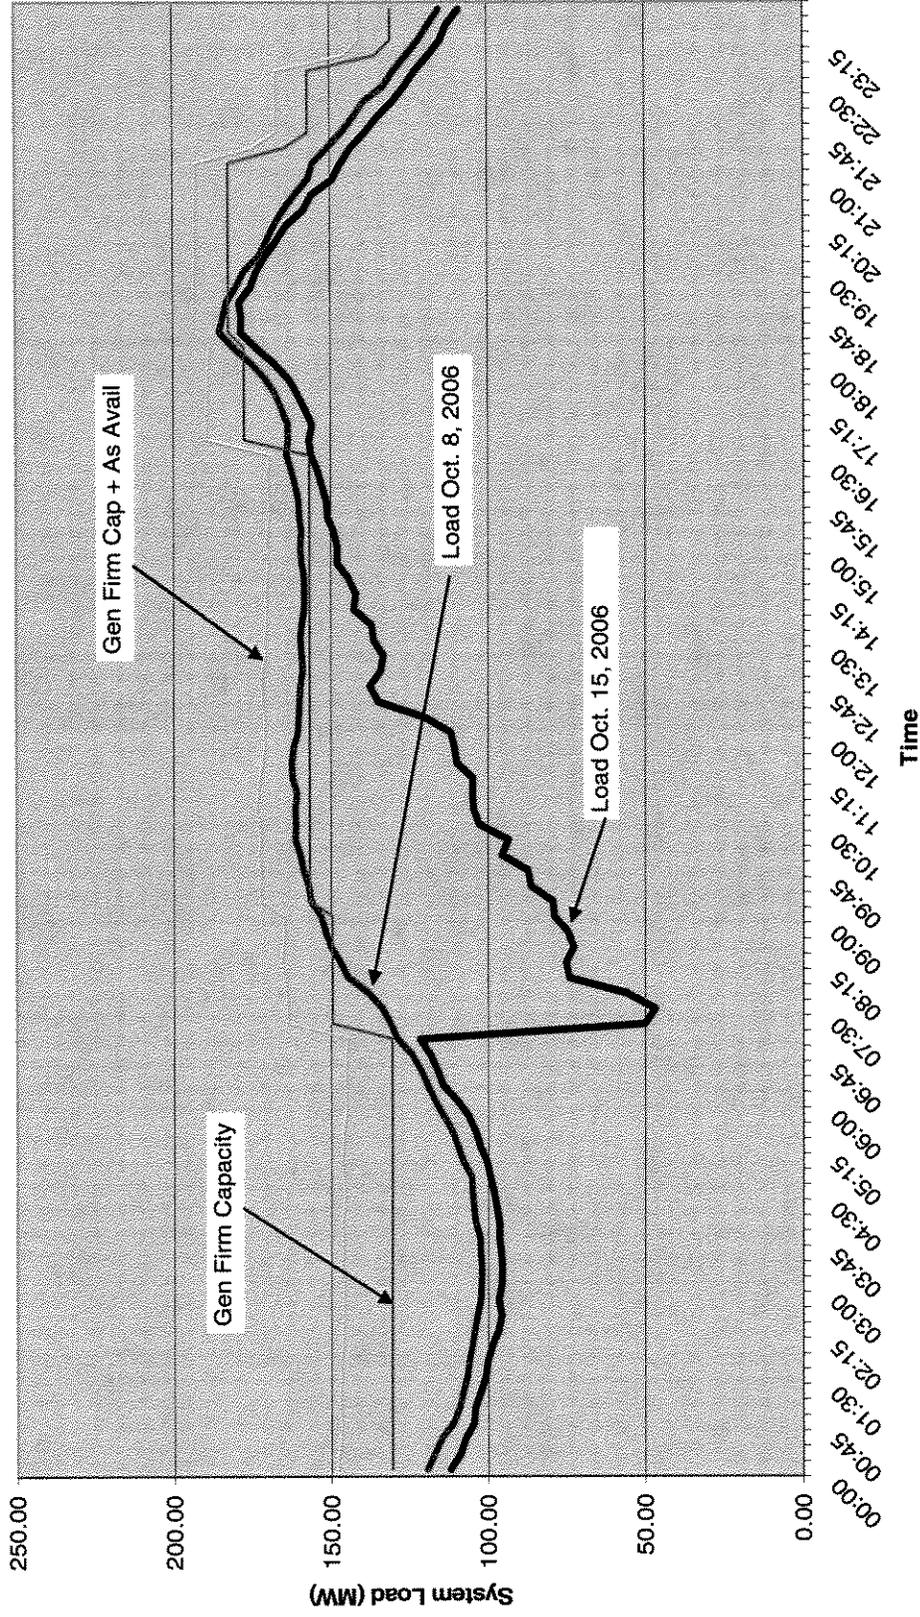
Figure 4: October 15, 2006 Generation Compared to Previous Sunday Load Curve

Figure 4 shows the load curve for October 15<sup>th</sup> in comparison to load on Sunday October 8<sup>th</sup>. The curve profiles for October 8 and 15 are similar prior to 0707 hrs and after 1800 hrs. Firm capacity and firm capacity with as-available generation are also shown on the graph, to illustrate the reserve margin that is typically available.

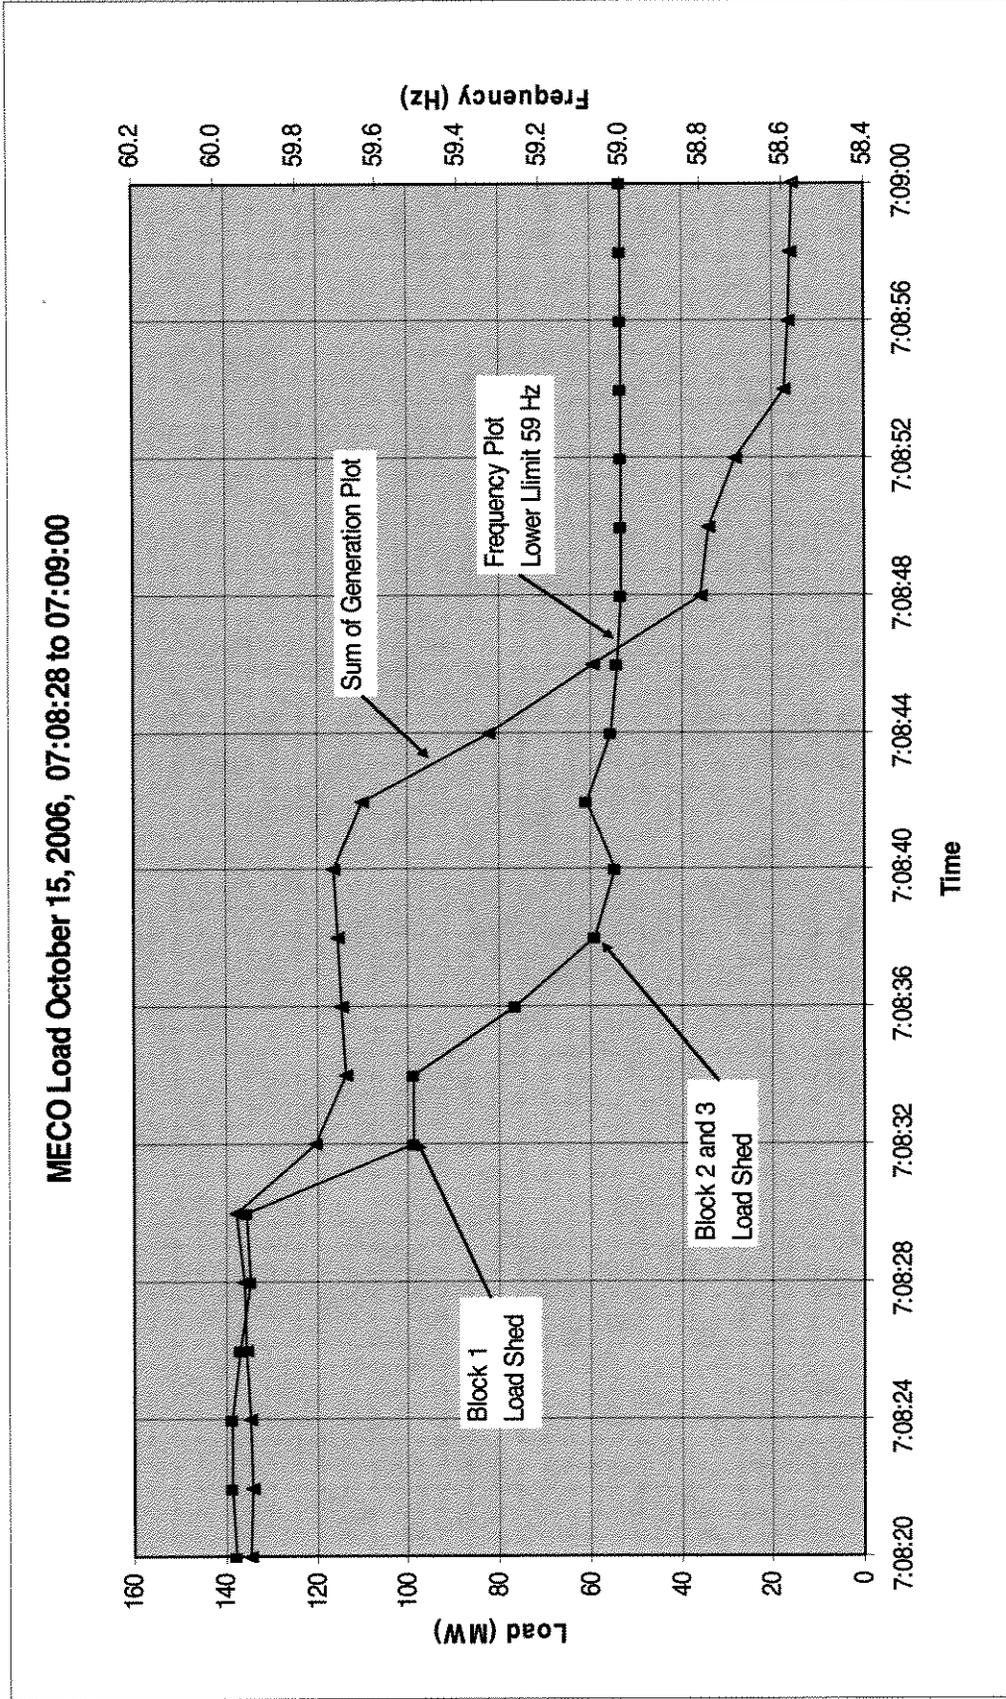
Figure 1: Load versus Frequency Timeline - October 15<sup>th</sup>, 2006, 07:08:20 to 07:09:00

were picking up a larger share of the load. This correlates with the SCADA report indicating blocks 2 and 3 shed five breakers. At 07:08:42 when K4 and KWP tripped, the frequency dipped and then straight-lined on the graph (Figure 1 and Figure 2) indicating it had dropped below the lower metering limit of 59 Hz.

All indications from the EMS and SCADA are that the automatic Under Frequency Load Shed (UFLS) scheme operated and shed load as designed. Figure 1 would indicate that the load shed block 1 operated above 59.5 Hz, but it is very likely that the frequency dipped low enough to trip load shed block 1 and then recovered to 59.5Hz within the two second EMS frequency scan interval. Load shed blocks 2 and 3 operated just prior to the point where the Kaheawa Sub 97 (KWP) tripped and the relay recorded the frequency at 56.05 Hz, indicating that they tripped within the appropriate frequency range. This load shed along with a ramp up in output from the remaining generators appeared to arrest the frequency decay due to the loss of M14 and M16. On the loss of M19 the remaining attached load overwhelmed the available generation and the system frequency rapidly declined. Unfortunately, the frequency monitoring equipment in place has a lower limit of 59 Hz so we do not have a clear picture of how the frequency behaved after it reached the lower measurement threshold.

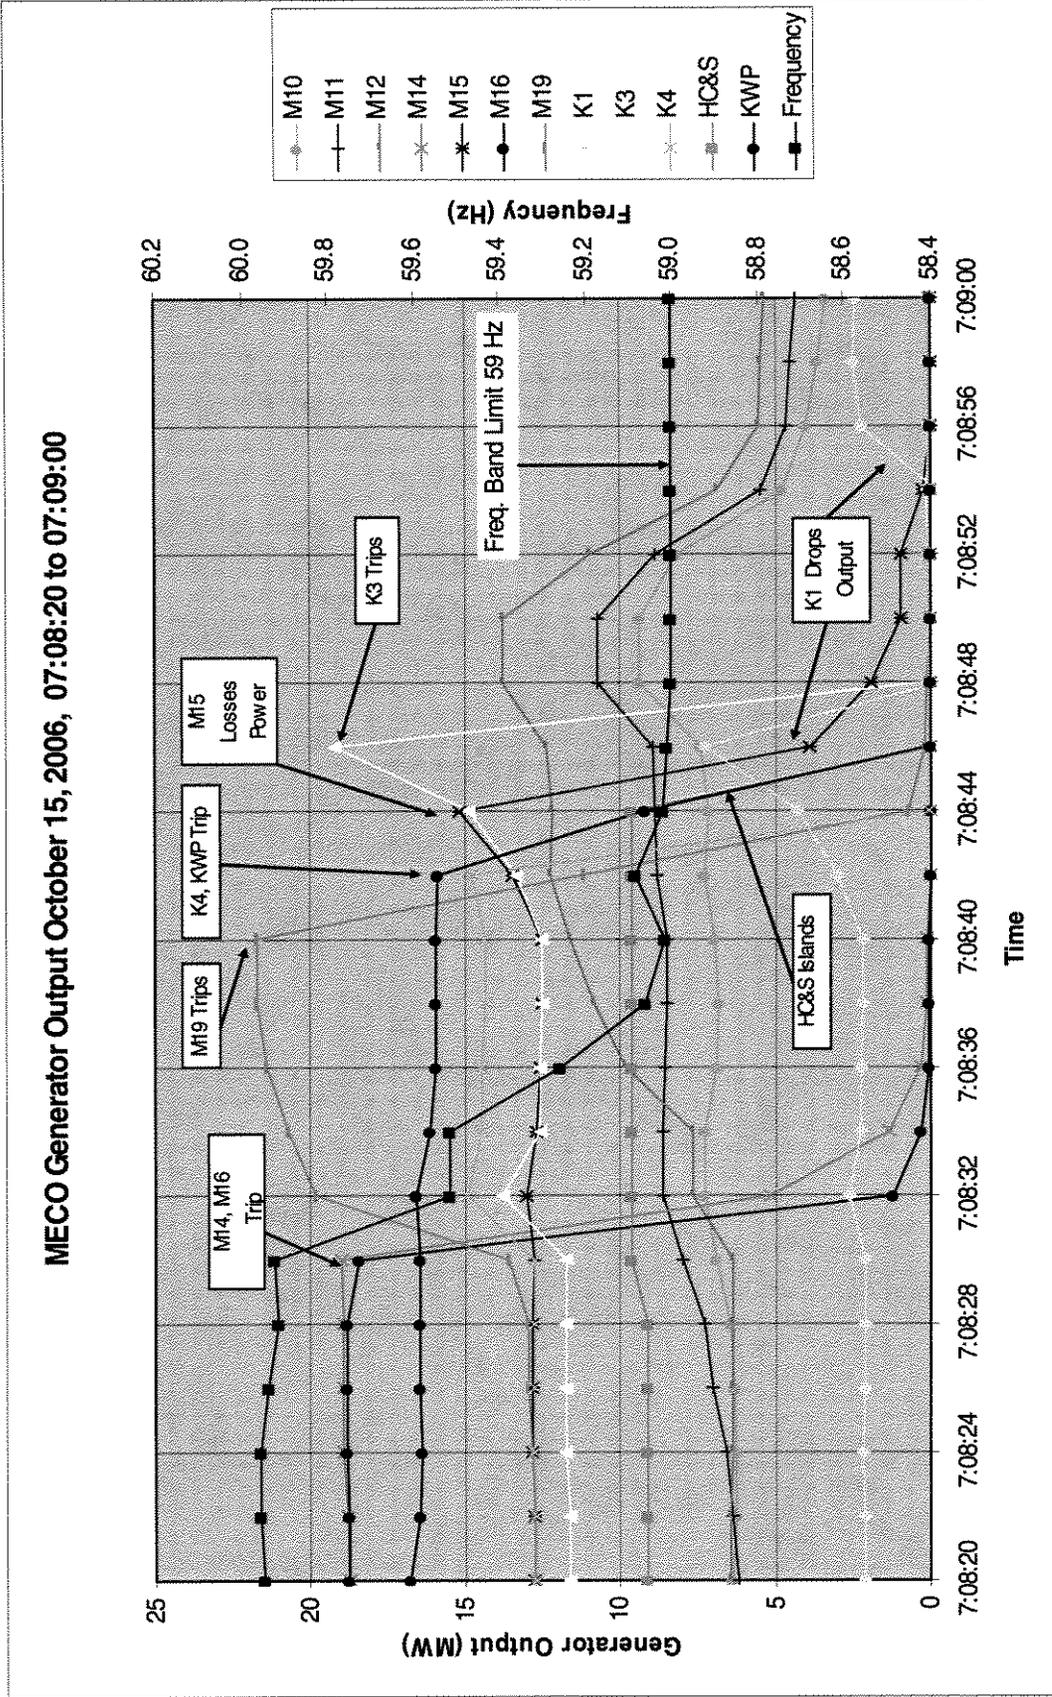
Figure 2: Individual Generator Output Timeline - October 15, 2006, 07:08:20 to 07:09:00

Power plants can be tripped in two ways. First, a trip to “shutdown” where the power reduces over a short time and the generator circuit breaker to the system remains closed until tripped by the operator (power output reduces over more than the 2 second scan interval). Second, a trip by a protective device that opens the generator circuit breaker to the system immediately, thus shutting off the power output (power output reduces to zero within the 2 second scan interval). Both of these type events can be seen in *Figure 2*.

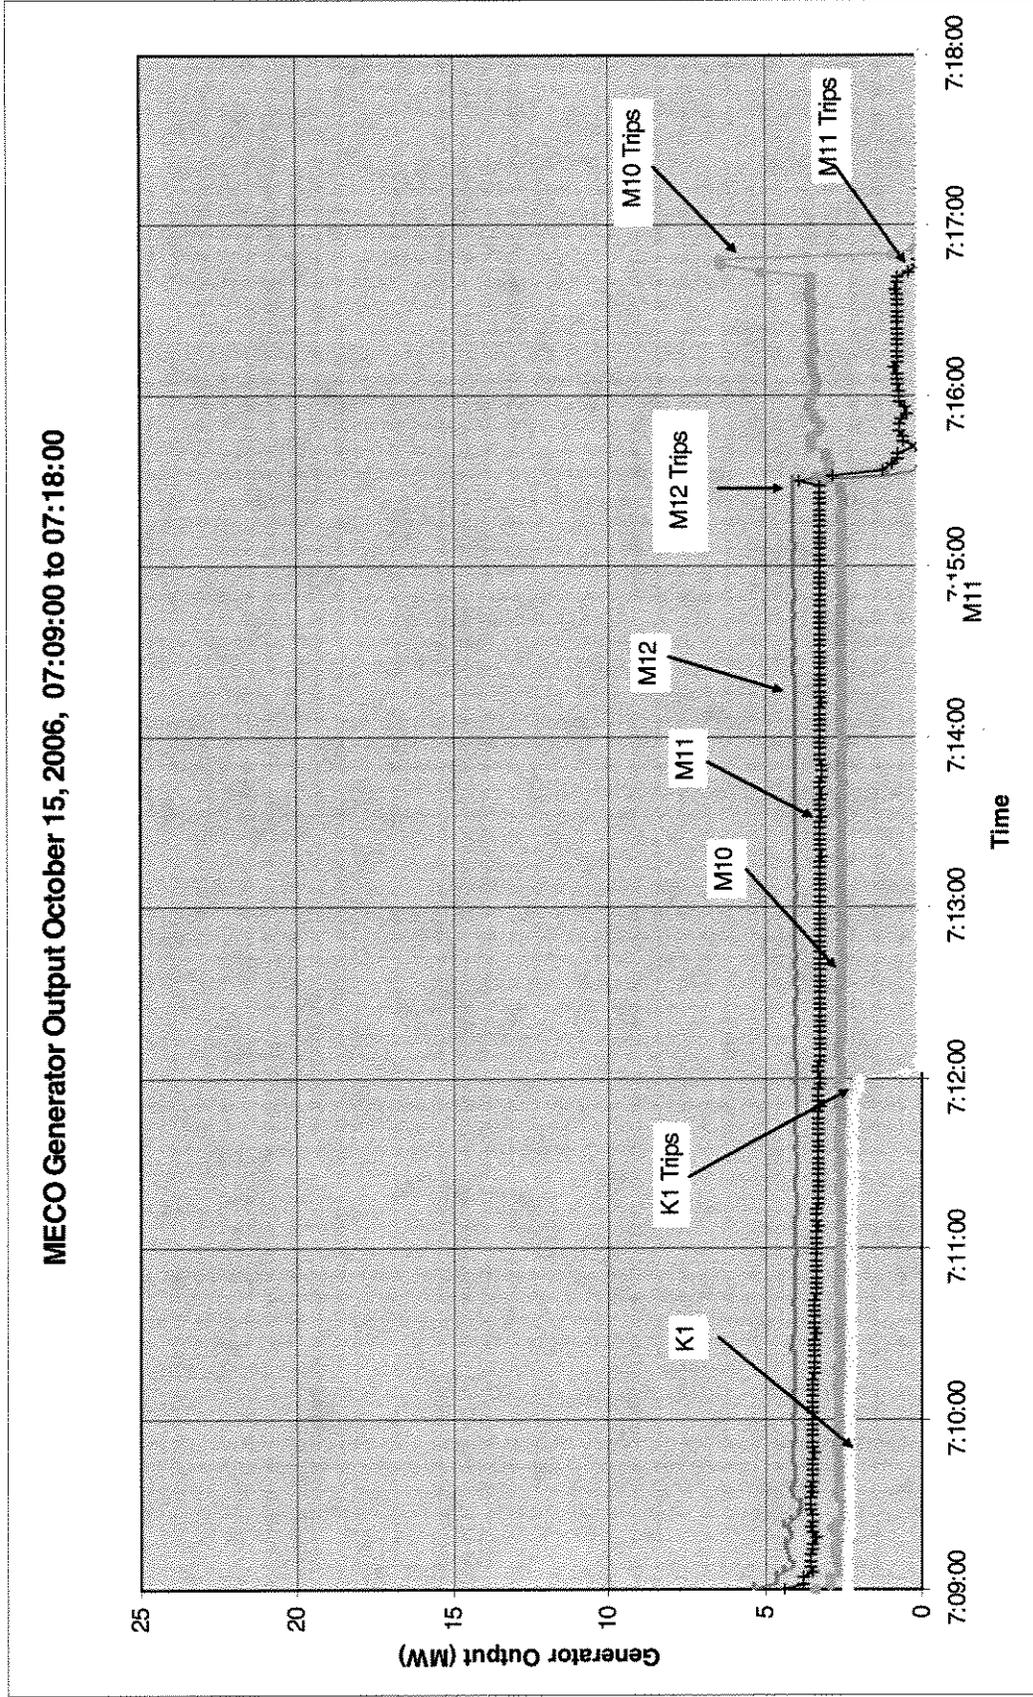
Figure 3: Individual Generator Output Timeline - October 15, 2006, 07:09:00 to 07:18:00

EMS logs, SCADA reports, and power plant DCS logs were analyzed to summarize the activities and system responses to the events. The EMS data provided in 2 second intervals is plotted in figures 1 through 4 to provide a visual interpretation of the data. At the onset of the earthquake, the system was operating normally with all transmission lines in service and generation properly dispatched to provide sufficient reserve in accordance with the MECO operating procedures. M11 was ramping up output as load was increasing. There were essentially two areas of events. In the first 20 seconds after the earthquake, a majority of the generation tripped and load was shed. In the remaining 8 minutes, generation settled out, but the remaining 4 generators eventually tripped.

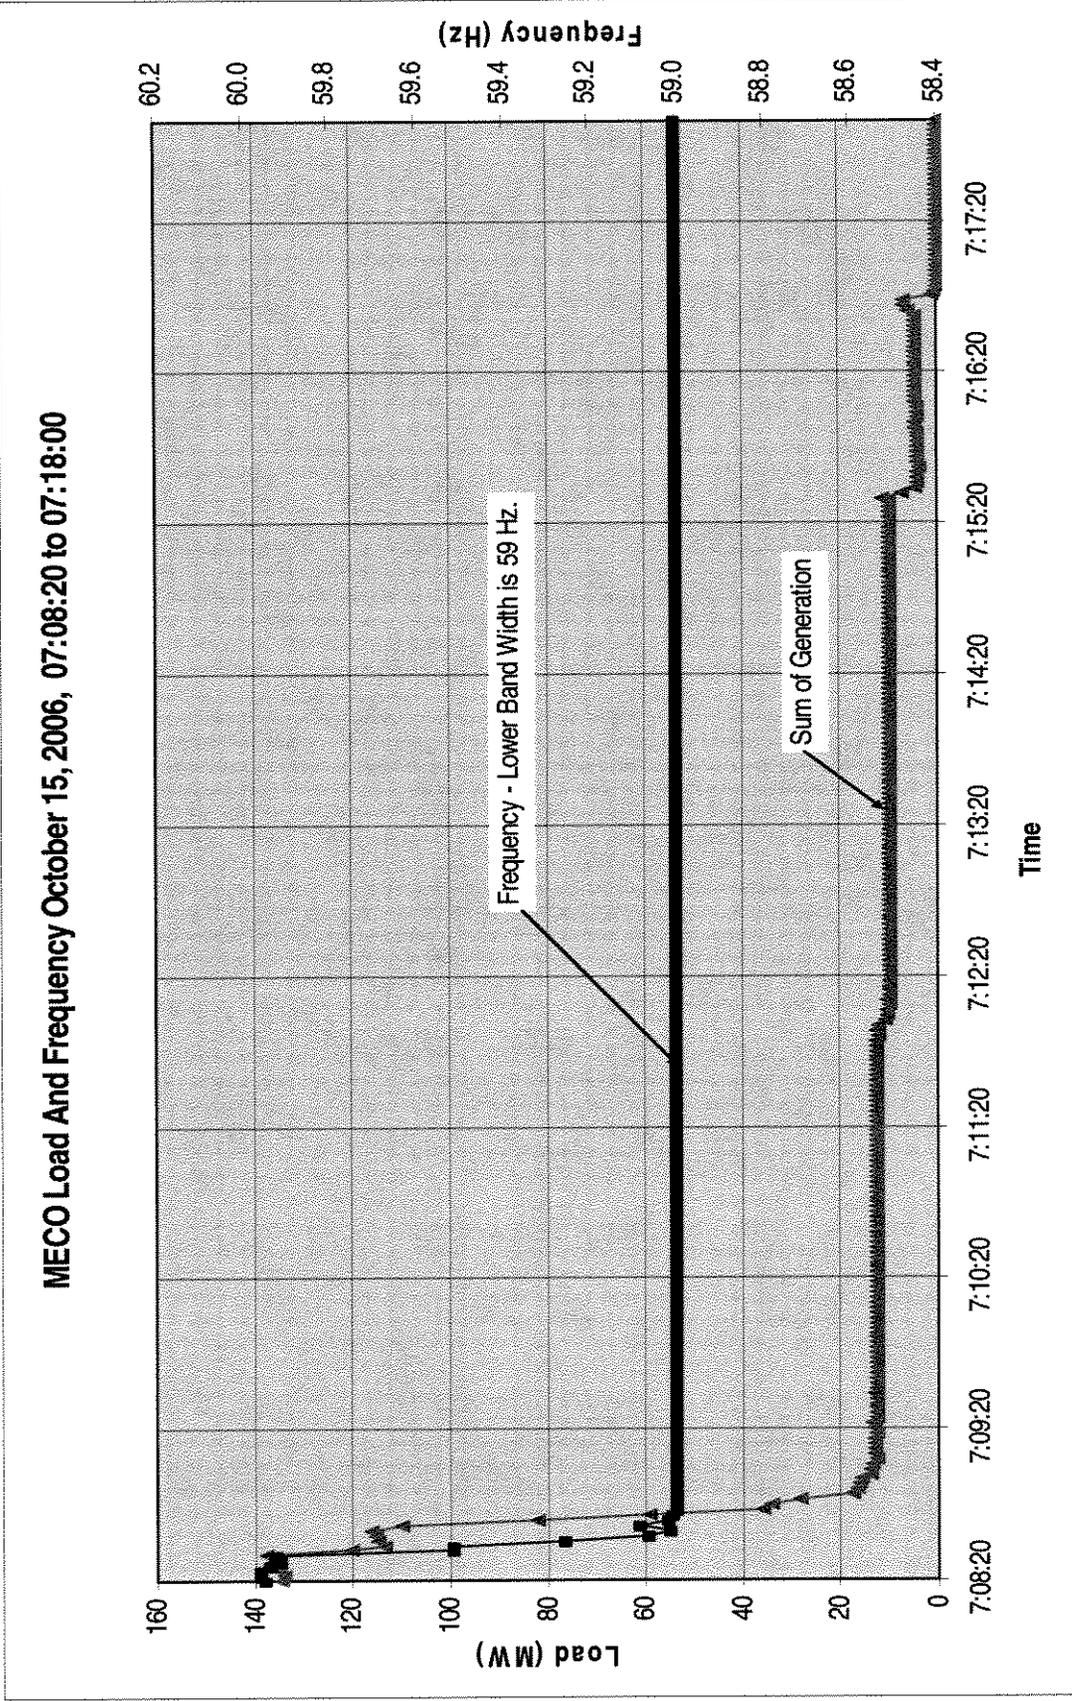
Figure 4: Load versus Frequency Timeline - October 15, 2006, 07:08:20 to 07:18:00

We have developed the sequence of events from just before the earthquake to the outage using information from the EMS, supervisory control and data acquisition (SCADA) reports, power plant distributed control system (DCS) alarm logs, relay event recordings, and employee interviews. This sequence of events coincides with the information displayed in the following figures. Figure 1 shows the system generation/load and frequency with the timing of load shed events on the MECO system from the time of the earthquake until M10 tripped. Figures 2 shows the megawatt output of the individual generating units and the system frequency from 07:08:20 to 07:09:00. Figure 3 shows the megawatt output of the remaining generating units from 07:09:00 to 07:18:00 when all units were off line. Figure 4 shows the system load and frequency from 07:08:20 to 07:18:00 to illustrate that the frequency remained below the 59 Hz.
