CONDOMINIUM PUBLIC REPORT

Project Name(*): THE ROYAL PALM AT WAIPIO - PHASES II & III
Address: See attached page 1a
(Conversion)

Registration No. 3653 Effective date: February 27, 2001
Expiration date: March 27, 2002

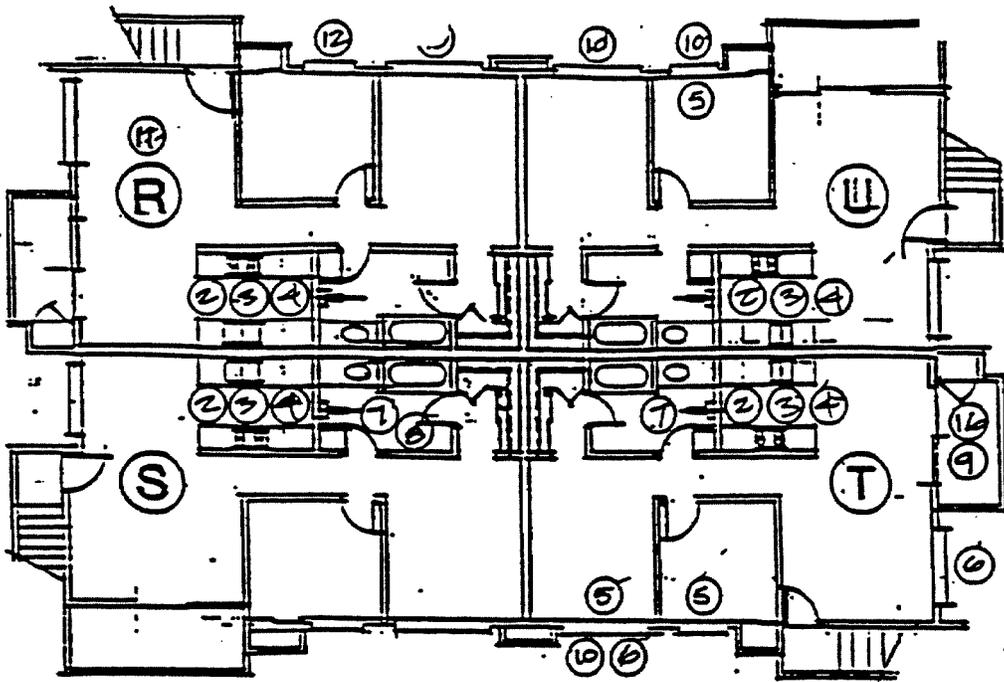
SECOND FLOOR PLAN
SC: 1/16" = 1'-0"

- A1- Deck soffit edge trim separation. Caulk w/flexible sealant.
- A2- Lower cabinets water damaged and finish mismatched at face.
- A3- P-lam countertop scarred.

- A4- Upper cabinet doors above sink, edge conditions worn. Replacement of cabinet doors may be necessary or add corner protection guards.
- A5- Mini blind blades bent. Replace damaged assembly unit w/new to match existing.

- A6- Window glass water stained.
- A7- Medicine cabinet mirror door finish pitted.
- A8- Towel bar finish tarnished.
- A9- Sliding door screen damaged. Replace w/new.

- A10- Window screen damaged replace w/new screen.
- A11- Carpet appears worn and dirty.
- A12- Window screen frame warped. Replace w/new to match existing or correct warped condition.

- A13- Light diffuser lens warped. Replace w/new to match existing.
- A14- Wasp nest on Lana exterior wall. Remove nest and touch-up paint to match existing.

- A15- Automatic door closer missing. new to match existing.
- A16- Screen door latch does not engage. Repair or replace as required.

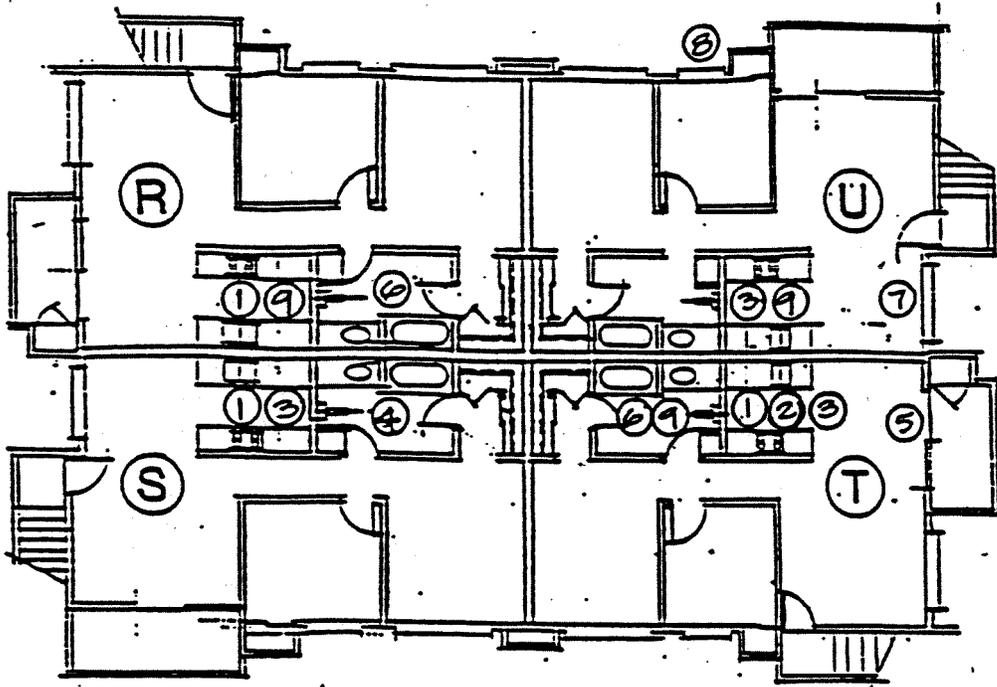
SECOND FLOOR PLAN
SC:1/16"=1'-0"

- A1- Upper cabinet doors above sink, edge conditions worn. Replacement of new cabinet doors may be necessary or add new corner protection guards.
- A2- Light diffuser lens warped.

- A3- Lower cabinets water damaged and mismatched at face condition.
- A4- Mirror finish at vanity pitted.
- A5- Sliding door jamb bent @ screen latch. Repair warped condition.

- A6- Medicine cabinet mirror door finish pitted.
- A7- Mini blind blades bent. Replace damage assembly unit w/new to match existing.
- A8- Window screen damaged. Replace w/new screen.

- A9- Drawer face edge worn.
- A10- Deck soffit edge trim separation. Caulk w/flexible sealant.
- A11- Tub/Bath wall separation caulk w/flexible sealant.

- A12- Patch opening in Gyp. Board ceiling to match existing.
- A13- Lower cabinet door face edges freyed.
- A14- Sliding door screen damaged. Replace w/new screen.

- A15- P.Lam counter top surface burned. Replace w/new to match existing.
- A16- P.Lam counter top bull nose chipped.
- A17- Touch-up paint around light switch

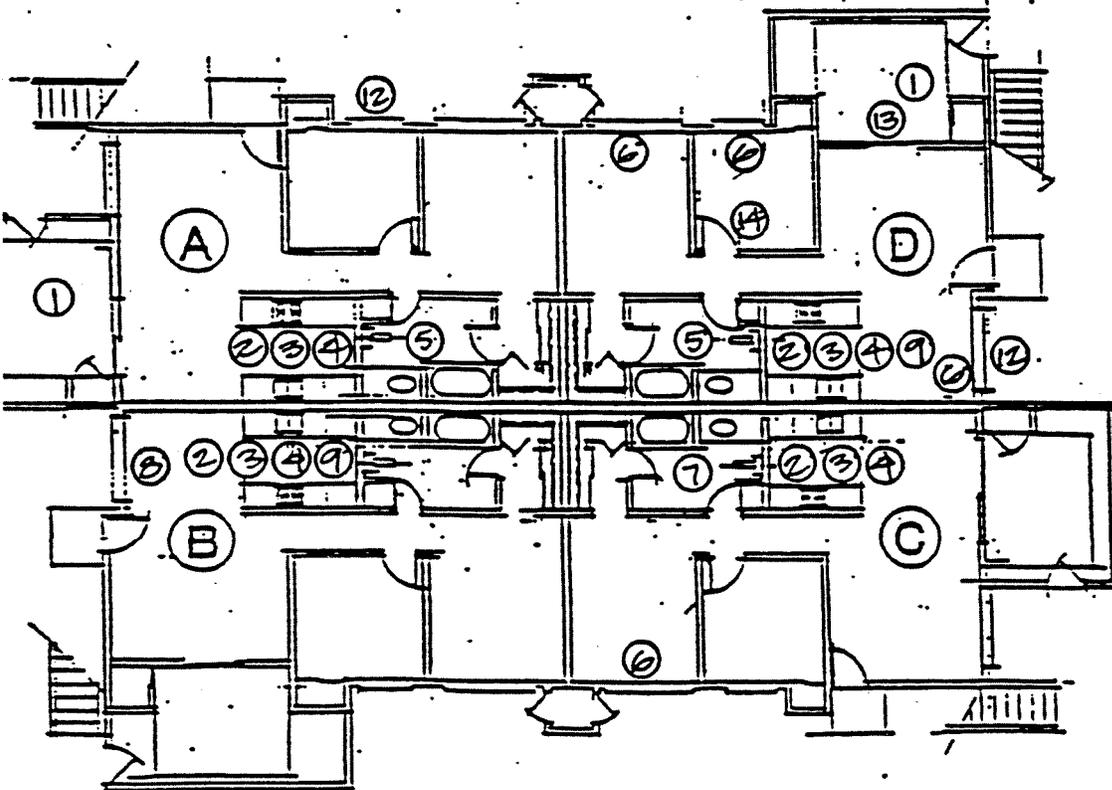
FIRST FLOOR PLAN
 SC: 1/16" = 1'-0"

- A1- Deck soffit edge trim separation caulk w/flexible sealant.
- A2- P.Lam counter top scarred.
- * A3- Lower cabinets water damaged at face condition.
- * A4- Upper cabinet doors above sink, edge condition worn. Replacement of cabinet doors may be necessary or add new corner protection guards.
- A5- Medicine cabinet mirror door finish pitted.
- * A6- Mini blind blades bent. Replace damaged assembly unit w/new to match existing.
- A7- Towel bar finish tarnished.
- * A8- Window glass water stained.
- * A9- Lower cabinets face mismatches.
- A10- Sliding door aluminum threshold pitted.
- * A11- Light diffuser lens cracked. Replace w/new to match existing.
- A12- Window screen frame pitted.
- * A13- Screen dock frame broken. Replace to match existing.
- A14- Door stop hardware missing. Replace w/n to match existing.
- A15- Window screen damaged. Replace w/new screen.

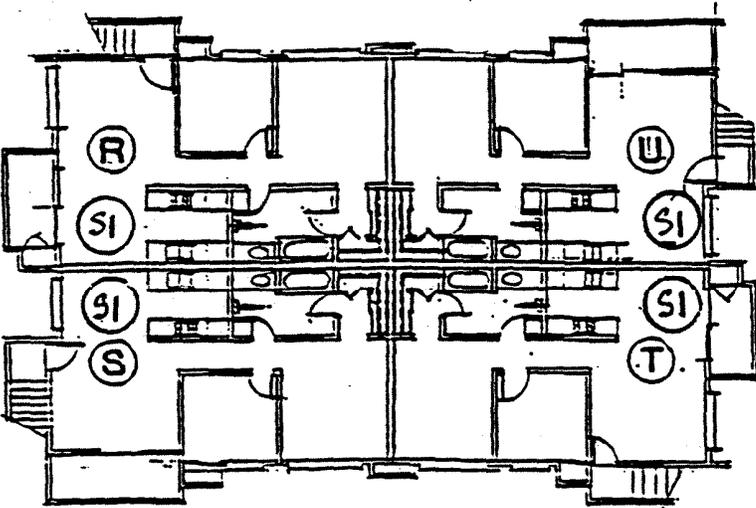
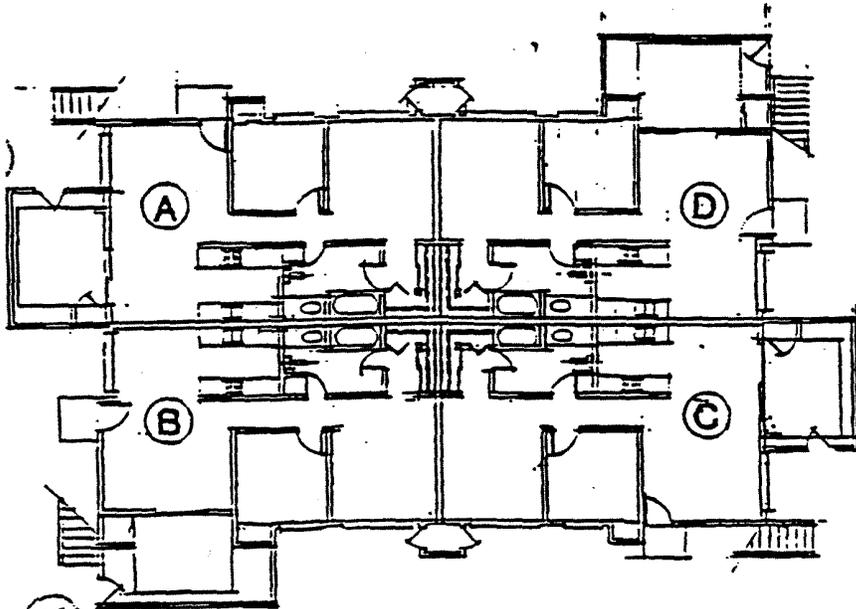
8-PLEX BUILDING # 7
GENTRY SUNPOINT ALANEO
 SUEDA & ASSOCIATES, INC.

- S1 - Vertical members of built up end trusses have stapled connections. Reinforce per Sketch S-1.
- S2 - Underside of Unit S stair landing is sagging. Seal off water infiltration, repair and refinish.
- S3 - Rot damage to tops of rail cap. Patch or replace and refinish.
- S4 - Rusted base at steel railing of exterior step. Repair or replace to match.

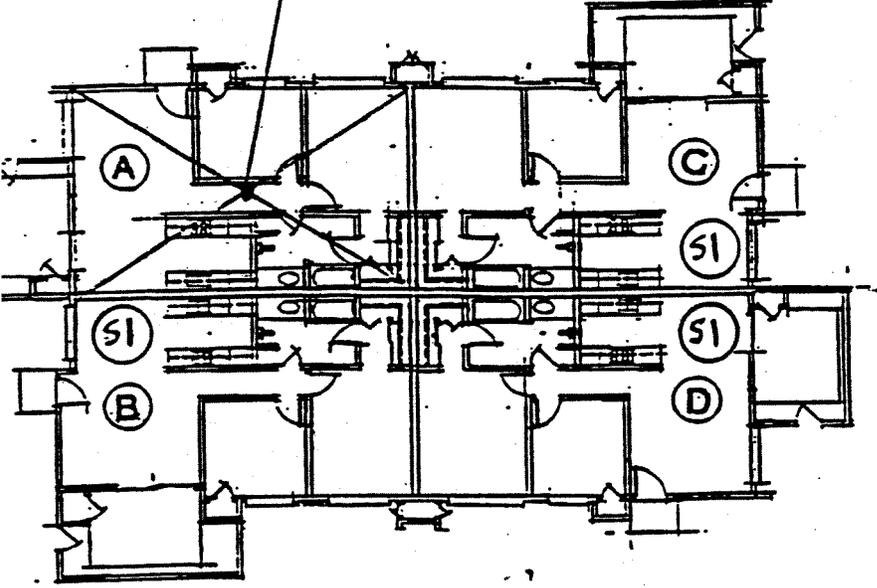
4-PLEX BUILDING # 8
GENTRY SUNPOINT ALANEO
SUEDA & ASSOCIATES, INC.

S1 - Vertical members of built up end trusses have stapled connections. Reinforce per Sketch S-1.

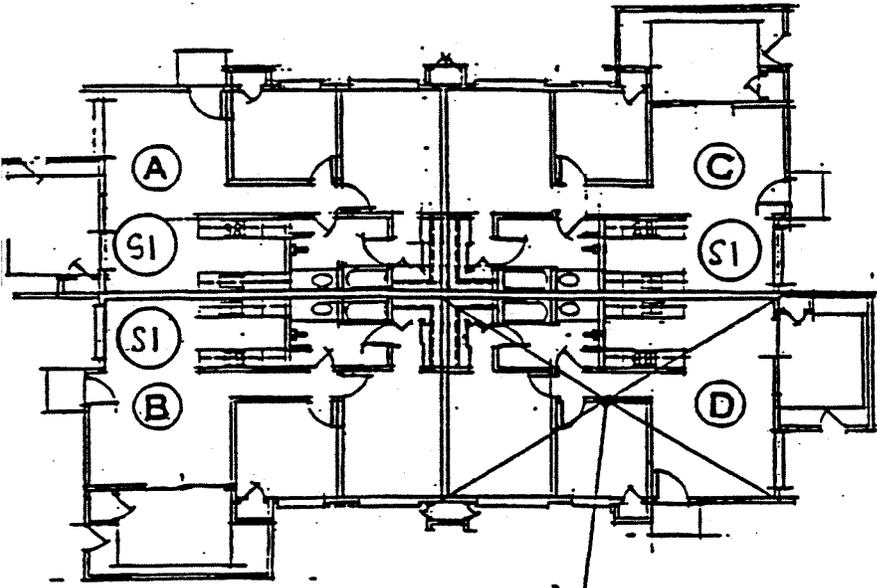
4-PLEX BUILDING # 12
GENTRY SUNPOINT ALANEO
 SUEDA & ASSOCIATES, INC.

- S1 - Vertical members of built up end trusses have stapled connections. Reinforce per Sketch S-1.
- S2 - Carport: Splits in 4X10beams Install lag screws per Sketch S-3.

- 4) Open Carports - A number of 4 x 14 and 4 x 10 garage beams had large splits. These horizontal cracks are probably the result of using "green" lumber. If permitted to continue, such splitting may result in excessive deflection. We recommend that these beams be reinforced with lag screws to curtail further splitting. See detail on Sketch S-3.

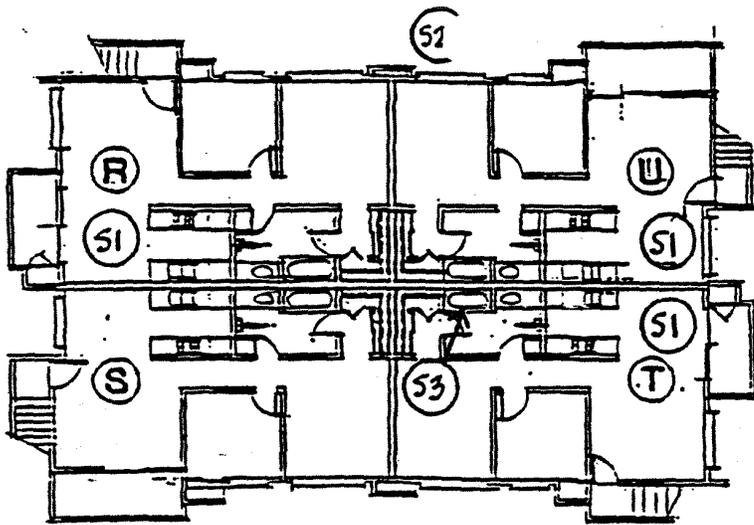
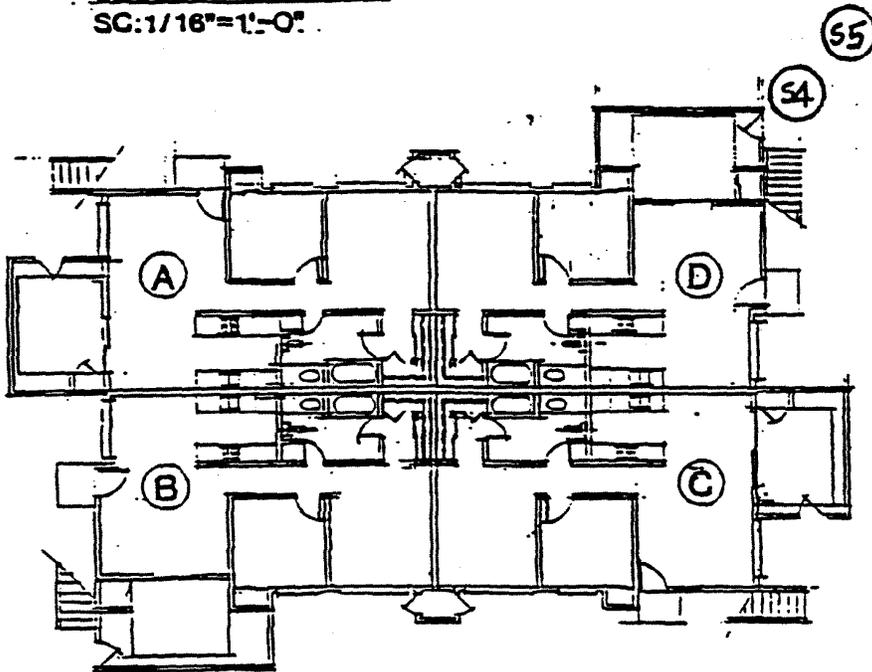
8-PLEX BUILDING # 16
GENTRY SUNPOINT ALANEO
 SUEDA & ASSOCIATES, INC.

- S1 - Vertical members of built up end trusses have stapled connections. Reinforce per Sketch S-1.
- S2 - Large birdnest observed. Remove debris from attic space and seal access openings at vents.
- S3 - Cracked 2'X2' section of gypboard at underside of rafter. Patch with 5/8" Type "X" material.
- S4 - Rusted fence post. Replace per Sketch S-4.
- S5 - Rot damaged wooden post for sign. Replace with new wood, wrapped with 30# felt and embedded in concrete (similar to Sketch S-4).
- S6 - Carport: Splits in 4X10 and 4X14 beams. Install lag screws @ 24" o.c. per Sketch S-3.

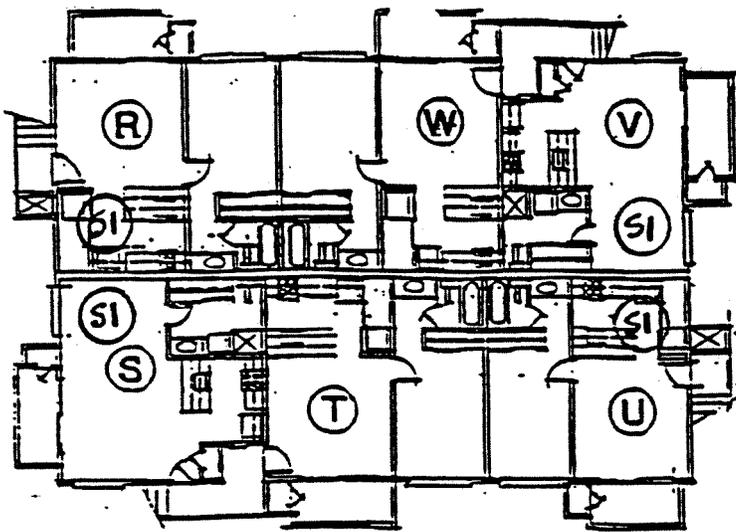
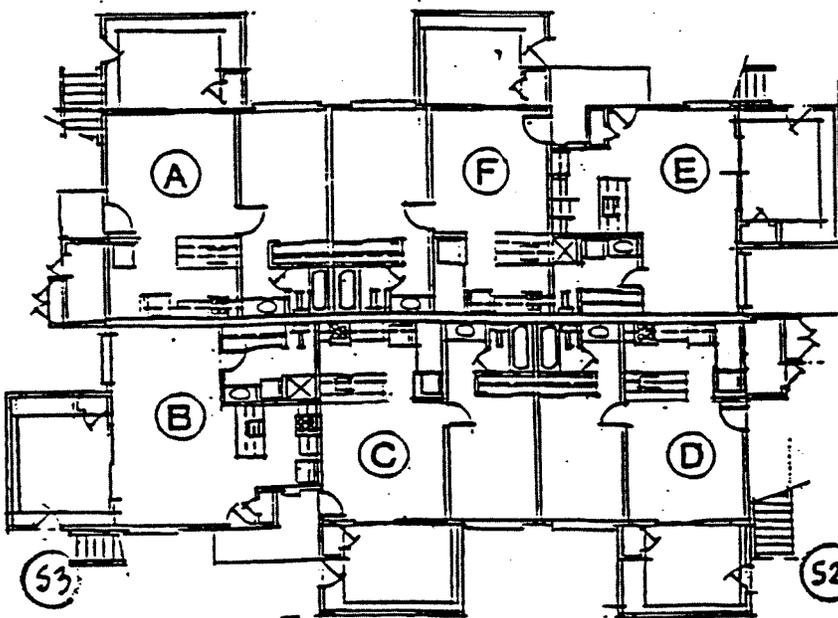
12-PLEX BUILDING # 24
GENTRY SUNPOINT ALANEO
 SUEDA & ASSOCIATES, INC.

- S1 - Vertical members of built up end trusses have stapled connections. Reinforce per Sketch S-1.
- S2 - Missing 2'x4' section of gypboard at demising wall in ceiling. Probably removed by cable installer (telephone or TV). Replace with new.
- S3 - Rusted railing at exterior steps. Repair or replace as needed.

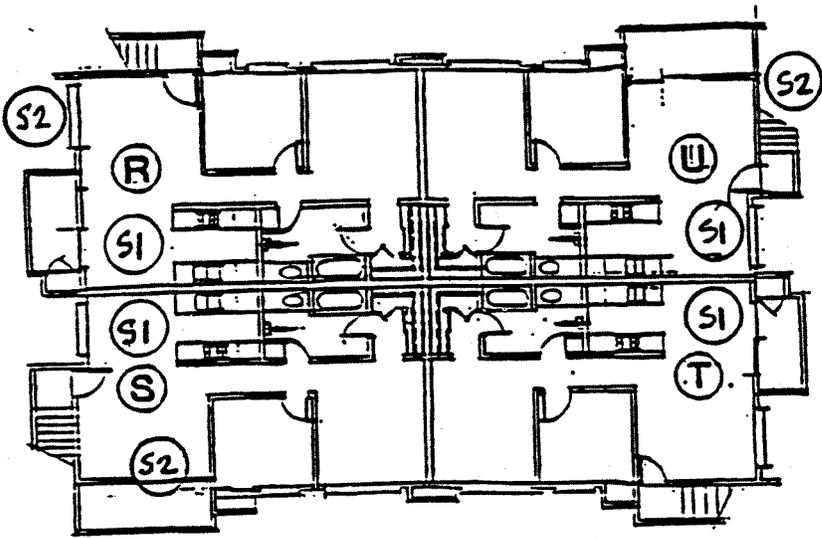
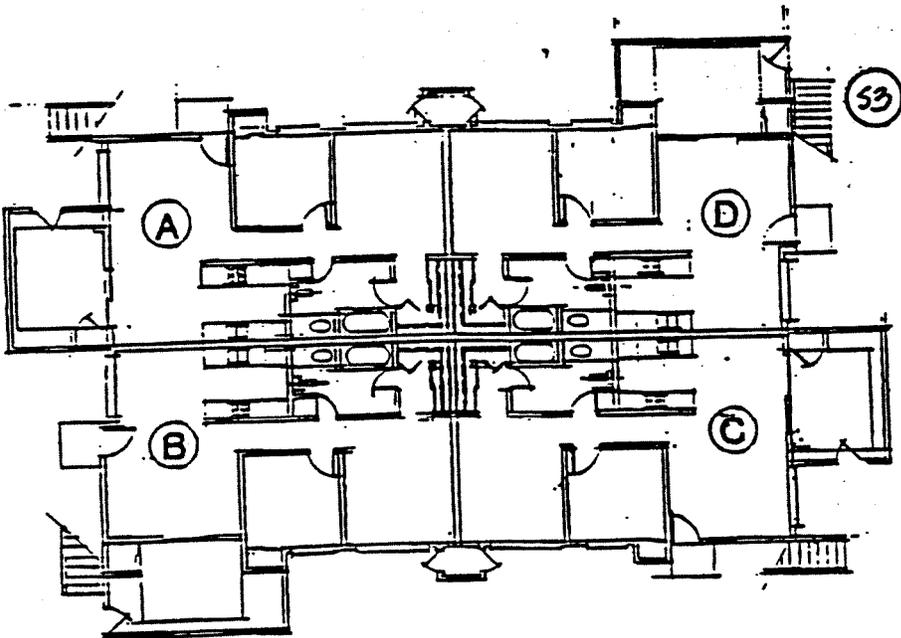
8-PLEX BUILDING # 39
GENTRY SUNPOINT ALANEO
 SUEDA & ASSOCIATES, INC.

- S1 - Vertical members of built up end trusses have stapled connections. Reinforce per Sketch S-1.
- S2 - Large birdnest observed. Remove debris from attic space and seal access openings at vents.
- S3 - Stair tread support angles rusted. Clean and repaint or replace.
- S4 - Carport: Remove birdnest accumulation and seal openings. Repair splits in 4X10 beams with lag screws per Sketch S-3.

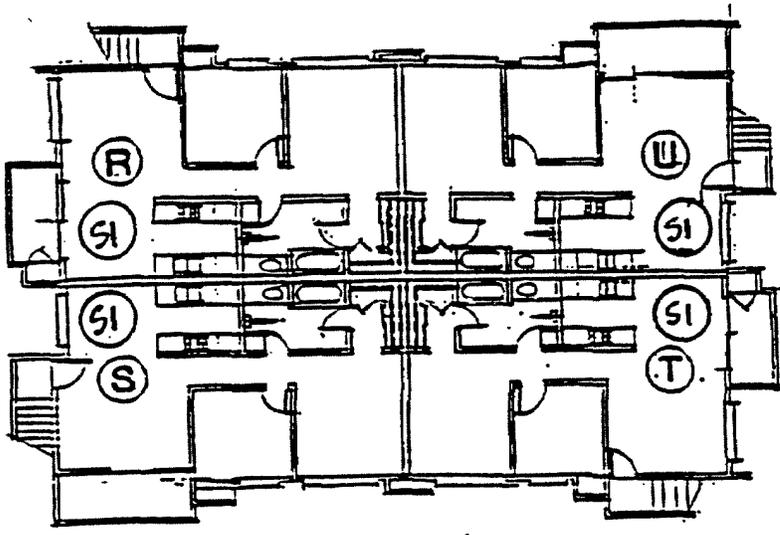
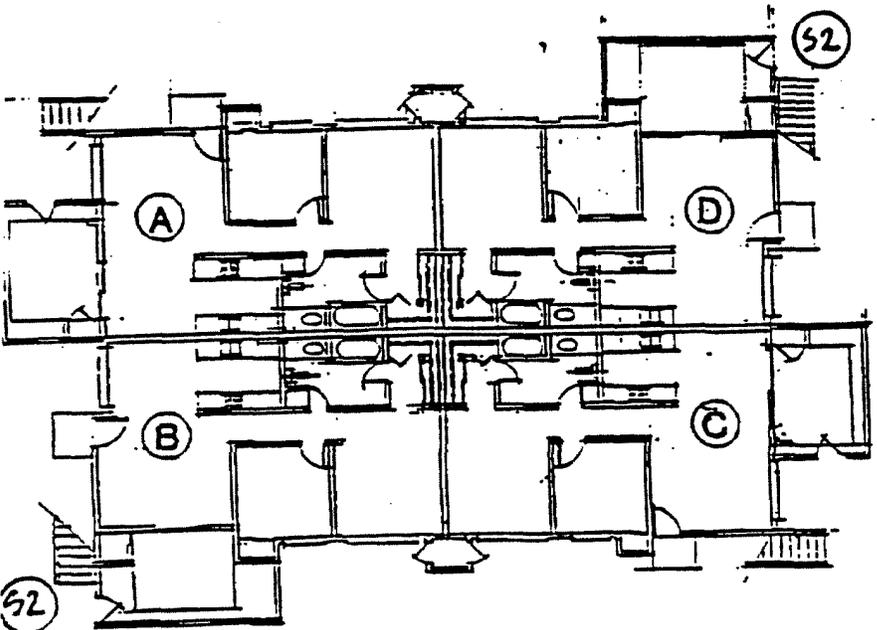
8-PLEX BUILDING # 45
GENTRY SUNPOINT ALANEO
SUEDA & ASSOCIATES, INC.

- S1 - Vertical members of built up end trusses have stapled connections. Reinforce per Sketch S-1.
- S2 - Minor rot damage at bottom of stair stringers. Treat with mildewcide and clear away soil accumulation around wood.
- S3 - Carport: Splits in 4X10 beams. Install lag screws @ 24" o.c. per Sketch S-3.

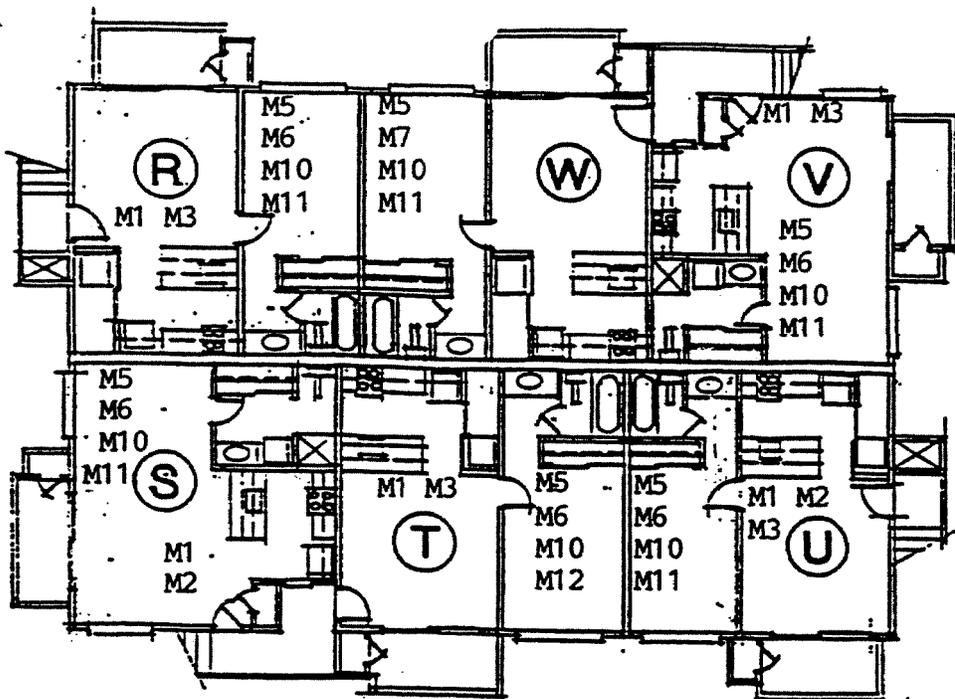
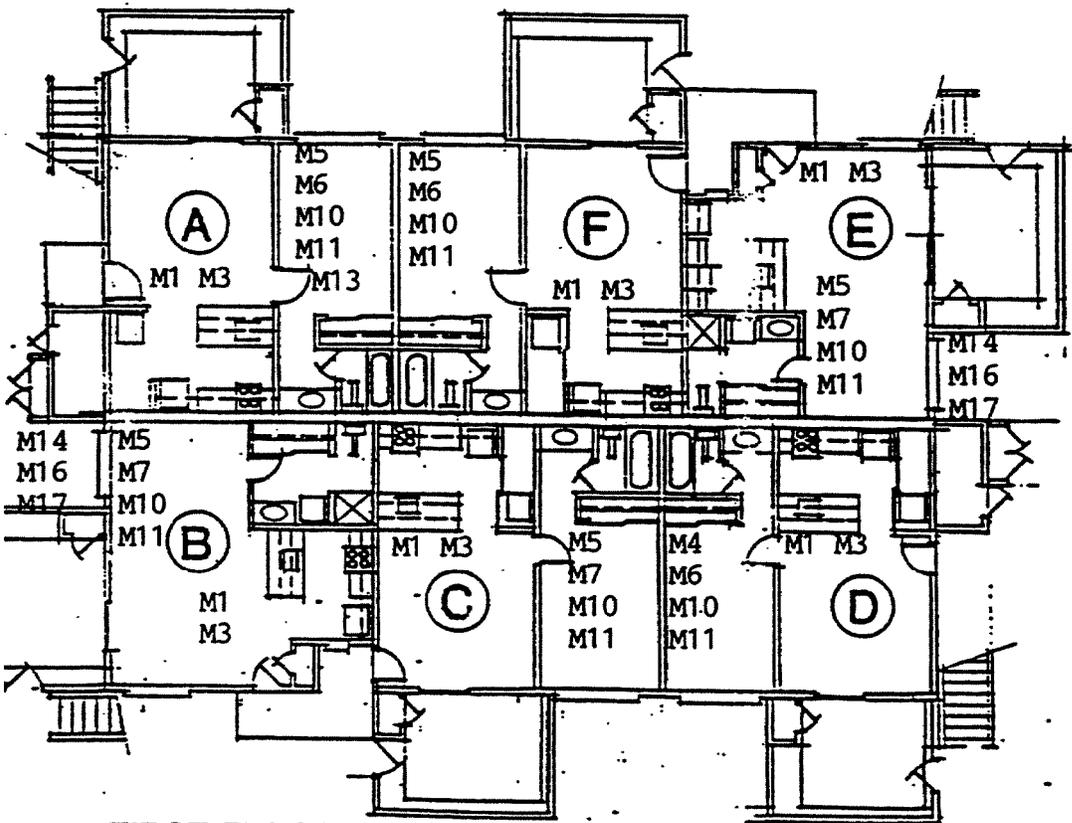
12-PLEX BUILDING # 24
GENTRY SUNPOINT ALANEO

Note: Straighten flex duct for exhaust fan in Unit "U".

M16 - Cleanout Heater Rooms.

M17 - Cleanout pressure reducer water valve box. Valve box filled with dirt.

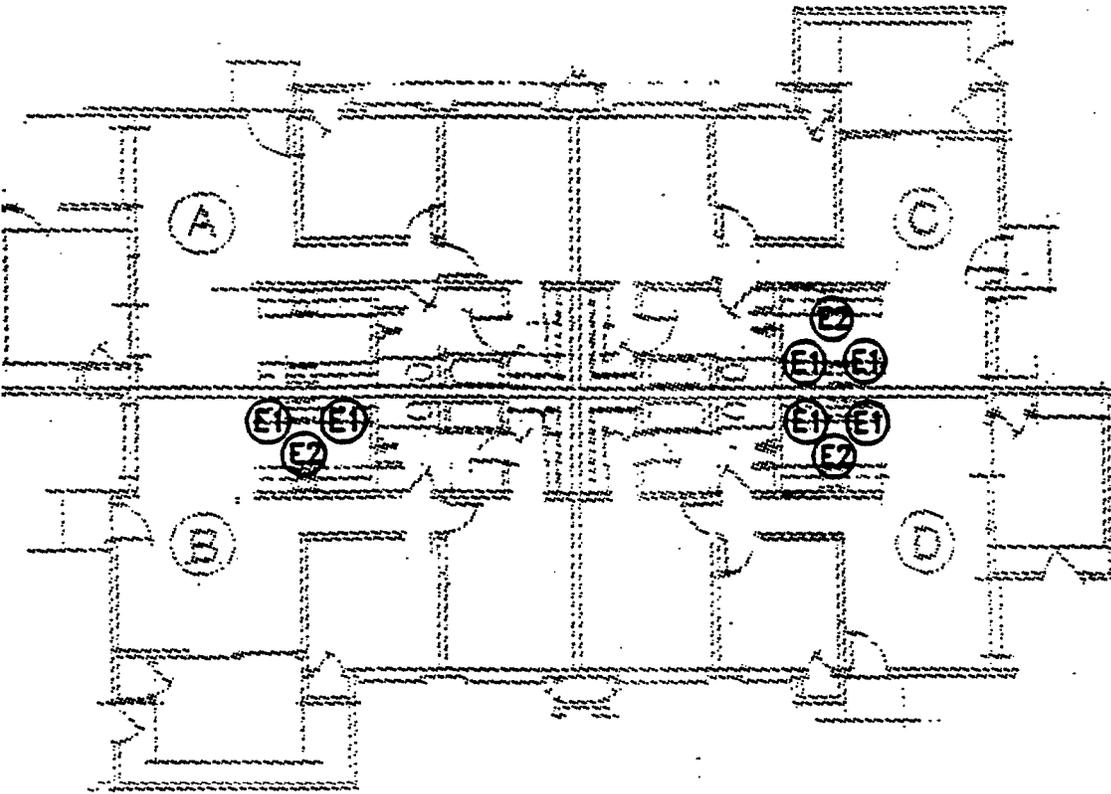
4-PLEX BUILDING #12
GENTRY SUNPOINT ALANEO

E-1 Replace duplex receptacle with new GFI type.

E-2 Replace polycarbonate diffusers (two 2 X 4) with new acrylic prismatic diffusers.

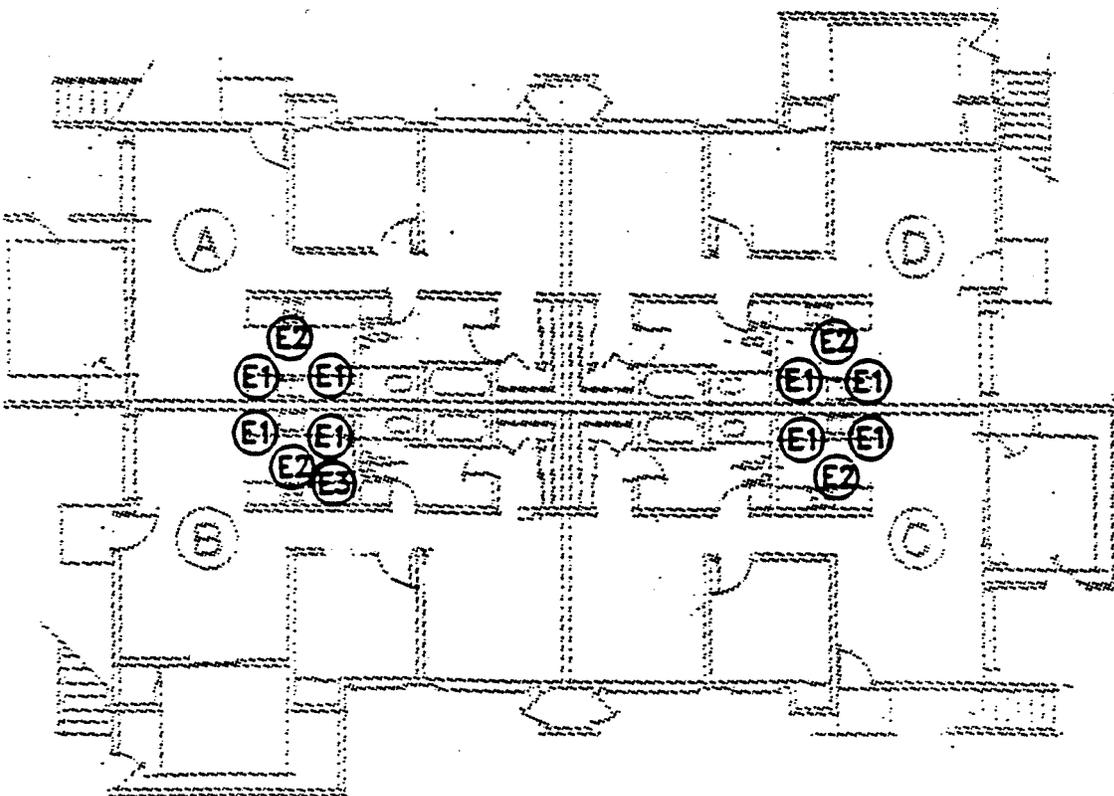
8-PLEX BUILDING #16
GENTRY SUNPOINT ALANEO

- E-1 Replace duplex receptacle with new GFI type.
- E-2 Replace polycarbonate diffusers (two 2 X 4) with new acrylic prismatic diffusers.
- E-3 Provide blanking cover for missing breakers (2).

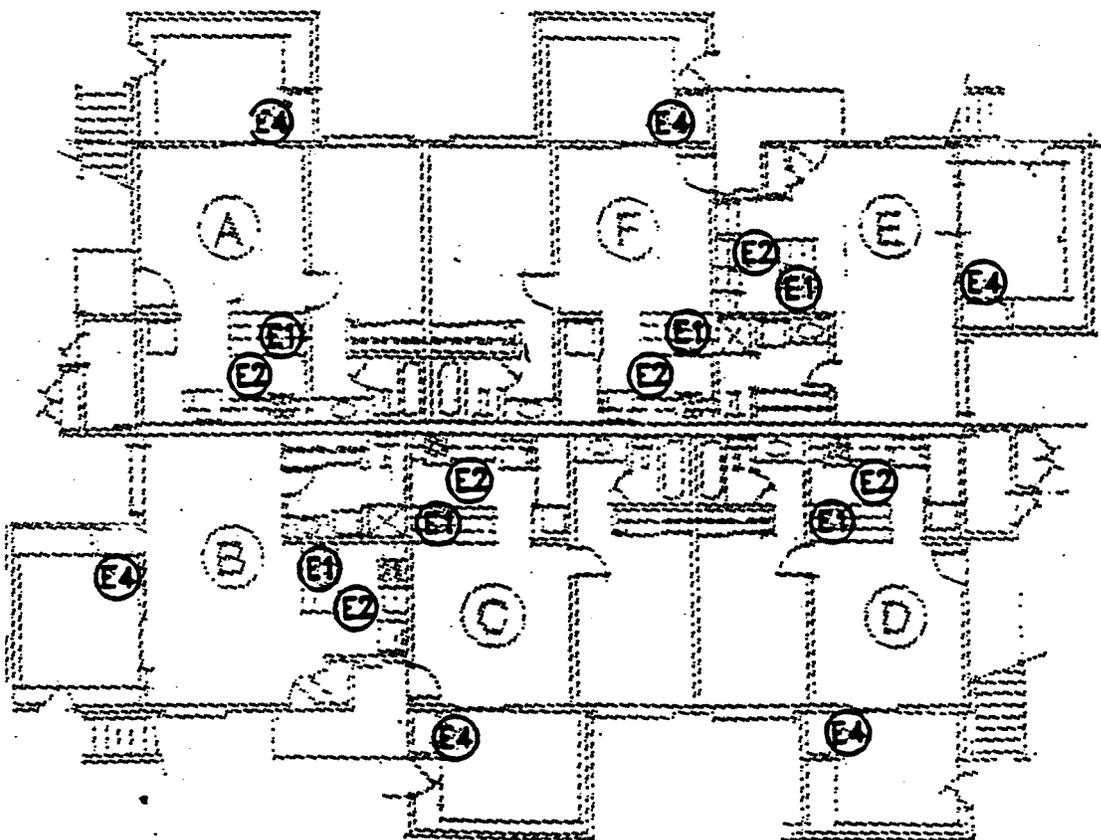
12-PLEX BUILDING # 24
GENTRY SUNPOINT ALANEO

- E-1 Replace duplex receptacle with new GFI type.
- E-2 Replace polycarbonate diffusers (two 2 X 4) with new acrylic prismatic diffusers.
- E-4 Provide new duplex, weatherproof GFI type receptacle at Lanai, if required.

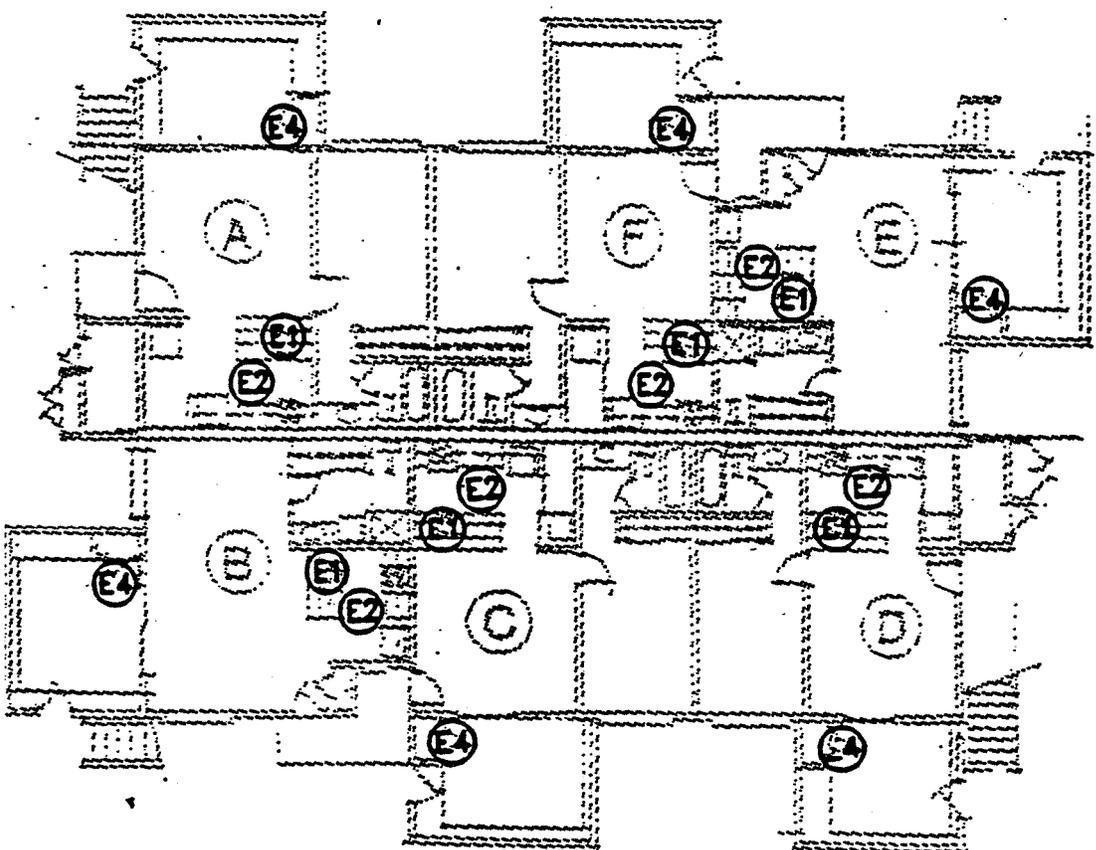
SECOND FLOOR PLAN
 SC: 1/16" = 1'-0"

- E-1 Replace duplex receptacle with new GFI type.
- E-2 Replace polycarbonate diffusers (two 2 X 4) with new acrylic prismatic diffusers.
- E-4 Provide new duplex, weatherproof GFI type receptacle at Lanai, if required.
- E-5 Resupport existing wall mounted luminaire.

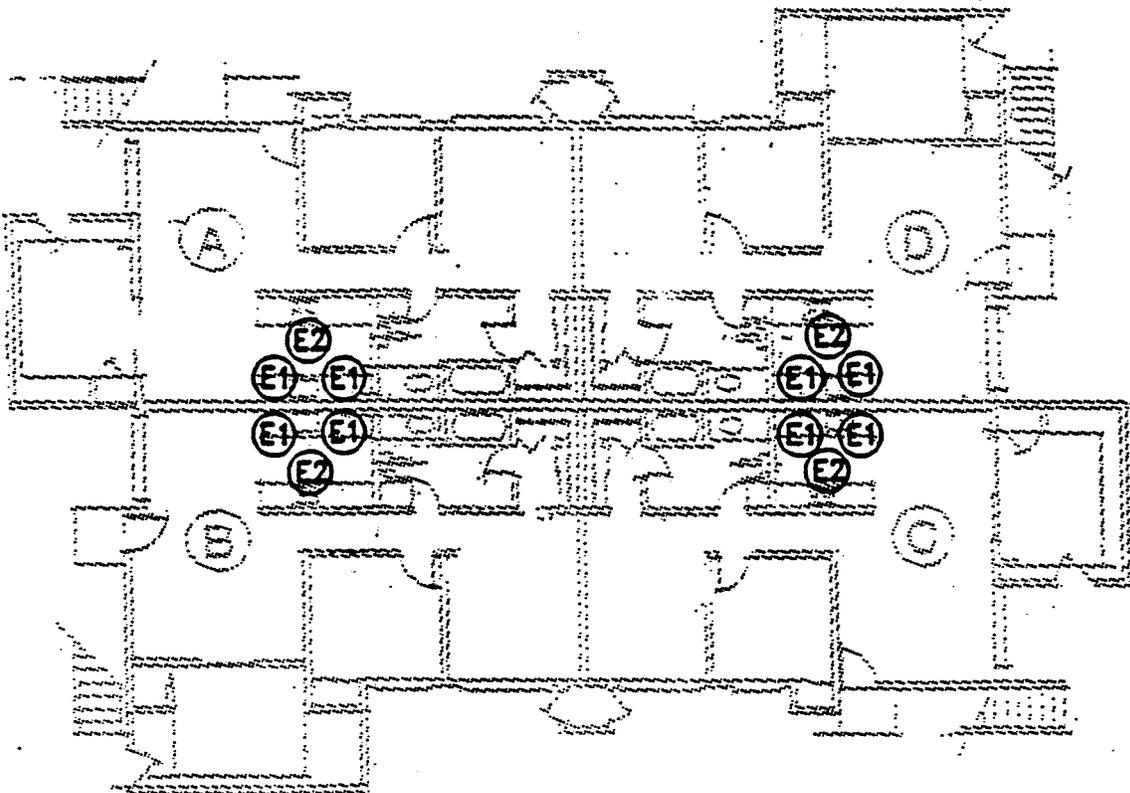
SECOND FLOOR PLAN
 SC: 1/16" = 1'-0"

- E-1 Replace duplex receptacle with new GFI type.
- E-2 Replace polycarbonate diffusers (two 2 X 4) with new acrylic prismatic diffusers.
- E-6 Replace ceiling fan.

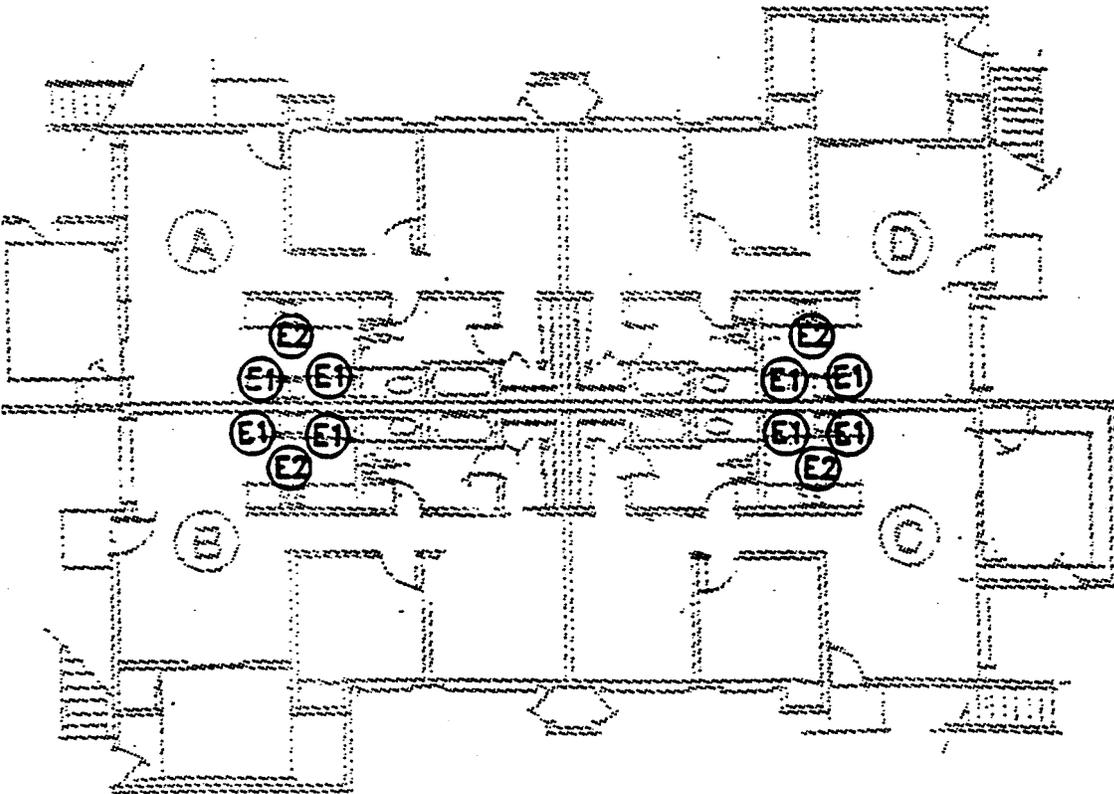
SECOND FLOOR PLAN
 SC: 1/16" = 1'-0"

- E-1 Replace duplex receptacle with new GFI type.
- E-2 Replace polycarbonate diffusers (two 2 X 4) with new acrylic prismatic diffusers.

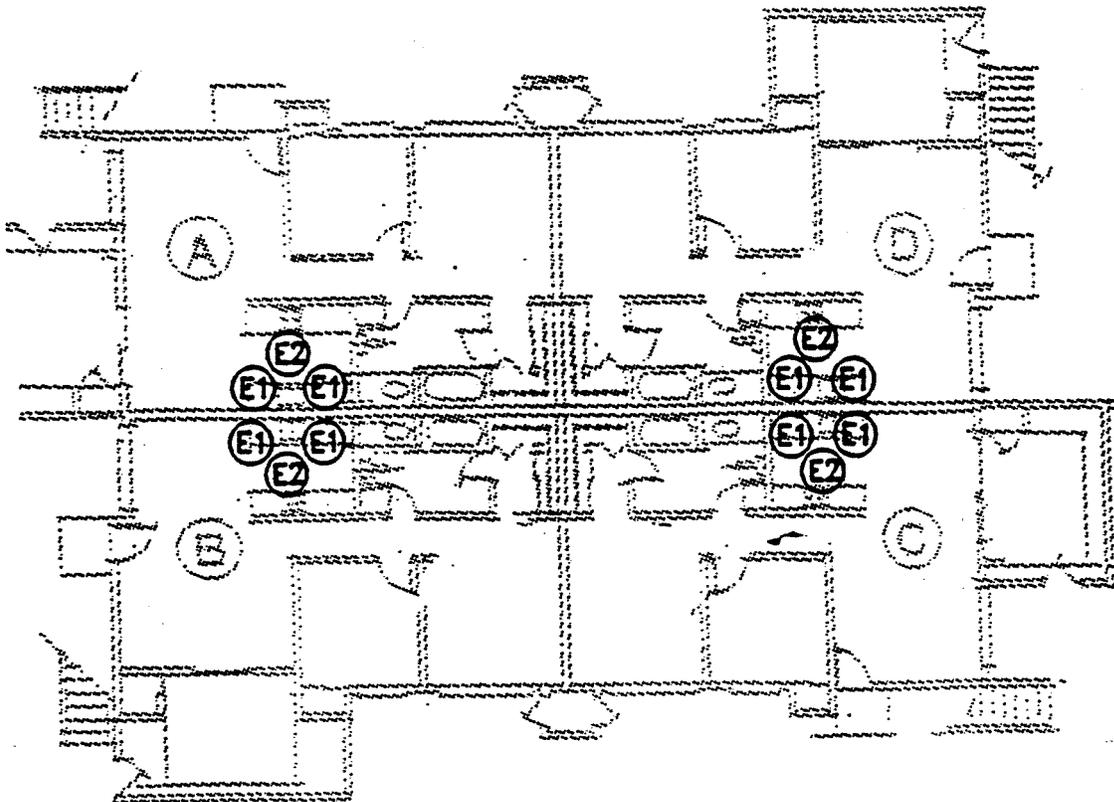
SECOND FLOOR PLAN
 SC: 1/16" = 1'-0"

E-1 Replace duplex receptacle with new GFI type.

E-2 Replace polycarbonate diffusers (two 2 X 4) with new acrylic prismatic diffusers.

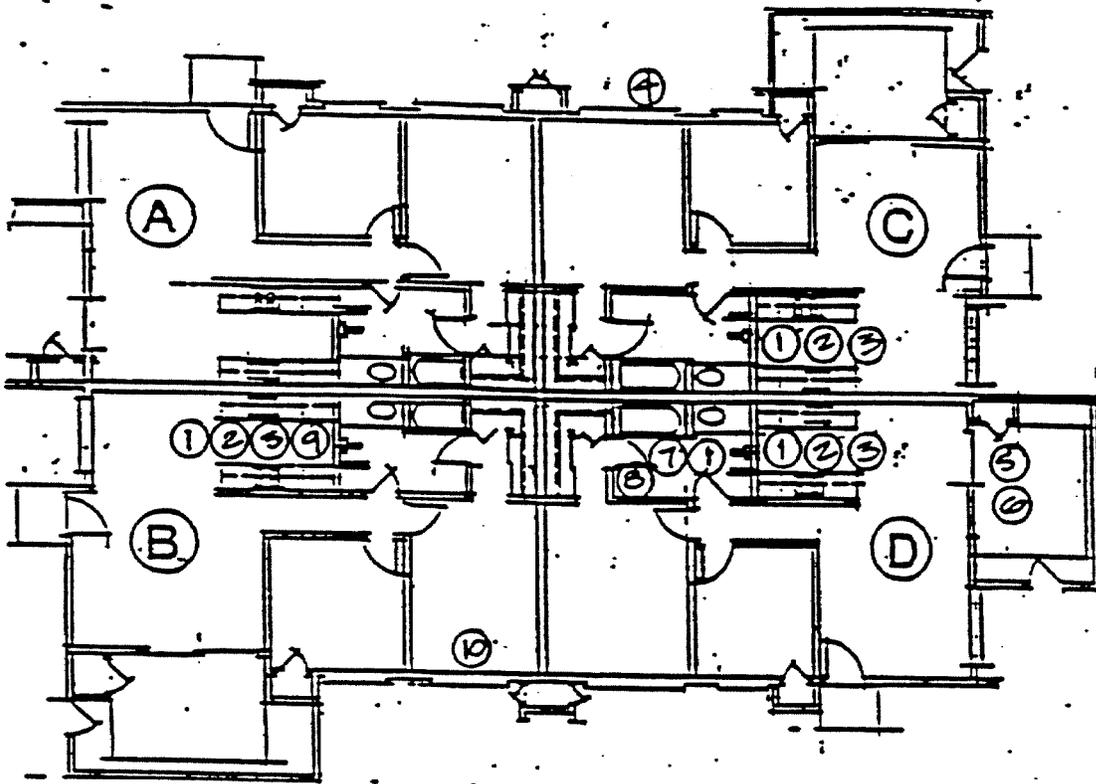
FIRST FLOOR PLAN
SC: 1/16" = 1'-0"

- A1- Lower cabinets water damaged and finish mismatched at face condition. *
- A2- Upper cabinet doors above sink, edge conditions worn. Repair of cabinet doors may be necessary or add new corner protection guards.
- A3- P. Lam countertop scarred. *
- A4- Window glass water stained. *
- A5- Sliding screen door operation untracks. Adjust door guide or may replace w/new door leaf.
- A6- Sliding door screen damaged. Replace w/new screen.
- A7- Medicine cabinet mirror door finish pitted. **
- A8- Upper cabinet door leafs. Do not match melamine finish colors differ. **
- A9- Light diffuser lens warped. Replace w/new to match existing.
- A10- Mini blind blades bent. Replace damaged assembly unit w/new to match existing.

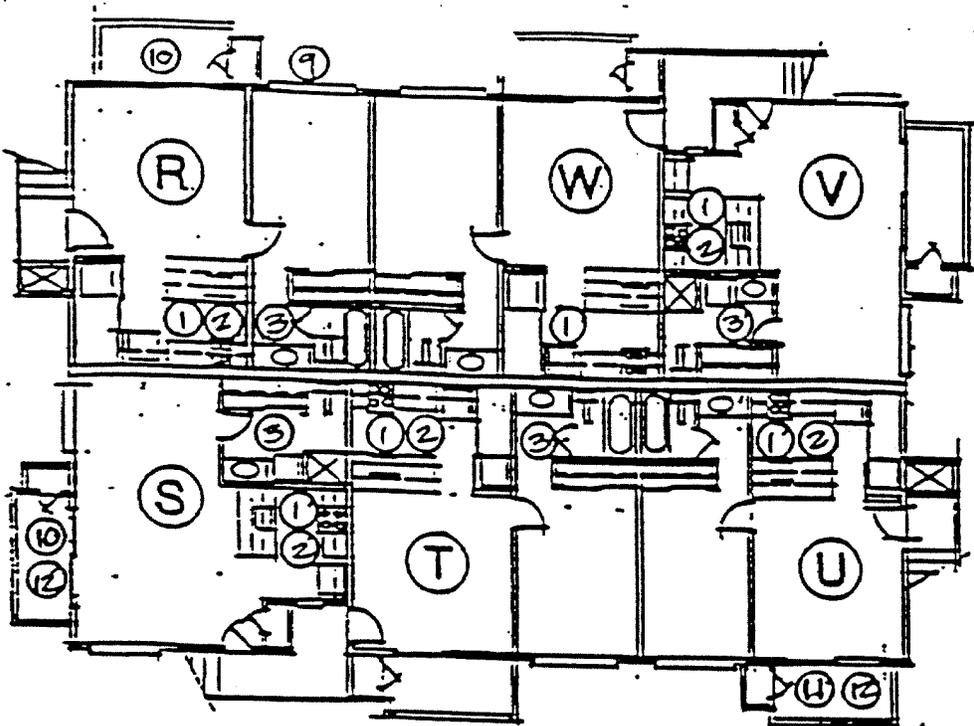
SECOND FLOOR PLAN
SC: 1/16" = 1'-0"

- A1- Lower cabinets water damaged and finish mismatched at face condition.
- A2- P.Lam counter top scarred.
- A3- Medicine cabinet mirror door finish pitted.

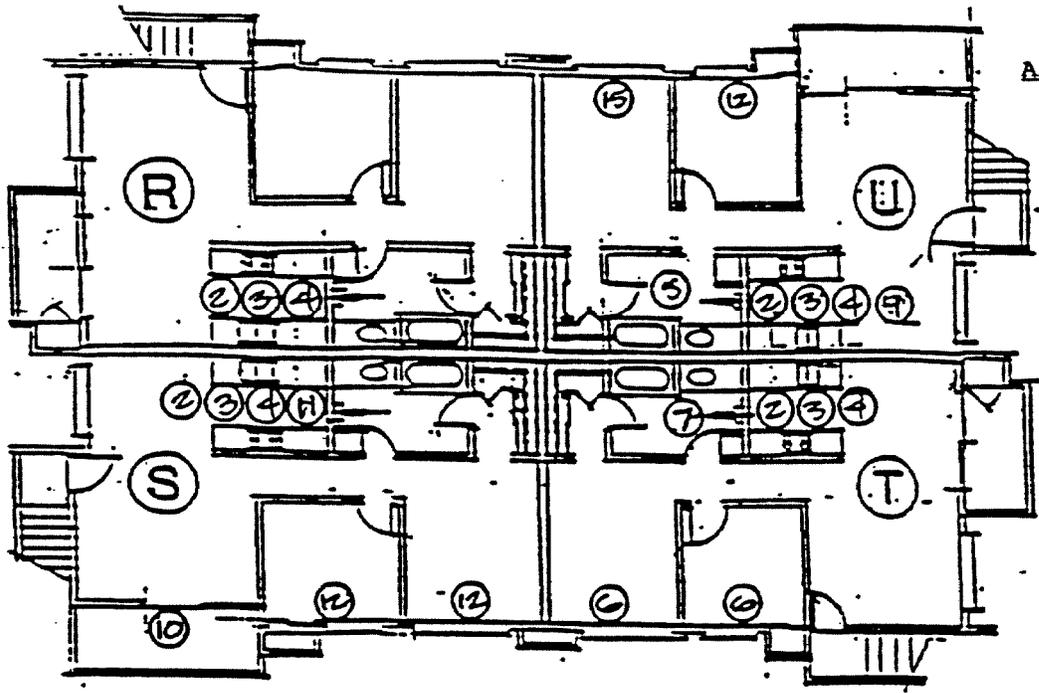
SECOND FLOOR PLAN
SC: 1/16" = 1'-0"

- A1- Deck soffit edge trim separation caulk w/flexible sealant.
- A2- P.Lam counter top scarred.
- A3- Lower cabinets water damaged at face condition.
- A4- Upper cabinet doors above sink, edge condition worn. Replacement of cabinet doors may be necessary or add new corner protection guards.
- A5- Medicine cabinet mirror door finish pitted.
- A6- Mini blind blades bent. Replace damage assembly unit w/new to match existing.
- A7- Towel bar finish tarnished.
- A8- Window glass water stained.
- A9- Lower cabinets face mismatches.
- A10- Sliding door aluminum threshold pitted.
- A11- Light diffuser lens cracked. Replace w/new to match existing.
- A12- Window screen frame pitted.
- A13- Screen dock frame broken. Replace to match existing.
- A14- Door stop hardware missing. Replace w/ to match existing.
- A15- Window screen damage Replace w/new screen

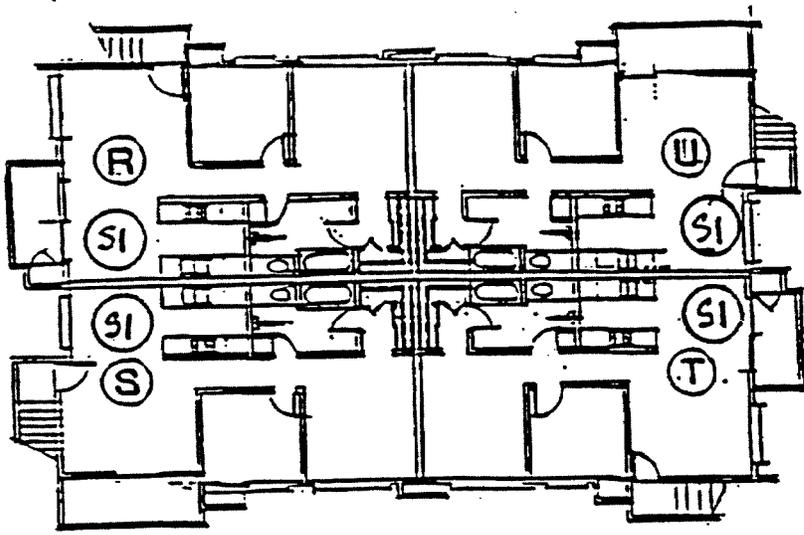
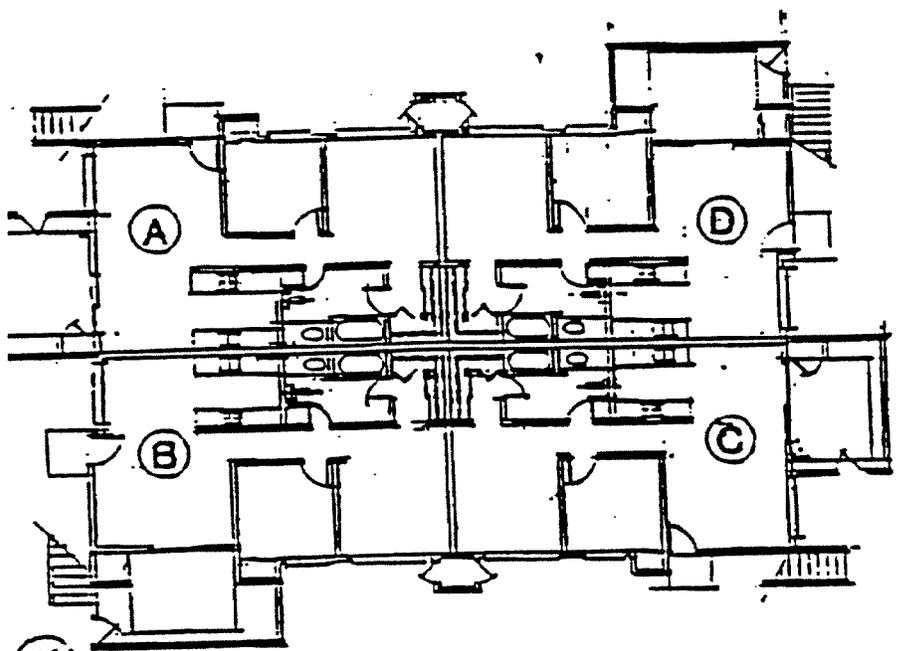
8-PLEX BUILDING # 7
GENTRY SUNPOINT ALANEO
SUEDA & ASSOCIATES, INC.

- S1 - Vertical members of built up end trusses have stapled connections. Reinforce per Sketch S-1.
- S2 - Underside of Unit S stair landing is sagging. Seal off water infiltration, repair and refinish.
- S3 - Rot damage to tops of rail cap. Patch or replace and refinish.
- S4 - Rusted base at steel railing of exterior step. Repair or replace to match.

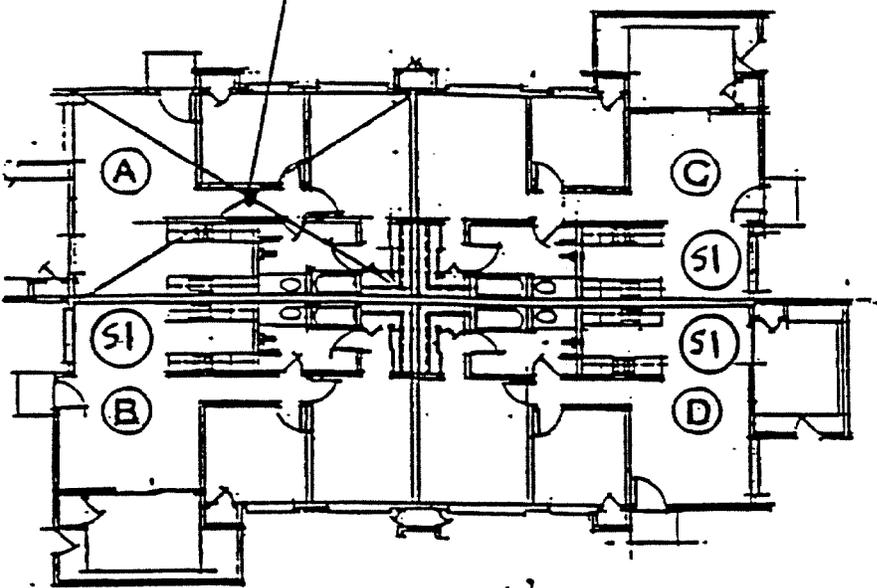
4-PLEX BUILDING # 8
GENTRY SUNPOINT ALANEO
SUEDA & ASSOCIATES, INC.

S1 - Vertical members of built up end trusses have stapled connections. Reinforce per Sketch S-1.
