CONDOMINIUM PUBLIC REPORT

Project Name(*): THE ROYAL PALM AT WAIPIO - PHASES II & III
Address: See attached page 1a
(Conversion)

Registration No. 3653 Effective date: February 27, 2001
Expiration date: March 27, 2002

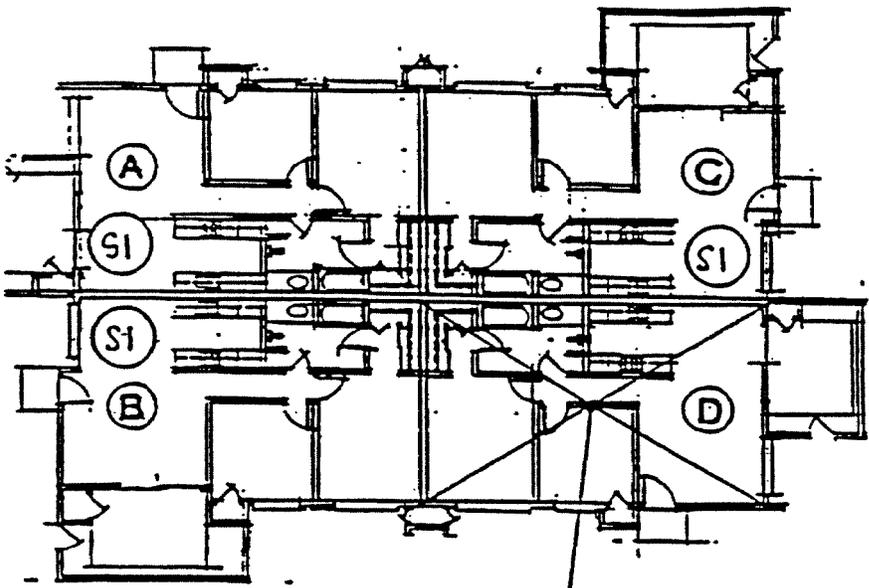
4-PLEX BUILDING # 12
GENTRY SUNPOINT ALANEO
 SUEDA & ASSOCIATES, INC.

- 4) Open Carports - A number of 4 x 14 and 4 x 10 garage beams had large splits. These horizontal cracks are probably the result of using "green" lumber. If permitted to continue, such splitting may result in excessive deflection. We recommend that these beams be reinforced with lag screws to curtail further splitting. See detail on Sketch S-3.

- S1 - Vertical members of built up end trusses have stapled connections. Reinforce per Sketch S-1.
- S2 - Carport: Splits in 4X10beams Install lag screws per Sketch S-3.

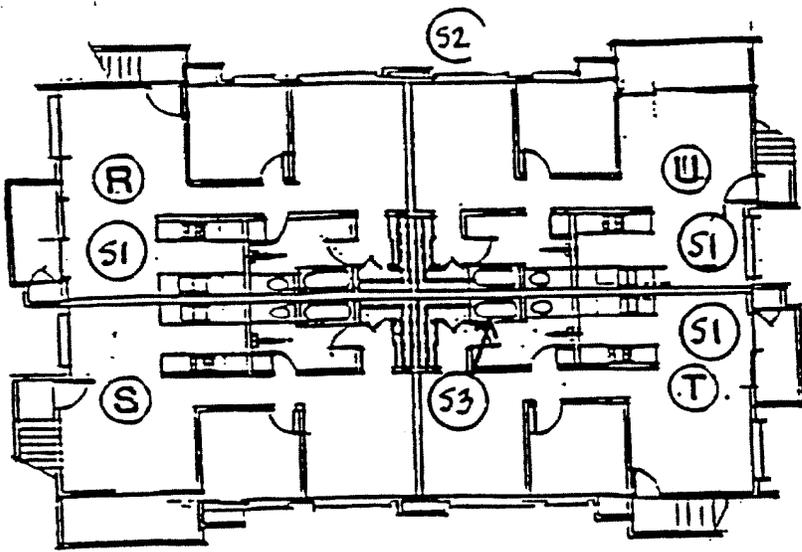
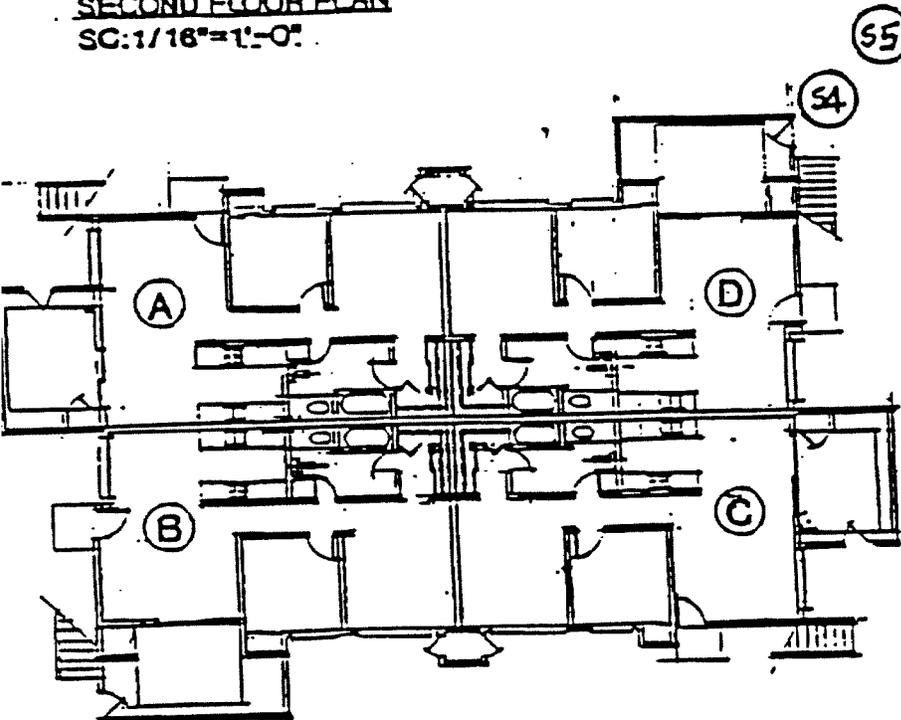
8-PLEX BUILDING # 16
GENTRY SUNPOINT ALANEO
 SUEDA & ASSOCIATES, INC.

- S1 - Vertical members of built up end trusses have stapled connections. Reinforce per Sketch S-1.
- S2 - Large birdnest observed. Remove debris from attic space and seal access openings at vents.
- S3 - Cracked 2'X2' section of gypboard at underside of rafter. Patch with 5/8" Type "X" material.
- S4 - Rusted fence post. Replace per Sketch S-4.
- S5 - Rot damaged wooden post for sign. Replace with new wood, wrapped with 30# felt and embedded in concrete (similar to Sketch S-4).
- S6 - Carport: Splits in 4X10 and 4X14 beams. Install lag screws @ 24" o.c. per Sketch S-3.

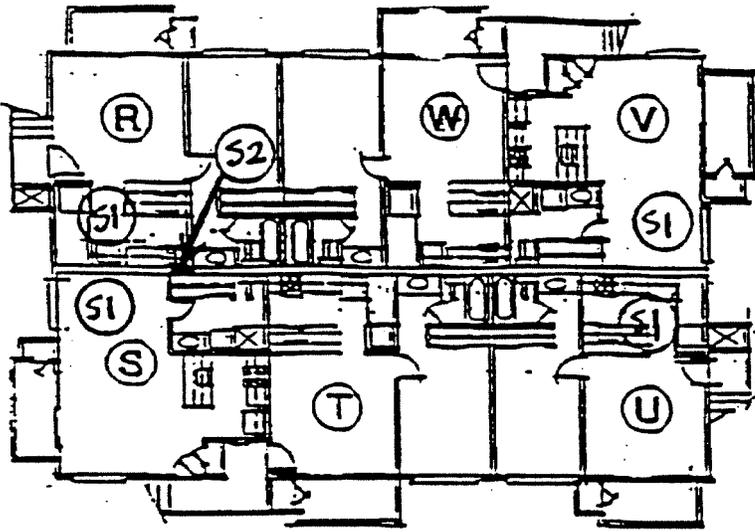
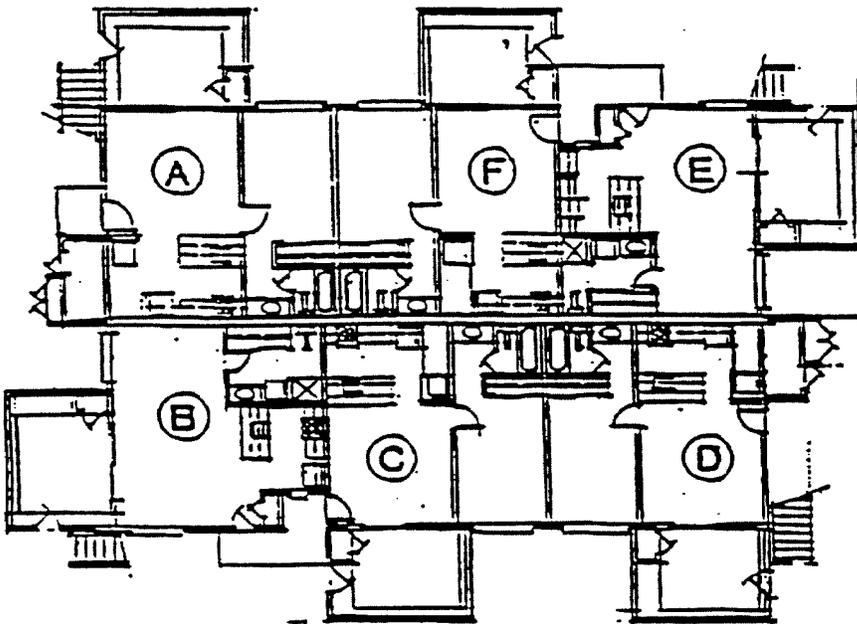
12-PLEX BUILDING # 33
GENTRY SUNPOINT ALANEO
SUEDA & ASSOCIATES, INC.

- S1 - Vertical members of built up end trusses have stapled connections. Reinforce per Sketch S-1.
- S2 - Missing 2'x4' section of gypboard at demising wall in ceiling. Probably removed by cable installer (telephone or TV). Replace with new.
- S3 - Rusted railing at exterior steps. Repair or replace as needed.

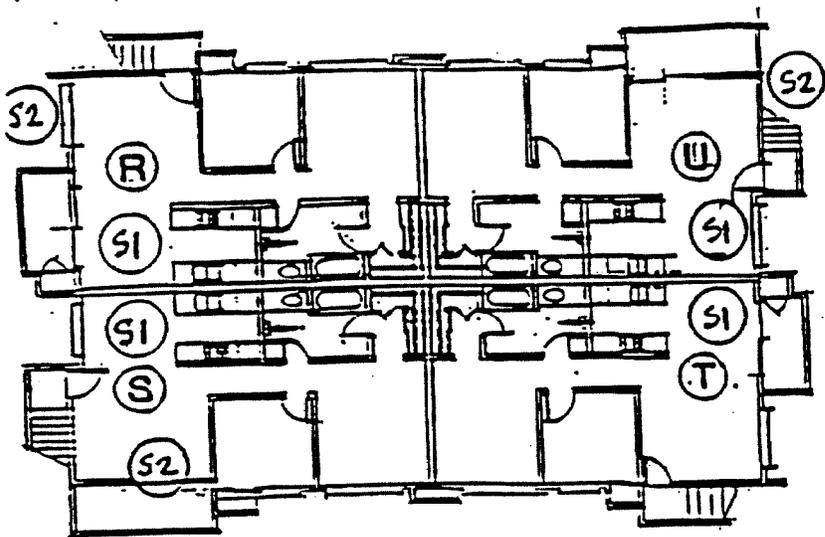
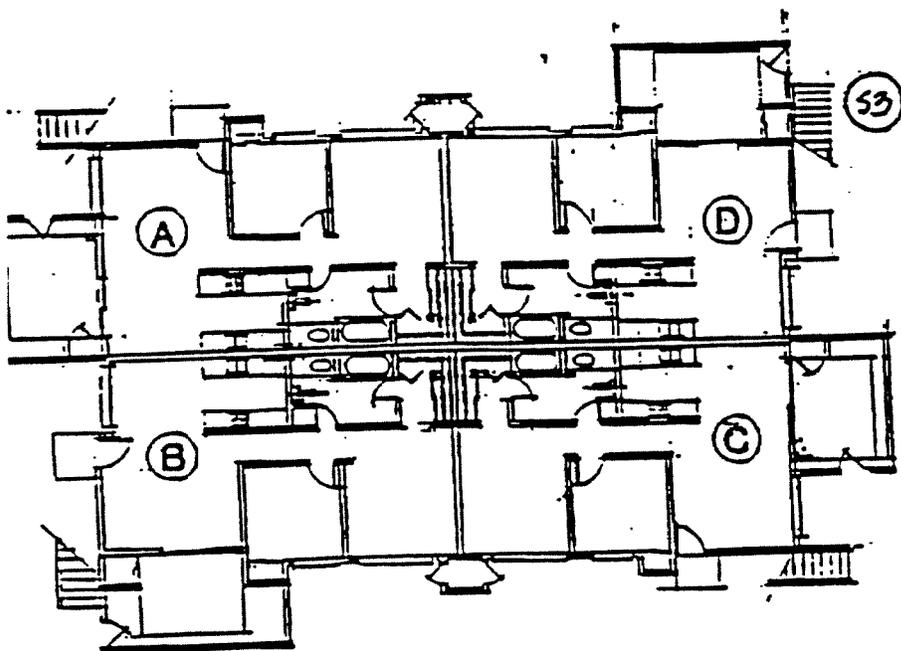
8-PLEX BUILDING # 39
GENTRY SUNPOINT ALANEO
 SUEDA & ASSOCIATES, INC.

- S1 - Vertical members of built up end trusses have stapled connections. Reinforce per Sketch S-1.
- S2 - Large birdnest observed. Remove debris from attic space and seal access openings at vents.
- S3 - Stair tread support angles rusted. Clean and repaint or replace.
- S4 - Carport: Remove birdnest accumulation and seal openings. Repair splits in 4X10 beams with lag screws per Sketch S-3.

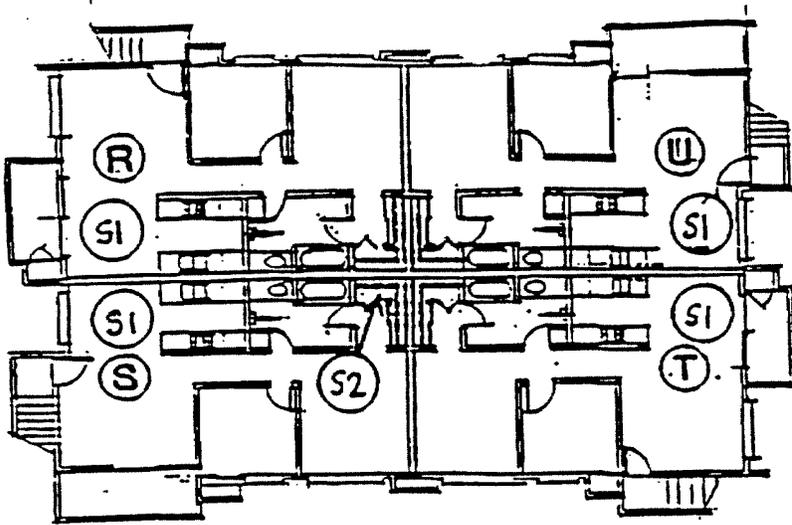
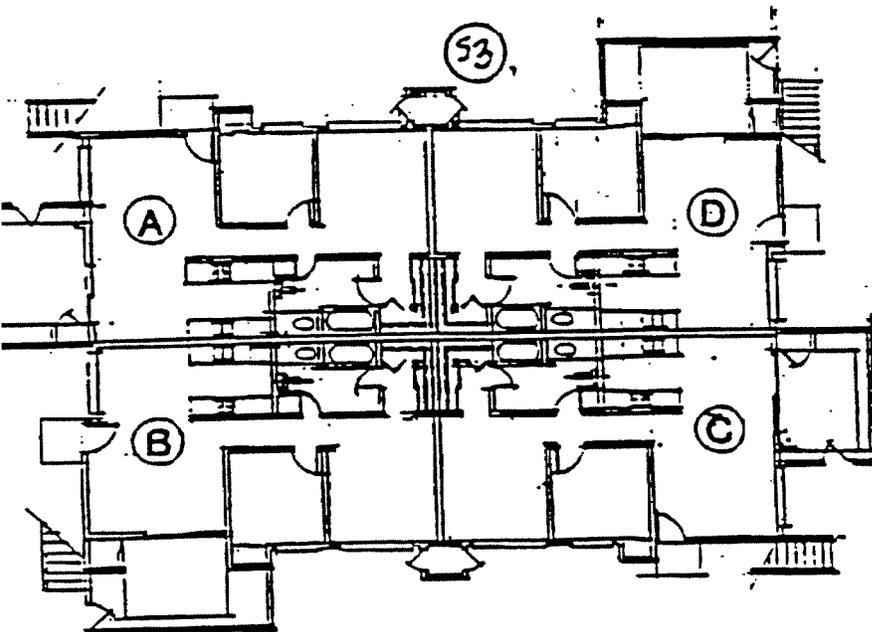
8-PLEX BUILDING # 41
GENTRY SUNPOINT ALANEQ
 SUEDA & ASSOCIATES, INC.

- S1 - Vertical members of built up end trusses have stapled connections. Reinforce per Sketch S-1.
- S2 - Access panel cracked at scuttle. Replace with new.
- S3 - Large birdnest in heater storage room. Remove debris and seal off access.
- S4 - Carport: Splits in 4X10 beams. Install lag screws per Sketch S-3.

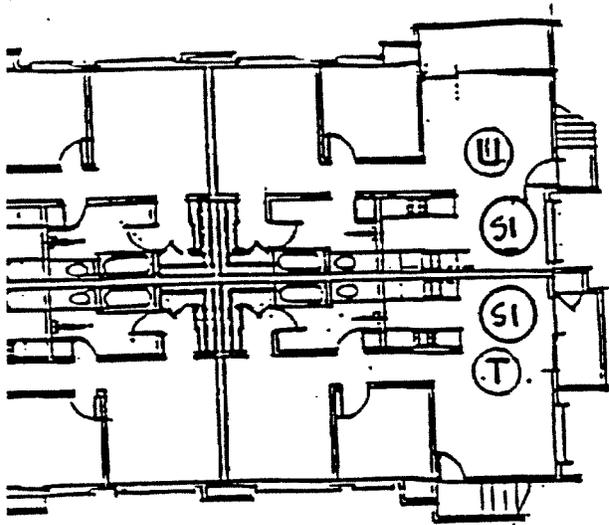
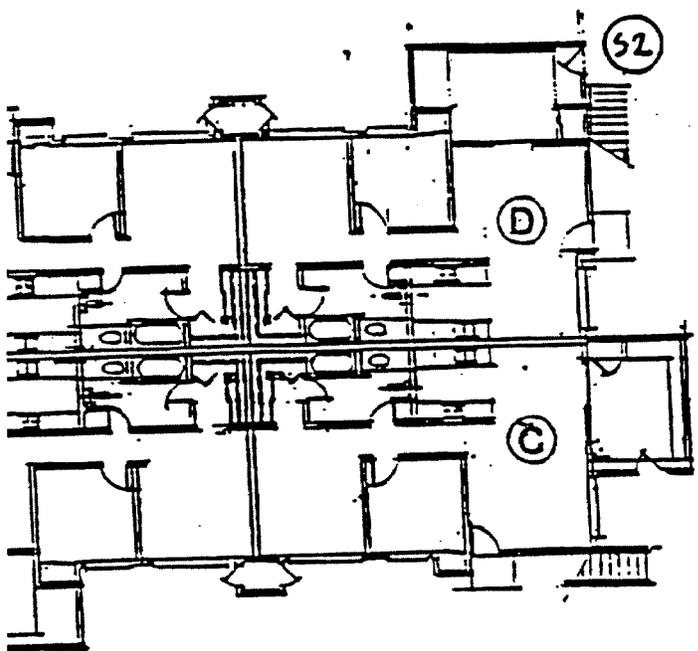
EX BUILDING # 45
RY SUNPOINT ALANEO
& ASSOCIATES, INC.

- S1 - Vertical members of built up end trusses have stapled connections. Reinforce per Sketch S-1.
- S2 - Minor rot damage at bottom of stair stringers. Treat with mildewcide and clear away soil accumulation around wood.
- S3 - Carport: Splits in 4X10 beams. Install lag screws @ 24" o.c. per Sketch S-3.

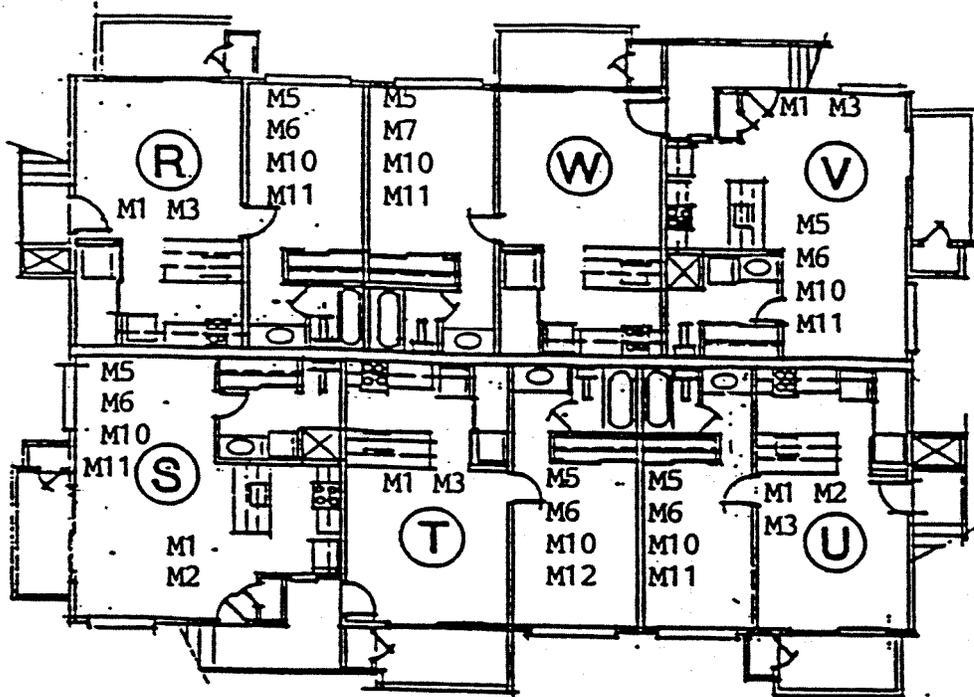
SECOND FLOOR PLAN
 SC: 1/16" = 1'-0"

Note: Straighten flex duct for exhaust fan in Unit "U".

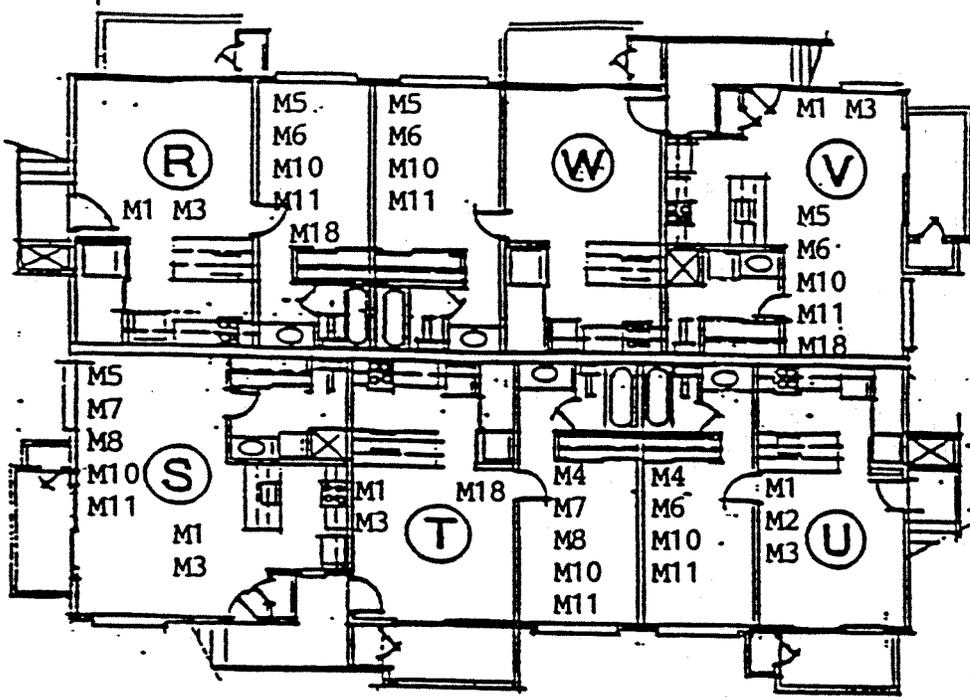
SECOND FLOOR PLAN
 SC: 1/16" = 1'-0"

Note: For Unit "R" flex duct in attic space is too long. Shorten flex duct.

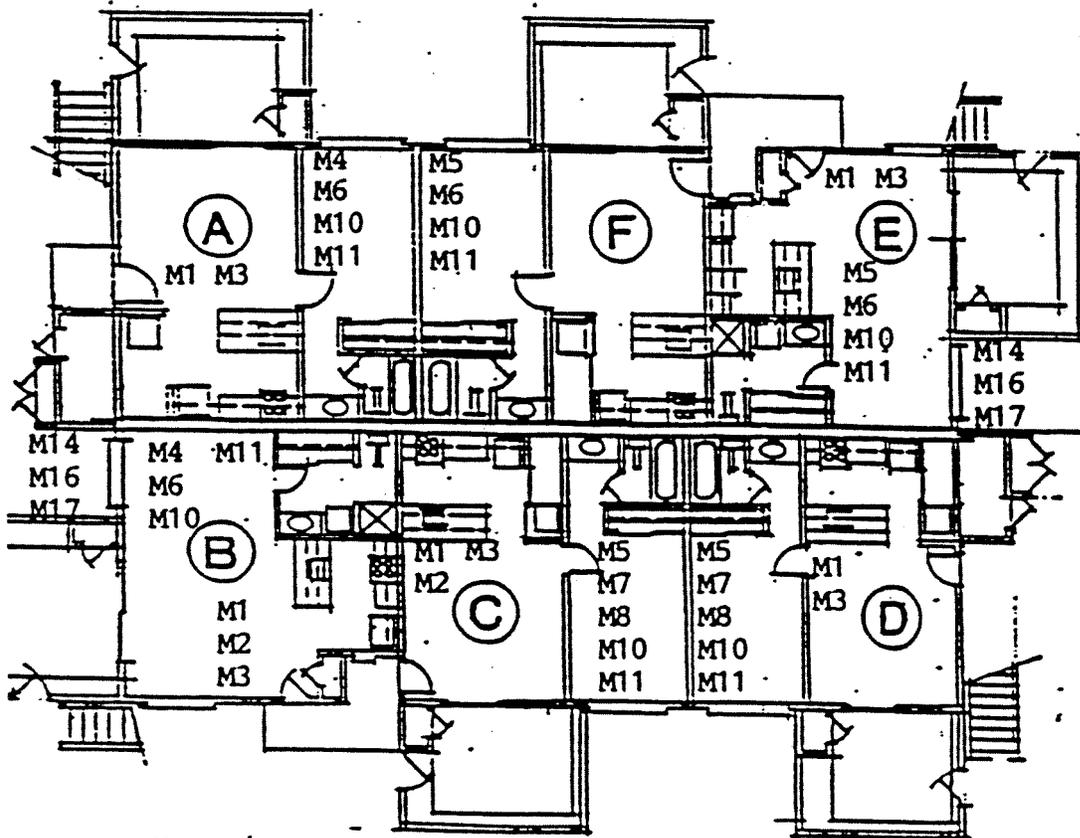
FIRST FLOOR PLAN
 SC: 1/16" = 1'-0"

M17 - Cleanout pressure reducer water valve box. Valve box filled with dirt.

M18 - Check and replace bath exhaust. Fan does not run or rattles or slow to start.

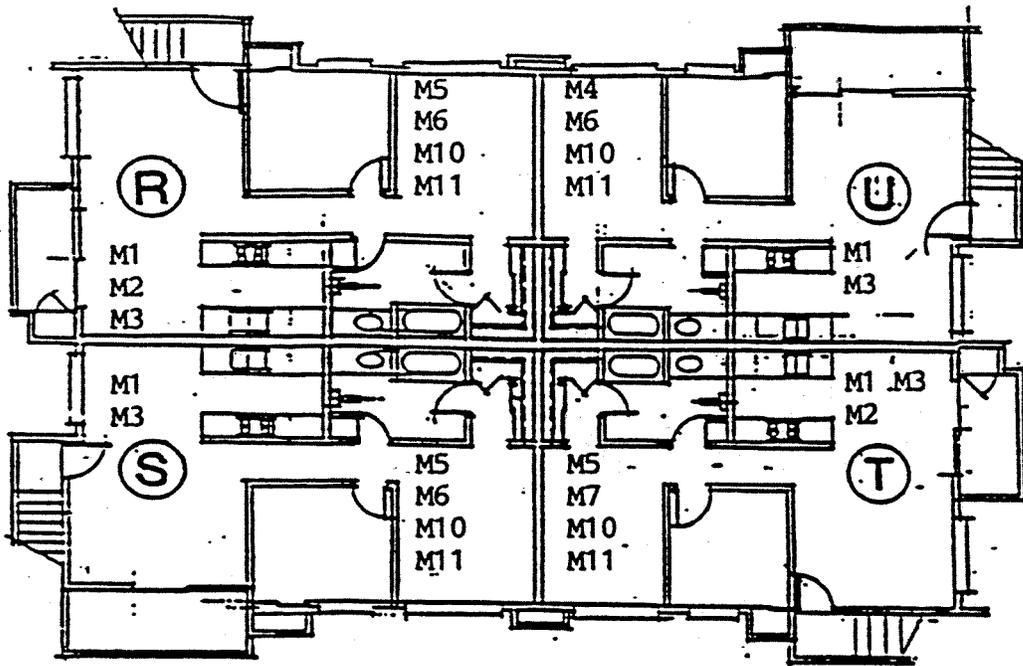
SECOND FLOOR PLAN
 SC: 1/16" = 1'-0"

M1 - Replace faucet. Faucet chrome pitted and corroded. Clean and polish kitchen sink.

M2 - Replace garbage disposal. Unit vibrates or grinding noise.

M3 - Clean kitchen hood and wash filter. Hood generally in good condition.

M4 - Replace water closet if necessary. Toilet badly stained. Clean water closet.

M5 - Clean water closet and change seat. Water closet only slightly stained.

M6 - Replace lavatory and faucet if cannot be cleaned. Lavatory badly stained and faucet corroded.

M7 - Clean and polish lavatory and faucet. Lavatory in good condition.

M12 - Replace shower valve assembly. Shower valve assembly corroded.

M13 - Replace missing shower head.

M16 - Cleanout Heater Rooms.

M17 - Cleanout pressure reducing water valve box. Valve box filled with dirt.

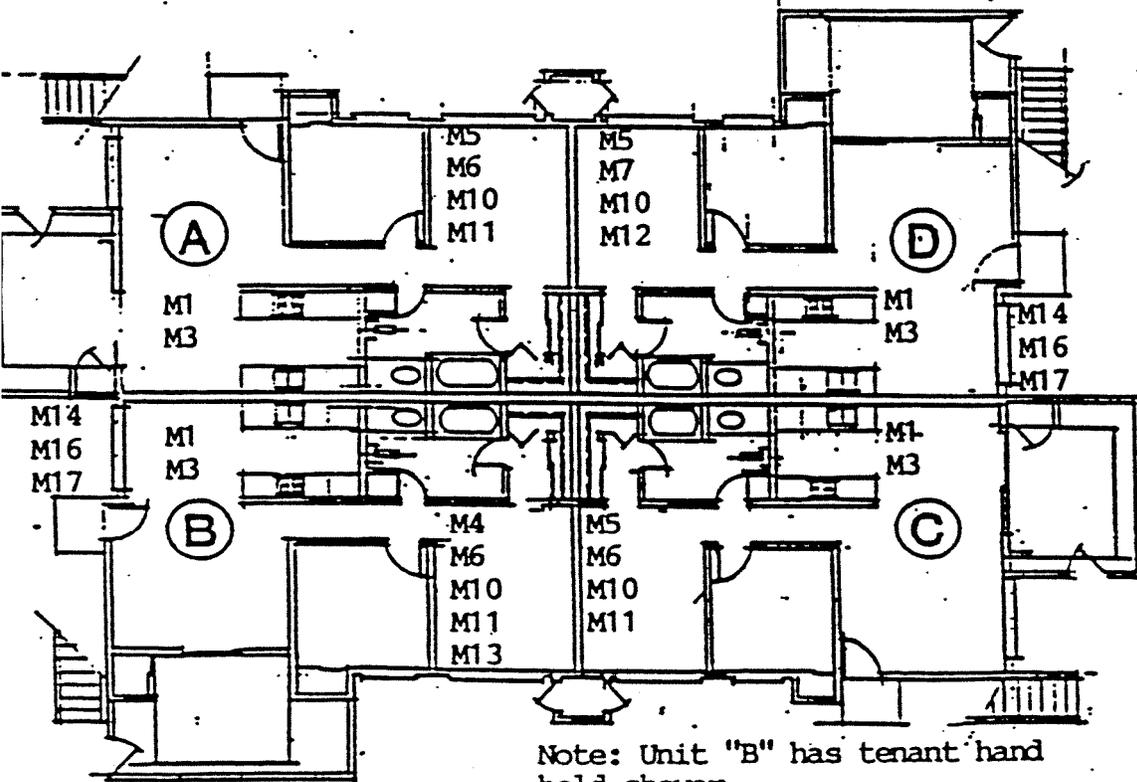
FIRST FLOOR PLAN
 SC: 1/16" = 1'-0"

Note: Unit "B" has tenant hand held shower.

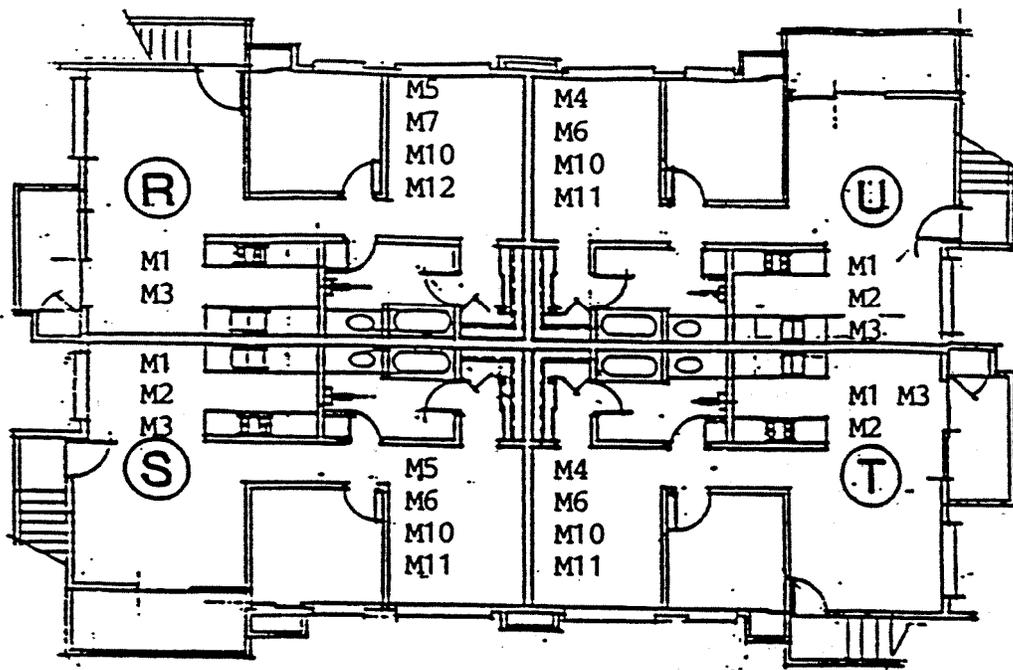
SECOND FLOOR PLAN

M1 - Replace faucet. Faucet chrome pitted and corroded. Clean and polish kitchen sink.

M2 - Replace garbage disposal. Unit vibrates or grinding noise.

M3 - Clean kitchen hood and wash filter. Hood generally in good condition.

M4 - Replace water closet if necessary. Toilet badly stained. Clean water closet.

M5 - Clean water closet and change seat. Water closet only slightly stained.

M6 - Replace lavatory and faucet if cannot be cleaned. Lavatory badly stained and faucet corroded.

M7 - Clean and polish lavatory and faucet. Lavatory in good condition.

M8 - Replace lavatory faucet. Faucet corroded.

M12 - Replace shower valve assembly. Shower valve assembly corroded.

M15 - Attach heater flue to heater. Loose flue.

M18 - Check and replace bath exhaust. Fan does not run or rattle or slow to start.

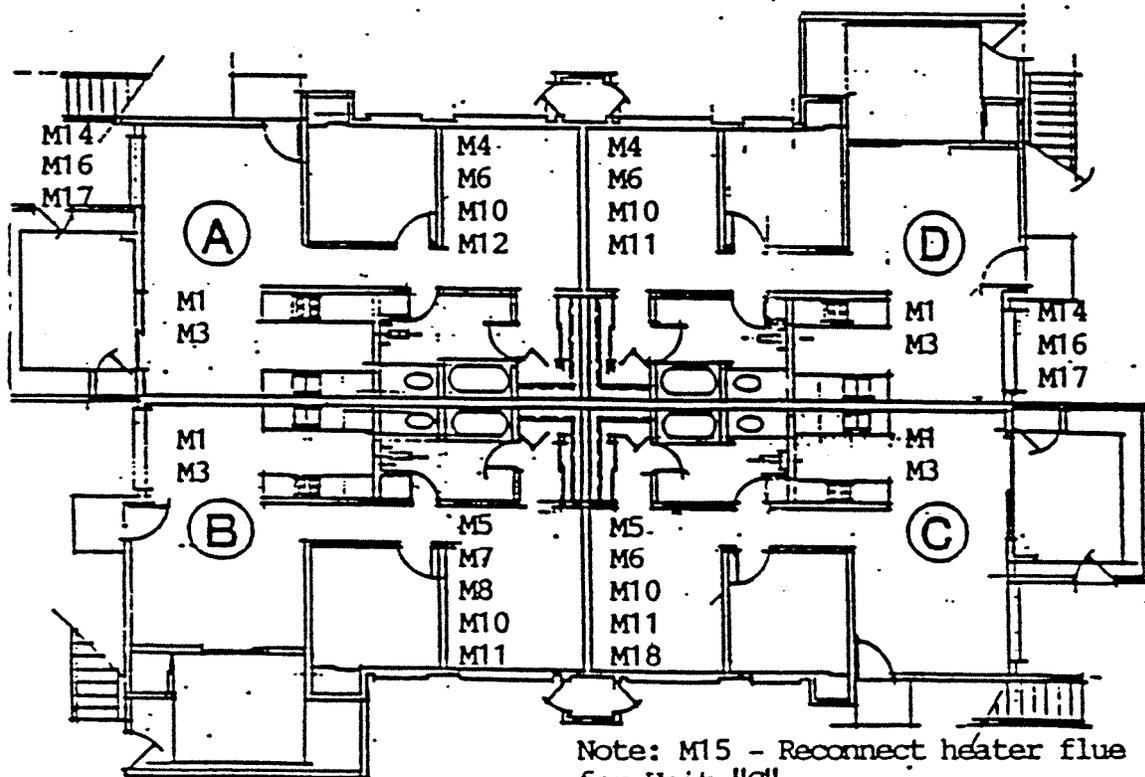
FIRST FLOOR PLAN

Note: M15 - Reconnect heater flue for Unit "C".

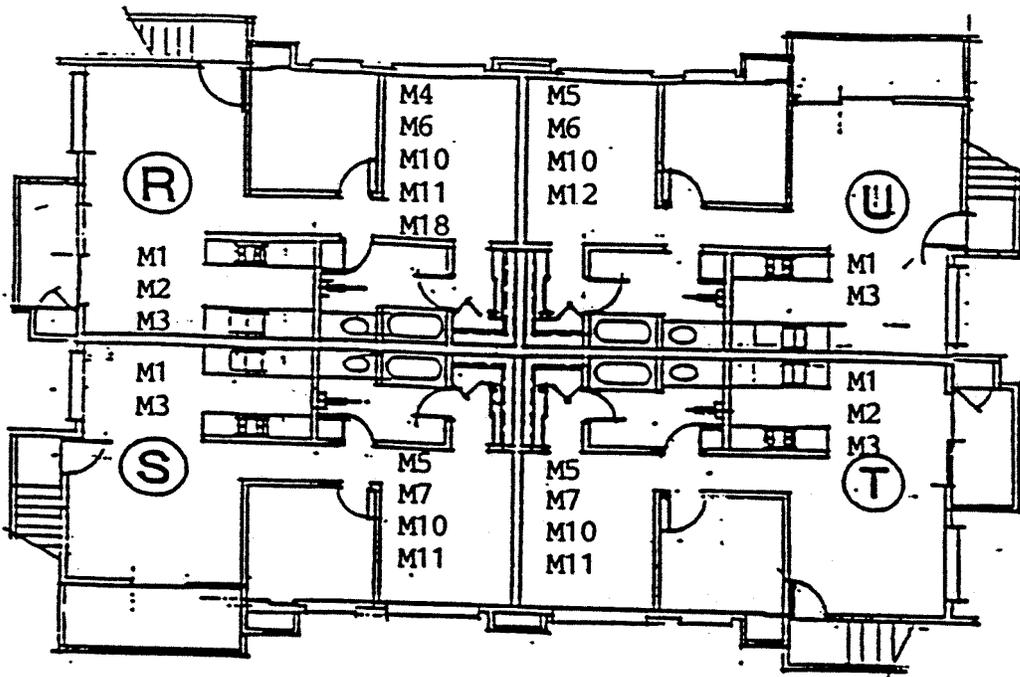
SECOND FLOOR PLAN
 SC: 1/16" = 1'-0"

M1 - Replace faucet. Faucet chrome pitted and corroded. Clean and polish kitchen sink.

M2 - Replace garbage disposal. Unit vibrates or grinding noise.

M3 - Clean kitchen hood and wash filter. Hood generally in good condition.

M4 - Replace water closet if necessary. Toilet badly stained. Clean water closet.

M5 - Clean water closet and change seat. Water closet only slightly stained.

M6 - Replace lavatory and faucet if cannot be cleaned. Lavatory badly stained and faucet corroded.

M7 - Clean and polish lavatory and faucet. Lavatory in good condition.

M12 - Replace shower valve assembly. Shower valve assembly corroded.

M17 - Cleanout pressure reducer water valve box. Valve box filled with dirt.

M18 - Check and replace bath exhaust. Fan does not run or rattles or slow to start.

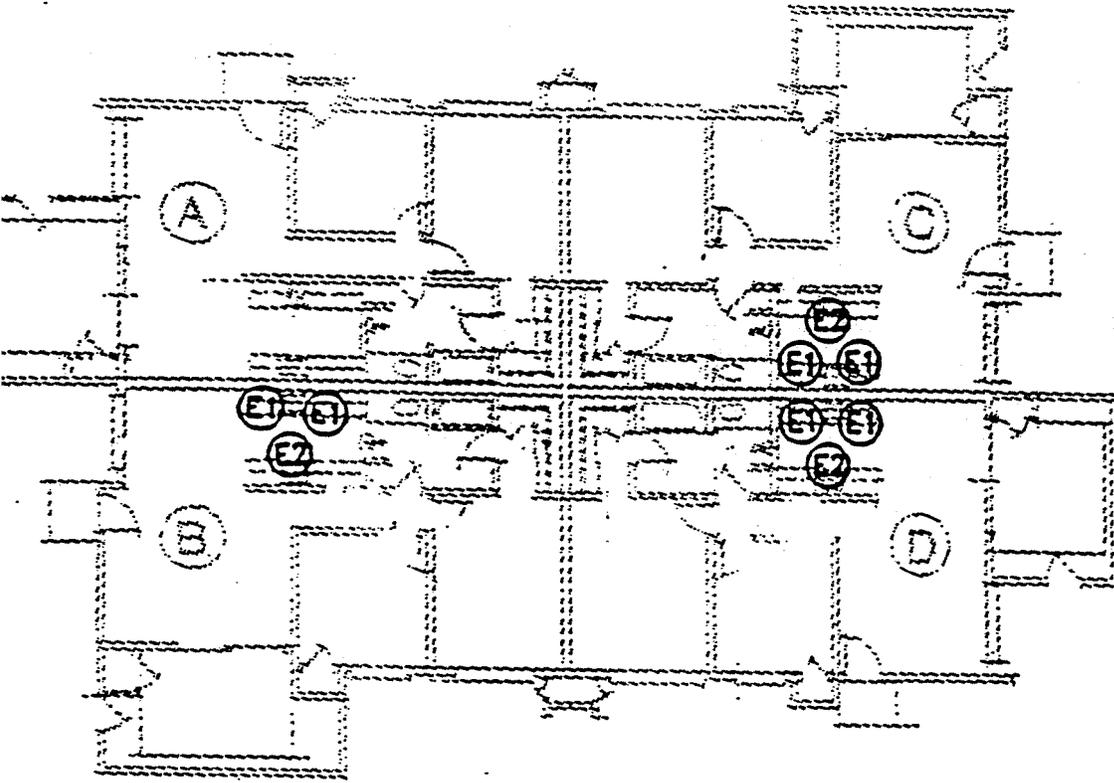
FIRST FLOOR PLAN
SC: 1/16" = 1'-0"

E-1 Replace duplex receptacle with new GFI type.

E-2 Replace polycarbonate diffusers (two 2 X 4) with new acrylic prismatic diffusers.

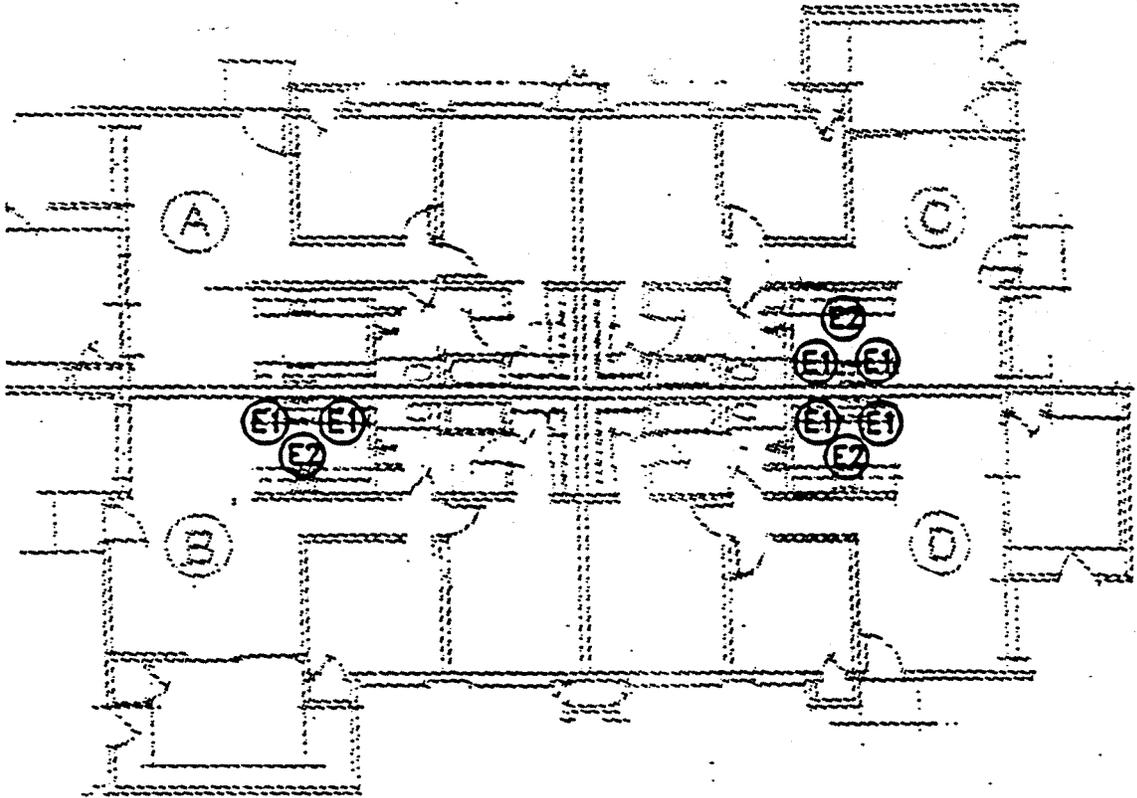
FIRST FLOOR PLAN
SC: 1/16" = 1'-0"

E-1 Replace duplex receptacle with new GFI type.

E-2 Replace polycarbonate diffusers (two 2 X 4) with new acrylic prismatic diffusers.

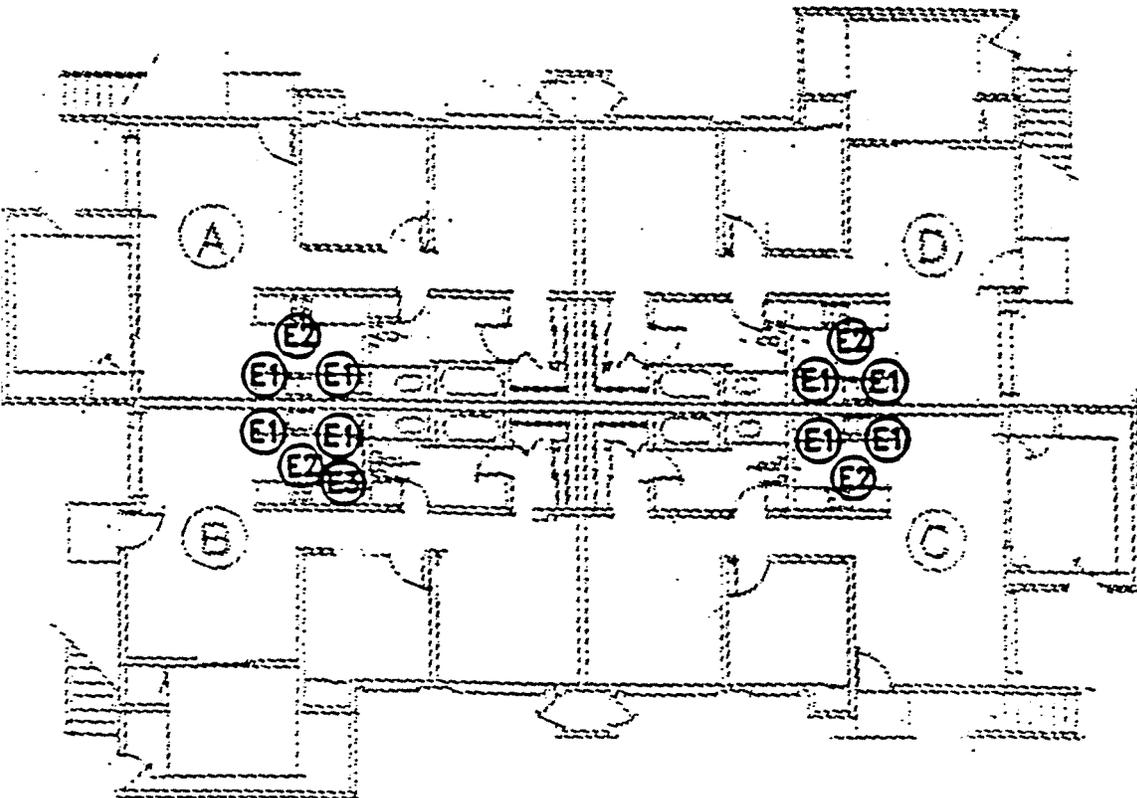
FIRST FLOOR PLAN
 SC: 1/16" = 1'-0"

- E-1 Replace duplex receptacle with new GFI type.
- E-2 Replace polycarbonate diffusers (two 2 X 4) with new acrylic prismatic diffusers.
- E-3 Provide blanking cover for missing breakers (2).

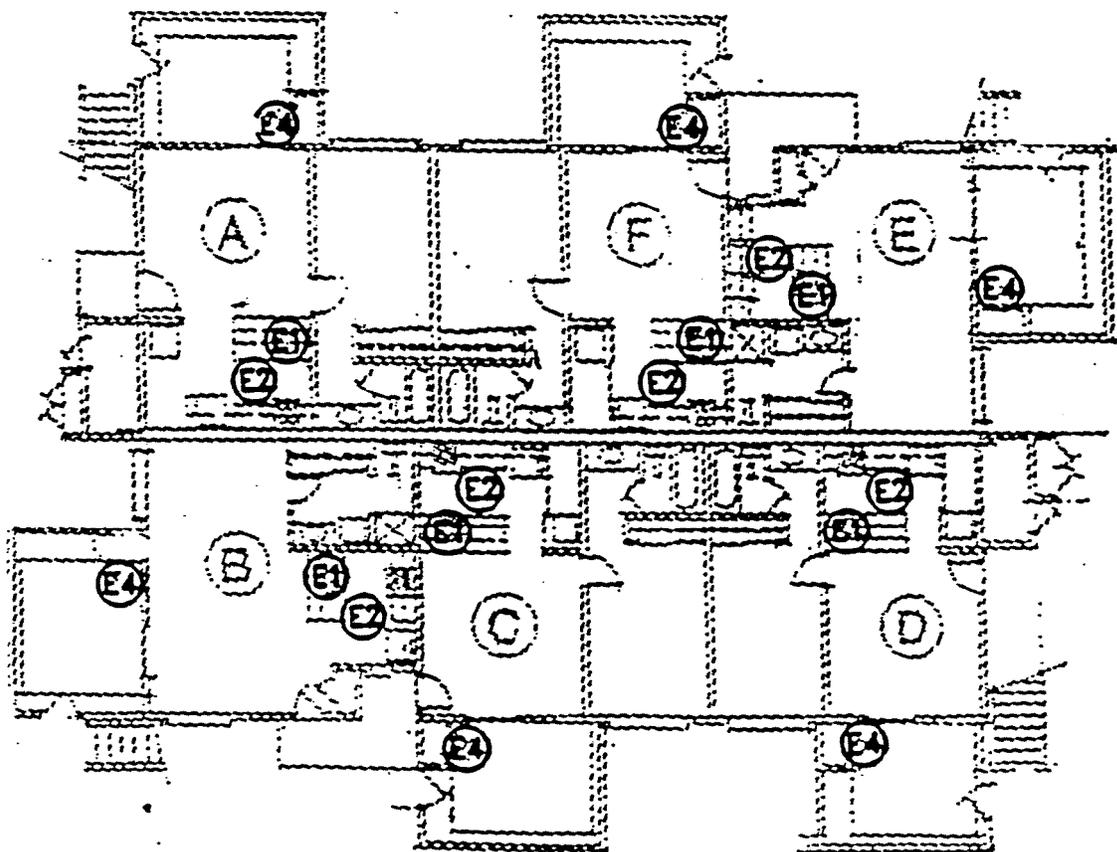
FIRST FLOOR PLAN
 SC: 1/16" = 1'-0"

- E-1 Replace duplex receptac with new GFI type.
- E-2 Replace polycarbonate diffusers (two 2 X 4) with new acrylic prisma diffusers.
- E-4 Provide new duplex, weatherproof GFI type receptacle at Lanai, if required.

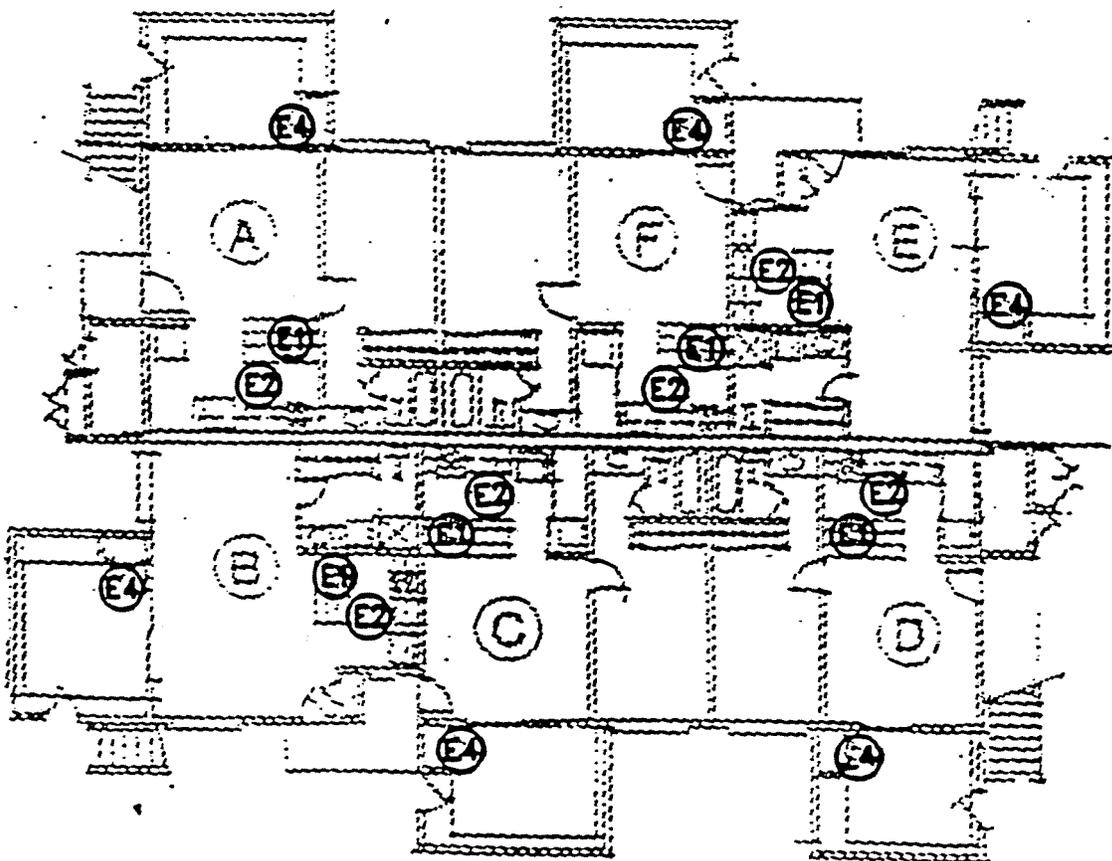
FIRST FLOOR PLAN
 SC: 1/16" = 1'-0"

- E-1 Replace duplex recepta with new GFI type.
- E-2 Replace polycarbonate diffusers (two 2 X 4) with new acrylic prism diffusers.
- E-4 Provide new duplex, weatherproof GFI type receptacle at Lanai, 1 required.
- E-5 Resupport existing wall mounted luminaire.

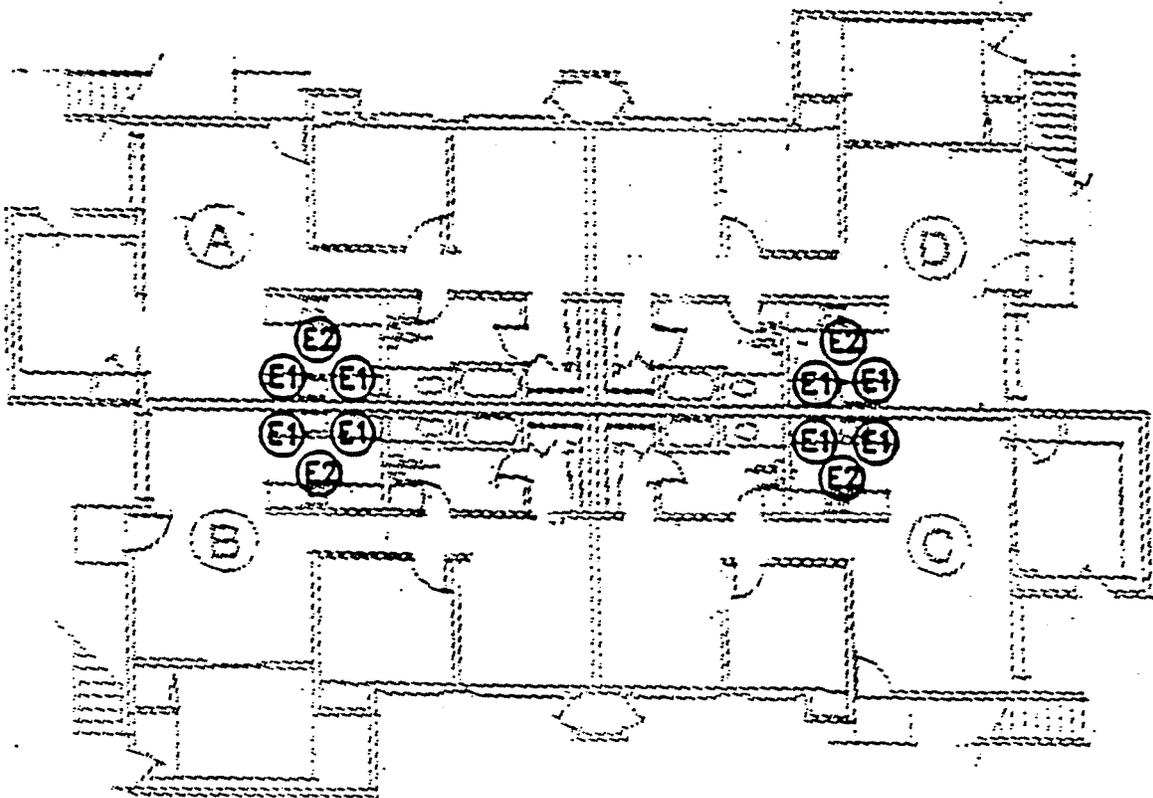
FIRST FLOOR PLAN
 SC: 1/16" = 1'-0"

- E-1 Replace duplex receptacle with new GFI type.
- E-2 Replace polycarbonate diffusers (two 2 X 4) with new acrylic prismatic diffusers.
- E-6 Replace ceiling fan.

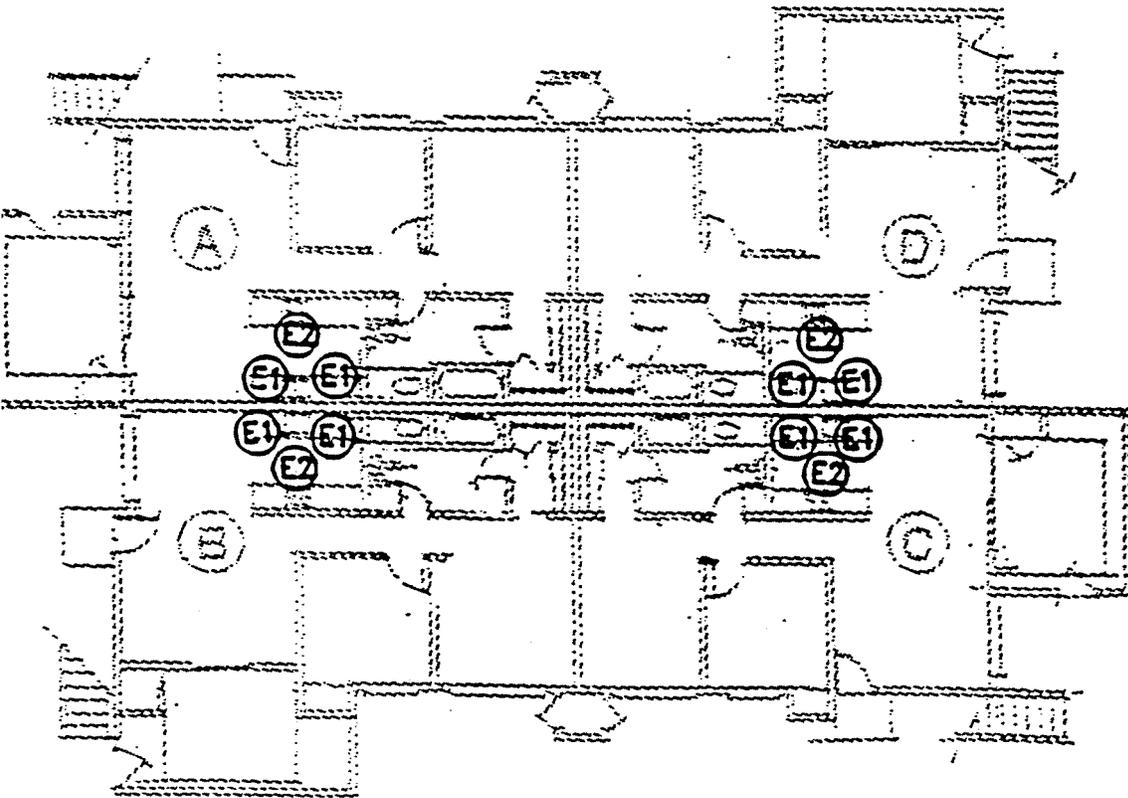
FIRST FLOOR PLAN
 SC: 1/16" = 1'-0"

- E-1 Replace duplex receptacle with new GFI type.
- E-2 Replace polycarbonate diffusers (two 2 X 4) with new acrylic prismatic diffusers.

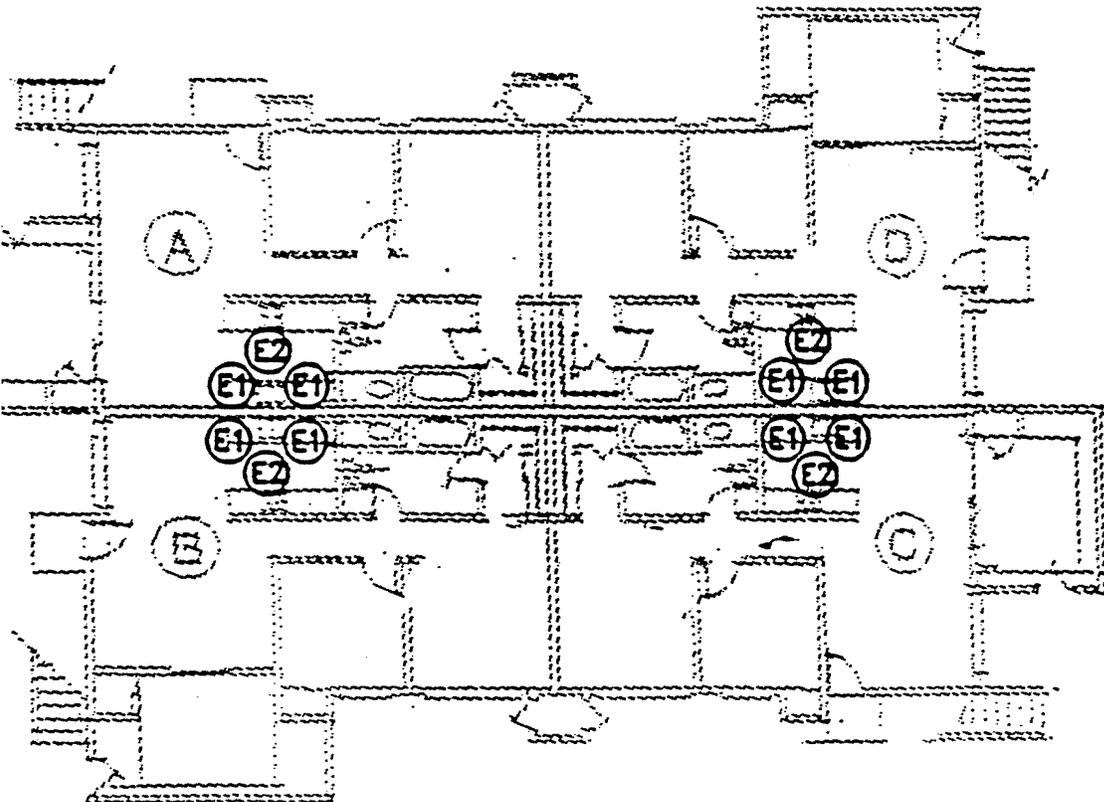
FIRST FLOOR PLAN
 SC: 1/16" = 1'-0"

E-2 Replace polycarbonate diffusers (two 2 X 4) with new acrylic prismatic diffusers.
