Subject: Docket No. 2006-0431  
Investigation of October 15-16 2006 Outage  
Information Request Responses

Hawaiian Electric Company, Inc. ("Hawaiian Electric") respectfully submits nine copies of its responses and objections to the information requests submitted by the Division of Consumer Advocacy on February 1, 2007 in the subject proceeding.<sup>1</sup>

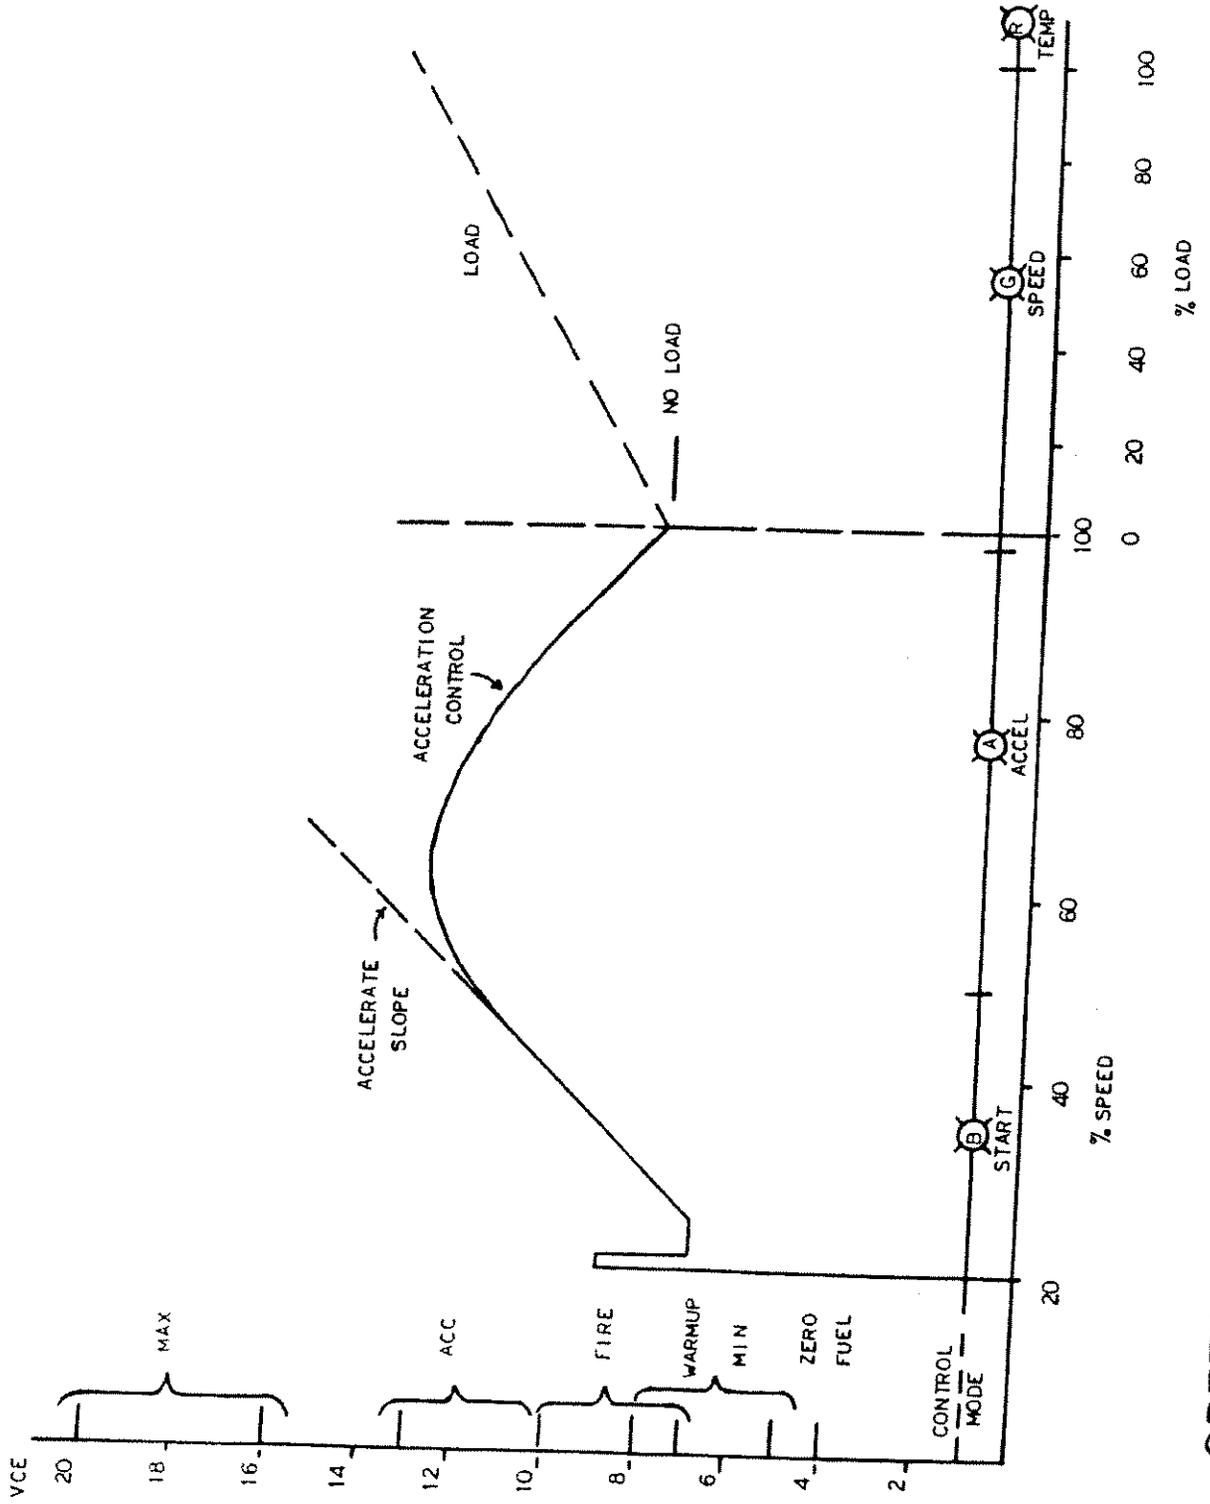
start), turbine acceleration rate, turbine exhaust temperature, and unit efficiency.

Acceleration rate and exhaust temperature are operational constraints to minimize stress to the machine during startup. Please see response to CA-IR-17.

VCE vs SPEED - I\_LOAD
