CONDOMINIUM PUBLIC REPORT

Project Name(*): KUHIO COURTE
Address: 2170 Kuhio Avenue, Honolulu, HI 96815

Registration No. 3436 (Conversion)

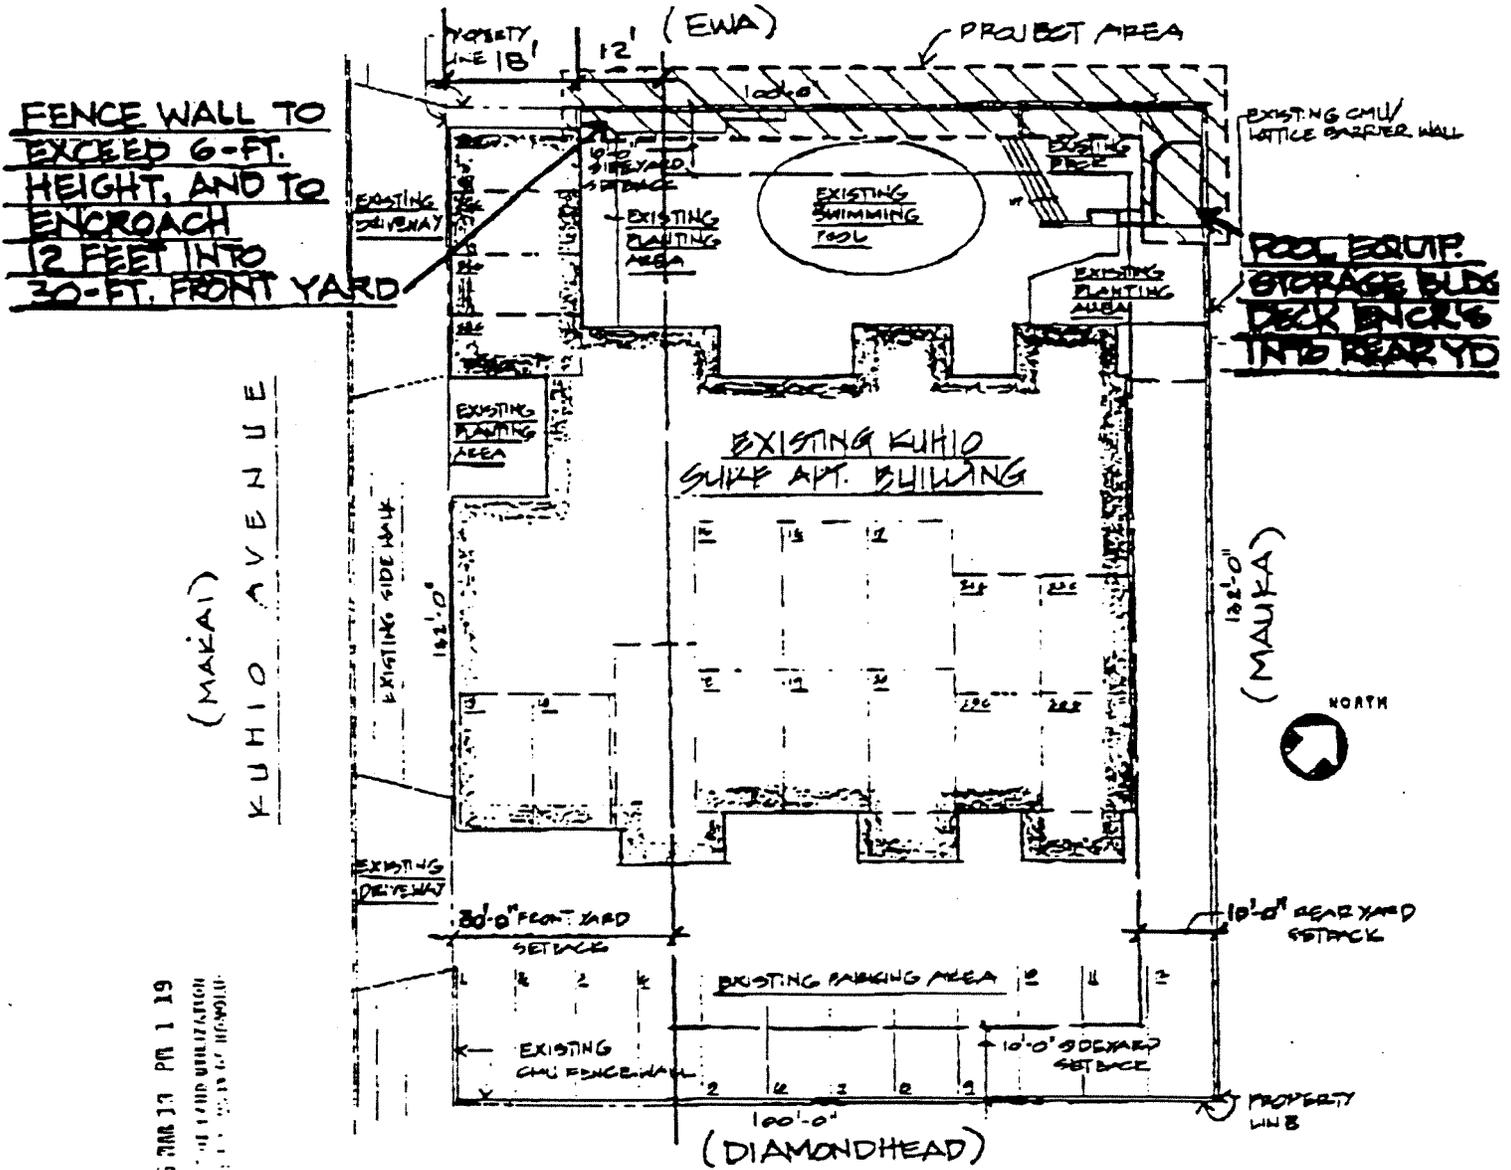
SITE PLAN

FENCE WALL TO EXCEED 6-FT. HEIGHT, AND TO ENCRCH 12 FEET INTO 30-FT. FRONT YARD

POOL EQUIP. STORAGE BLDG. DECK ENCRS INTO REARYD

- 6. Public Hearing Testimony: The agent spoke in support of the request. He said the fence wall is "decorative", and it is not visible from Kuhio Avenue. He said it was built about one year ago, without a building permit. He stated that the 2-story apartment building along the ewa side is about 5 feet from the property line, and the fence provides visual buffering for pool users on the site. He said the fence would protect the pool from "objects" thrown from the apartment building over the property line (although that has never happened). He noted that the 2 adjoining lots (diamondhead and mauka, Parcels 56 and 53) are also owned by the applicant. In regard to the deck encroachment, the agent said it serves as a storage area and covers the swimming pool equipment. No other testimony was given.

There are, however, mitigating circumstances which support the enclosure of the pool equipment/storage area. The enclosure increases density by only a minimal amount. If the pool equipment were unenclosed, it could pose a potential safety hazard to guests. Under the circumstances, a variance is a reasonable solution.

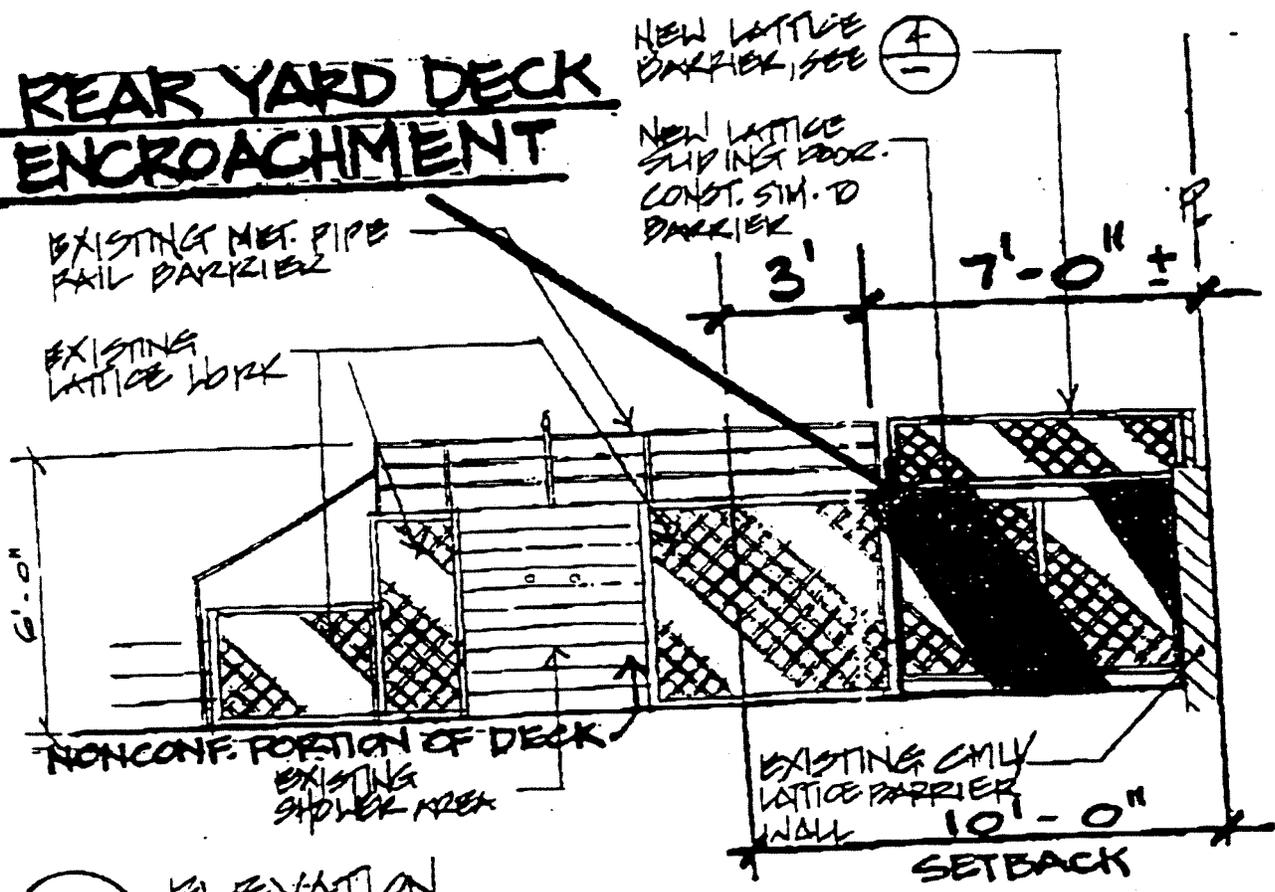
B ELEVATION
SCALE: 1/4" = 1'-0"

REAR YARD DECK ENCROACHMENT
