**DEVELOPER'S PUBLIC REPORT  
FOR A CONDOMINIUM**

CONDOMINIUM PROJECT NAME	PACIFICANA ATLAS
Project Address	1125 Young St., Honolulu, HI 96814 and 1150 South King St., Honolulu, HI 96814
Registration Number	6300 ( <b>conversion</b> )
Effective Date of Report	<b>June 6, 2007</b>
Developer (s)	HIDC PACIFICANA LLC, a Hawaii limited liability company

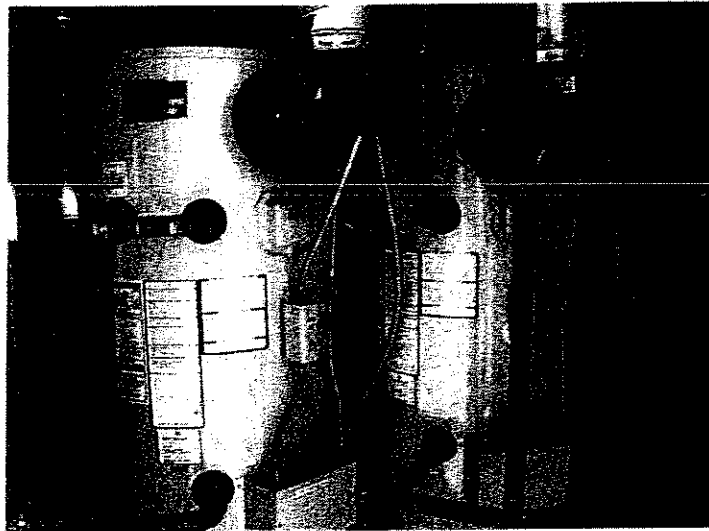
The hot water heaters are located on the roof and the heaters are in good condition. These heaters replaced the original equipment. The heaters are Bock 66W-625SD and are rated at 625,000 BTUH, 606 GPH and 65 gallons storage capacity.

Hot Water Heaters

The heaters are larger than 199,000 BTUH, therefore are considered boilers. The use of the heaters requires a State Boiler Permit.

This component involves the replacement of two gas-fired, 65 gallon, 625,000 BTU water heaters located on the building roof. The system also includes a circulating pump and 1 hp booster pump. The existing heaters were replaced in 2002 and are in good condition. The cost for the heaters include an allowance for a lifting system to remove the old heaters and bring up the new ones.

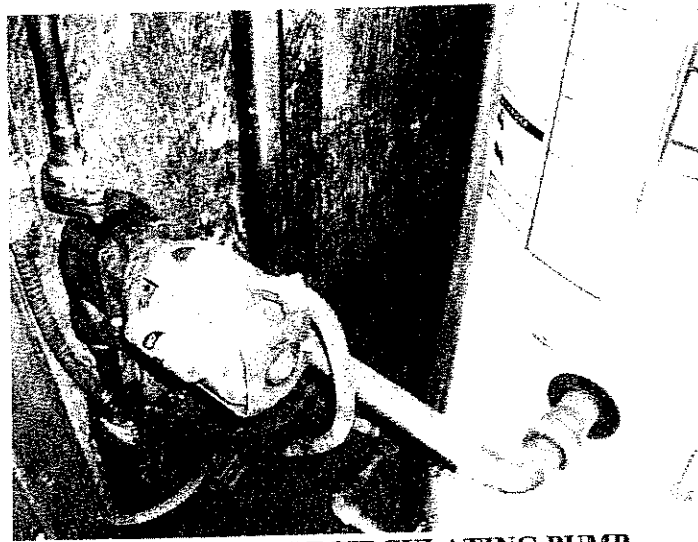
The hot water is recirculated to the heaters on the roof. The recirculating pump is in good condition.

**HOT WATER RECIRCULATING PUMP**

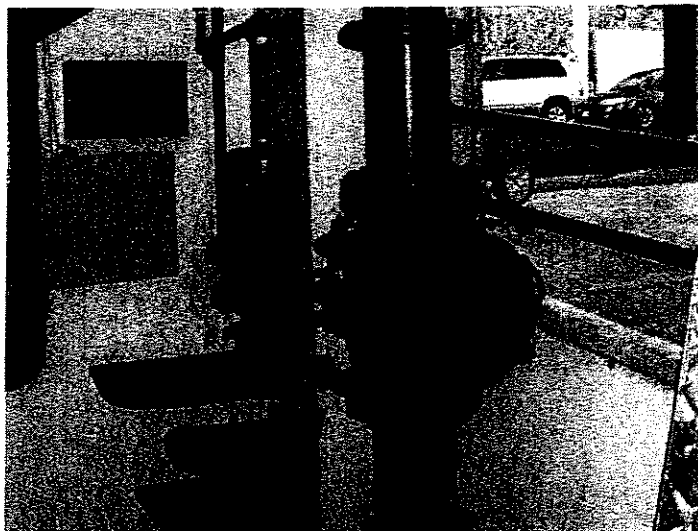
The fire sprinkler riser is located in the first level parking at the Northeast corner of the building and is in good condition although it has the original alarm valve assembly. There are no tamper switches on the assembly. The fire sprinkler system is shared with the Atlas Building. There is a post indicator valve facing Young Street and is corroded at the base.

**FIRE ALARM VALVE ASSEMBLY**

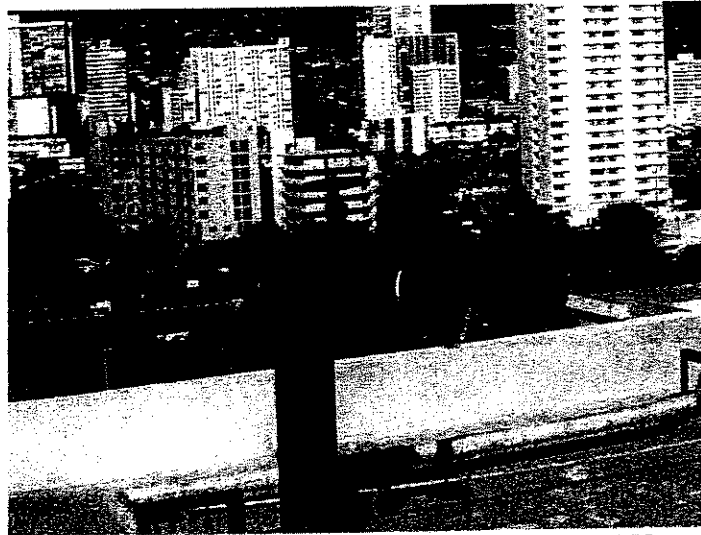
The roof fire department connection on the roof is in good condition.

**ROOF FIRE DEPARTMENT CONNECTION**

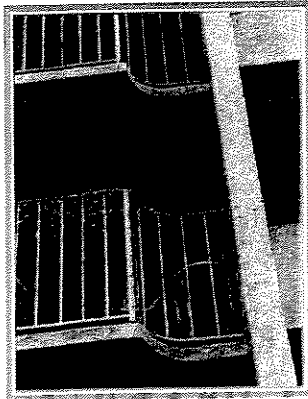
1. Many instances of concrete spall were observed on the exterior face of the building in particular at the edges of the apartment lanai's (see photos 6 & 7).

Photos 6 & 7: Showing concrete spall at apartment lanai edge.

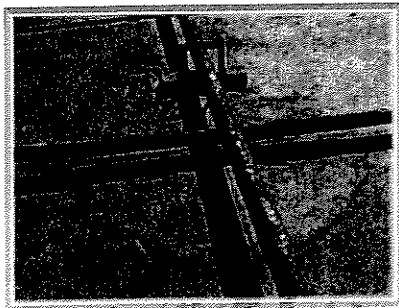
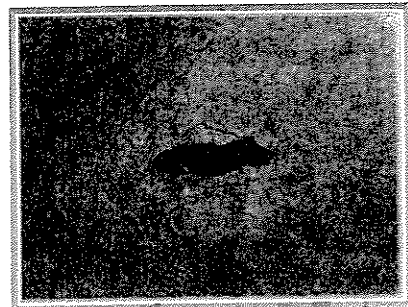
1. It was reported by the building manager that water had at one time leaked from the roof into unit #1003
2. Alligator cracking pattern was observed in the roofing membrane (see photo 13)
3. In some areas roof membrane was damaged (see photo 14)

Photos 13 & 14: Showing roof damage

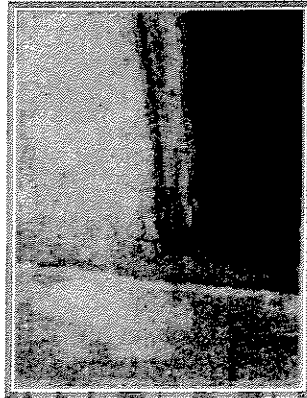
1. No damage was observed at the pool deck.
2. Some damage was observed in the bottom left corner of the jamb of the door leading to the pool area (see photo 15)

**Photos 15:** *Showing damage to the jamb of the door leading to the pool area.*

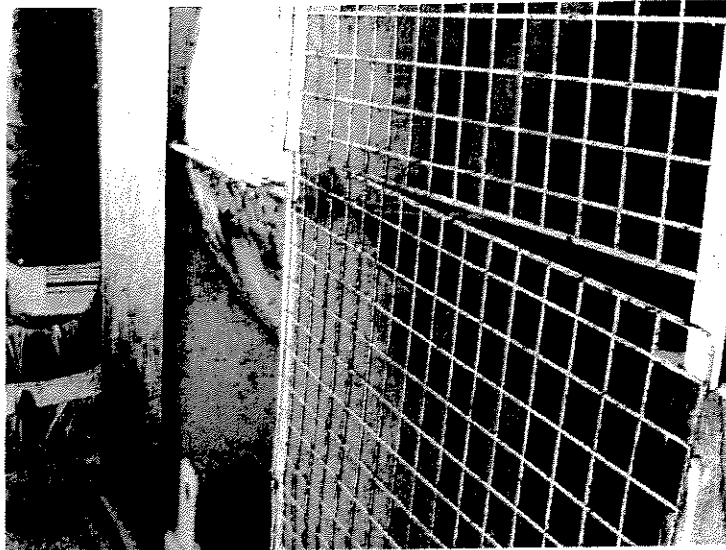
The cooling tower is in poor condition with corroded casing, basin fan wheels and squirrel cage. The cooling tower is a forced draft type with centrifugal fans.

Cooling Tower Fan in Poor Condition

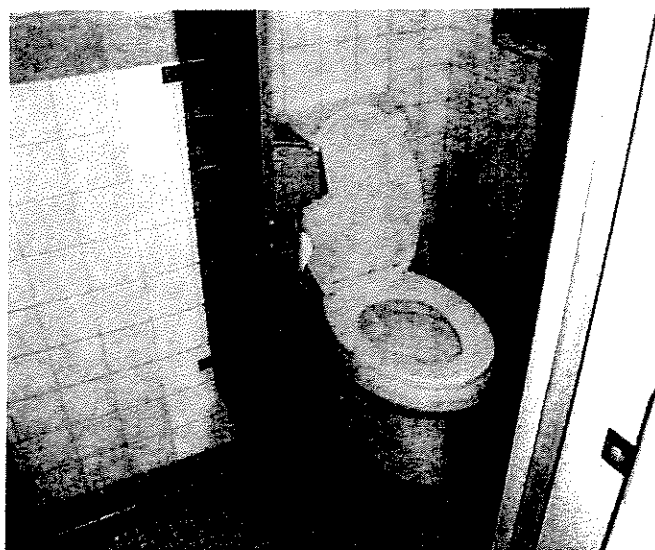
**Public Restrooms:** The water closets are tank type and in fair condition. The lavatories are countertop type and in fair condition. The urinal in the Men's room is in fair condition. The fixtures do not meet ADA requirements.

Tank Type Toilet

**Plumbing Fixture Recommendations:** The plumbing fixtures do not meet ADA requirements. Therefore in the ADA guest rooms the fixtures need to be replaced with new fixtures meeting ADA and low flow requirements. The water closets are in fair condition. Toilets should be cleaned and polished and the toilet seats replaced with new. The supply valve and supply risers need to
