#8: Fall from Roof

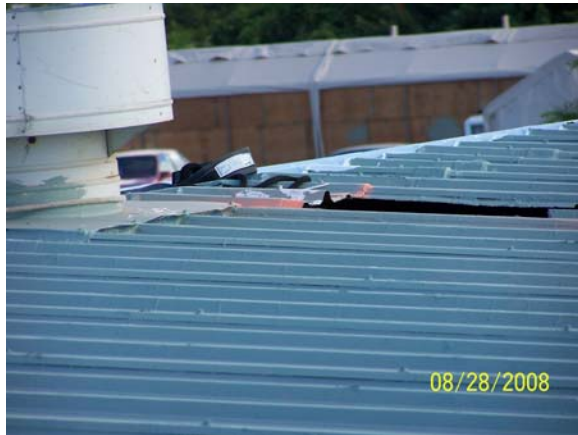
In mid-2008, a twenty-five year old roof worker was severely injured when he fell 24' through a fiberglass skylight and landed on the concrete floor below. The laborer was applying a coat of roofing material with a roller pole when he fell through the skylight. As a result of the fall, the victim broke his right elbow and his pelvis on the right and left sides.

The victim stated that he had never received fall protection training prior to the accident; the company does not have records of employees receiving fall protection training when working at heights above 6 feet. On the day of the accident, none of the workers on the roof were using a fall protection system. One of the workers had previously used a body belt in place of a full-body harness while working on the roof. The skylights were known to be a hazard, but no measures were taken to prevent tripping in or stepping into a skylight.

1. Train employees in fall protection before they are allowed to work at levels above 6 feet in height.
2. Develop Standard Operating Procedures and/or conduct a Job Hazard Analysis prior to performing work tasks.
3. Ensure that all employees use appropriate fall protection systems when working at heights above 6 feet.
4. Management should conduct routine audits periodically to ensure job safety.
5. A copy of the company Safety and Health Program should be provided and clearly communicated to all employees.
6. Provide body harnesses as part of a personal fall arrest system. Body belts were disallowed effective January 1, 1998.
